Hi-Fi Products Service Bulletin

Model: MDS-501

No. 435

Subject: The Input Source sound level is reduced when power is switched off

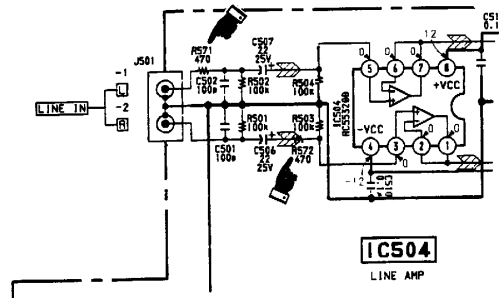
When the Rec-Out of an amplifier is connected to the Line-in of the MDS-501, the sound level of the input source may drop when power to the MDS is switched off.

Solution: Replace the following resistors located on the AU board:

REF	FORMER		NEW	
	DESCRIPTION	PART NUMBER	DESCRIPTION	PART NUMBER
R571	470 OHM 1/6W RESISTOR	1-259-420-11	10K OHM 1/6W RESISTOR	1-259-452-11
R572
