Hi-Fi Products Service Bulletin

Model: DTC59ES; DTC690

No. 443

Subject: No Play Mode

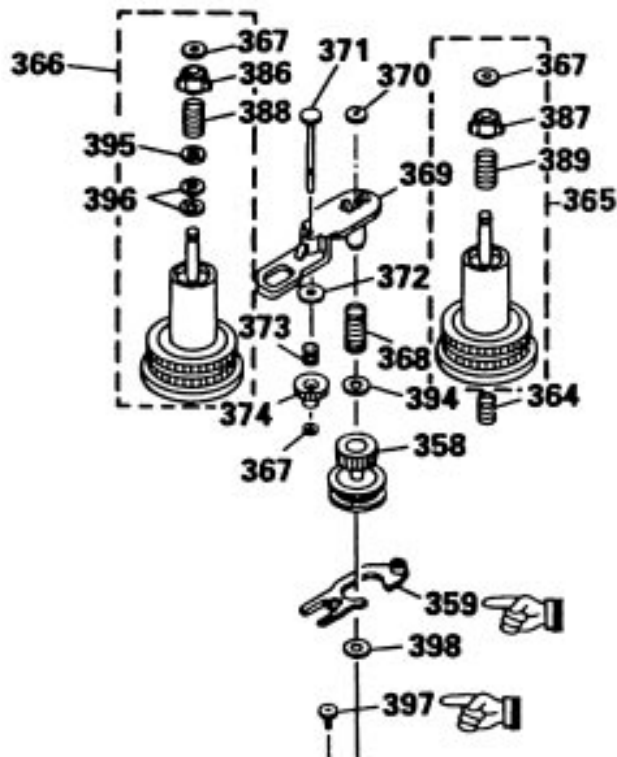
The unit will not enter PLAY when changing from a FF or REW mode. This is due to tape slack when the mechanism stops.

Remove the Slider Reel Lock (ref.#359 p/n 3-368-411-01) and the screw (ref. #397). See diagram below.
