# Hi-Fi Products Service Bulletin

**Model:** HCD-C33, C55

**No.** 446

**Subject:** CD Mechanism Binding

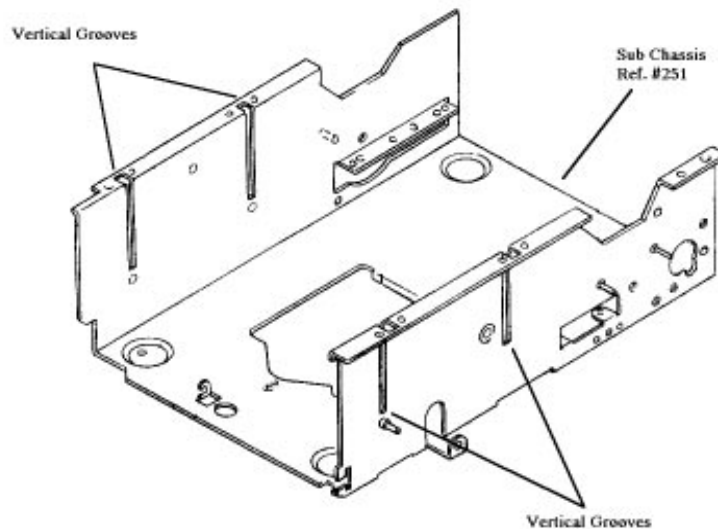
1.) On some units, rough edges have been found on the vertical cut grooves of the sub chassis assy ref. #251.

In both examples the chassis assy, sub should be replaced. The part number for the chassis assembly is X-4944-558-1. The chassis replacement should take no longer than one hour.

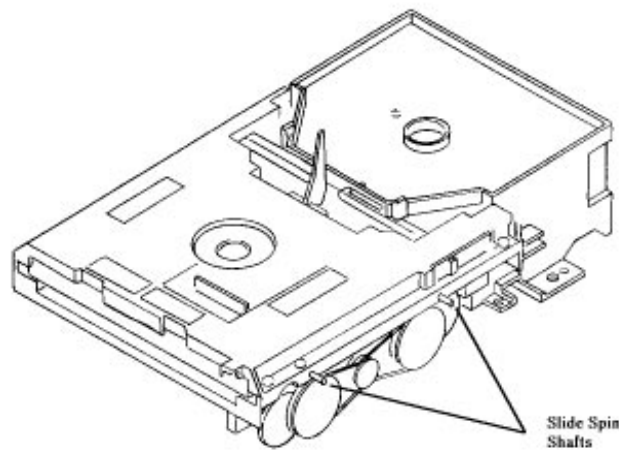
The rough edges within the vertical grooves cause the slide spin shaft (see insert) to bind. This stops the elevators Up/Down motion.

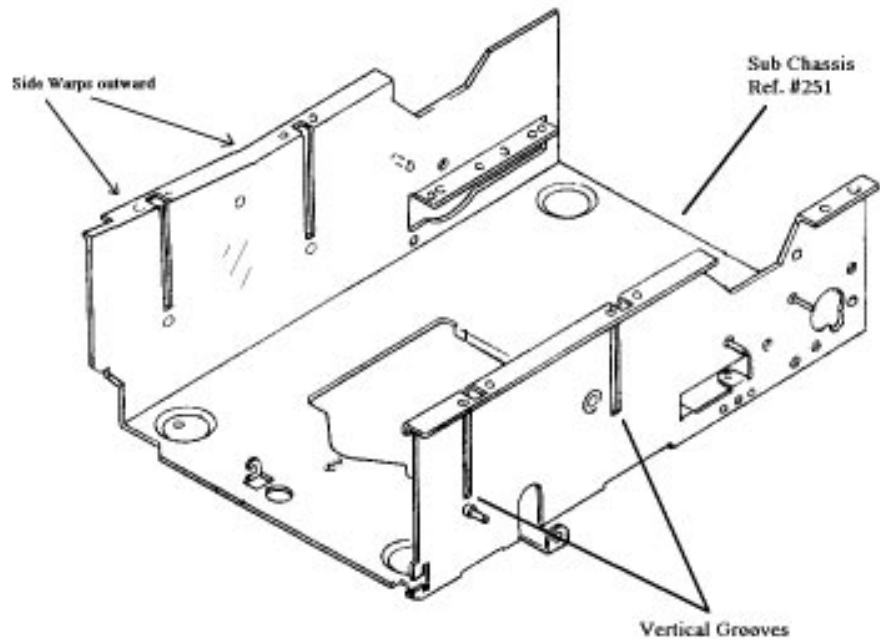
2.) In another instance, the sub chassis assy (ref.#251) can warp causing the vertical grooves to misalign. The combination of a warped chassis and misaligned grooves will cause the elevator assembly to jam.
