Hi-Fi Products Service Bulletin

Model: CDP-X779ES

No. 448

Subject: Intermittant Lock-up of Functions

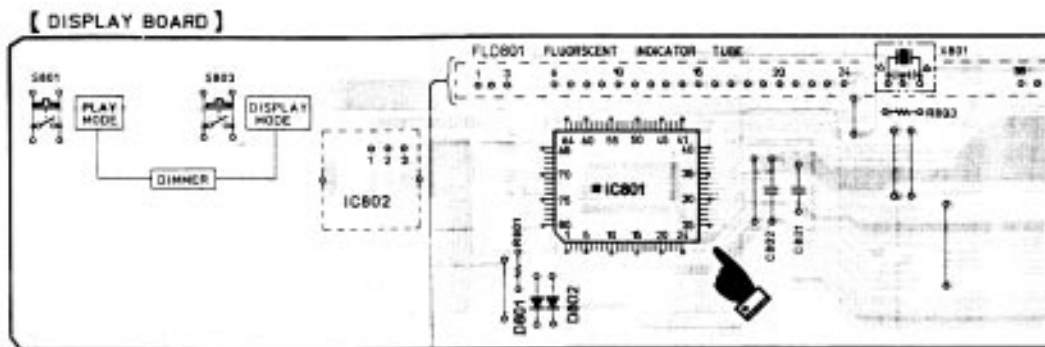
(57) The customer will complain that the unit will intermittantly not operate.

Note: Before replacing IC801 check connectors CN801 and CN301. Poor contact between the Master system controller and the Subsystem controller will cause similar symptoms.

Replace System Control IC801 with the improved version MSC62408-101GS-V1K. The part number for the improved part is 8-759-167-74.
