# Hi-Fi Products Service Bulletin

**Model:** MDS-501

**No.** 451

**Subject:** RF/Servo Board Procedure when replacing  
Optical Device

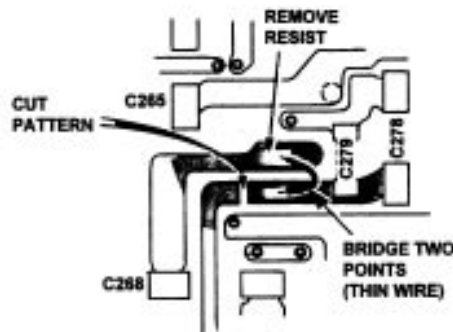
After replacing the optical device, you may find that the unit will play CD discs but not MO discs. Proper adjustment also may not be possible after replacing the optics.

- Cut the pattern at the location shown below.
- Remove the resist on the board at the spots indicated, and bridge the two points using a thin wire.
