# Hi-Fi Products Service Bulletin

**CSA-13**

**Model:** HCD-H305, HCD-H405, HCD-H605, MHC-C305, MHC-C405, MHC-C605      **No. 456**

**Subject:** Mis-operation due to wrong position of the disc tray.      **Date:** November 10, 1995

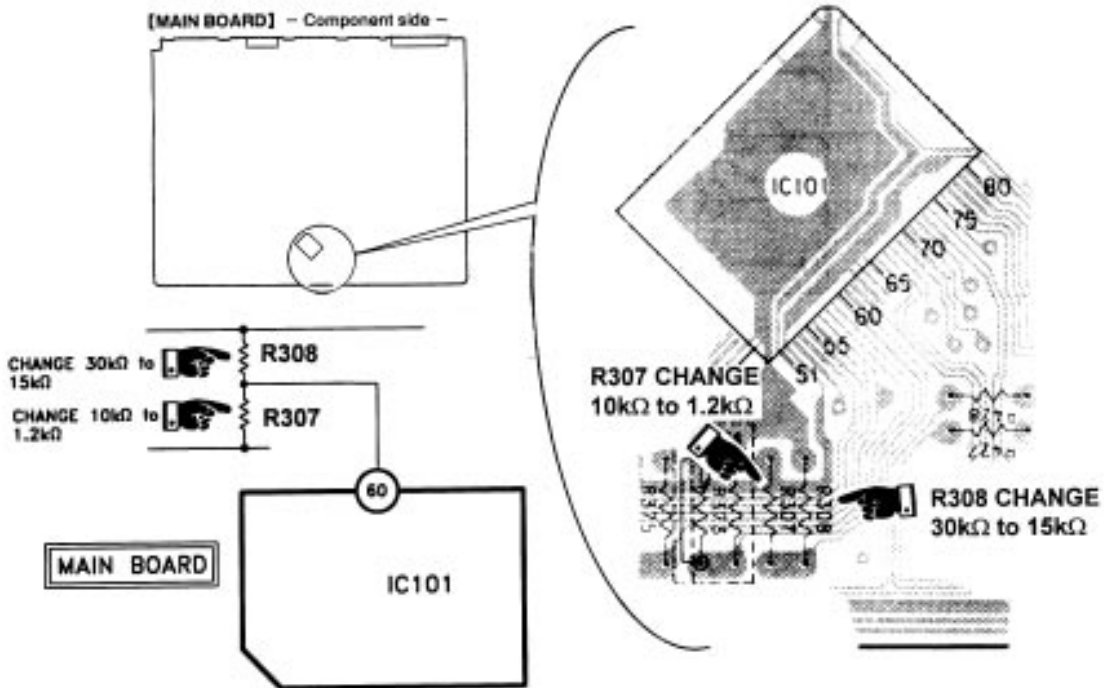
**Symptom:**  
(161) The disc tray may stop during operation.

**Solution:** If a customer complains of this, replace R307 and R308 with the new values to improve tray position sensing circuit.

REF	FORMER		NEW	
	DESCRIPTION	PART NUMBER	DESCRIPTION	PART NUMBER
R307	RESISTOR, 10K $\Omega$	1-249-429-11	RESISTOR, 1.2K $\Omega$	1-249-418-11
R308	RESISTOR, 30K $\Omega$	1-247-866-11	RESISTOR, 15K $\Omega$	1-249-431-11
