# Hi-Fi Products Service Bulletin

**Model:** TC-WR445

**No.** 457

**Subject:** Erratic Deck Operation

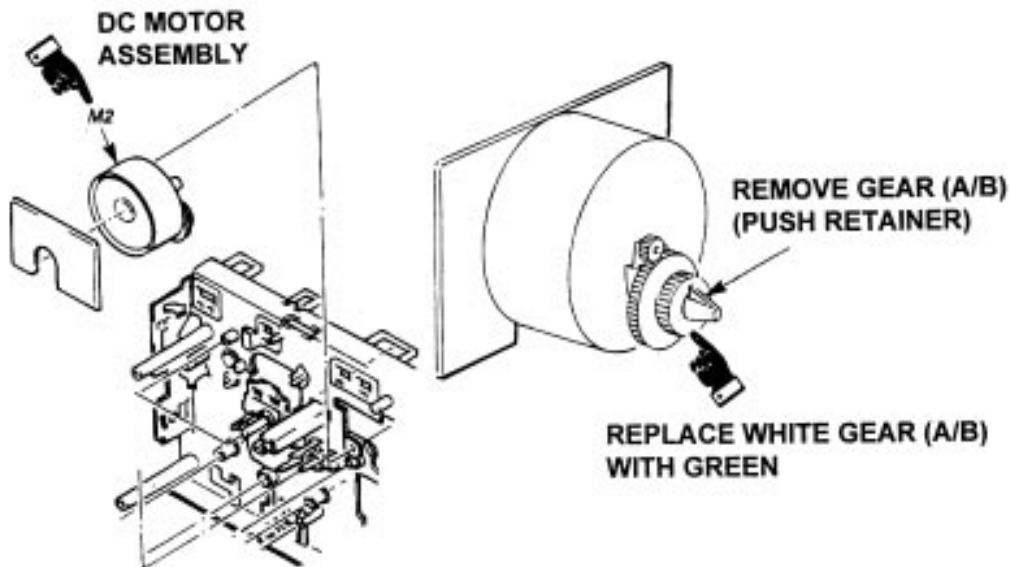
Deck A operates erratically due to incomplete meshing of Gear (A/B) and trigger lever.

Replace Gear (A/B) in the DC motor assy. See part numbers listed below.

REF	FORMER		NEW	
	DESCRIPTION	PART NUMBER	DESCRIPTION	PART NUMBER
M2	GEAR (A/B)	3-918-330-01	GEAR (A/B)	3-918-330-02
