Hi-Fi Products Service Bulletin

Model: FH-209W, FH-211W, HST-190, HST-750W,
TC-FX170, TC-FX211, TC-V33W, TC-W255,
TC-W285, TC-W285, TC-W300, TC-W310,
TC-W380, TC-W390

No. 473R1

Subject: Plastic Screw Kit Available for Mounting Tape
Transport Motor

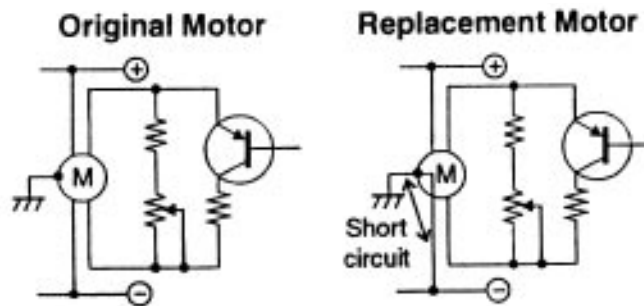
The original Tape transport motor for the listed models is no longer available. Replacement motors are available under the following part numbers: X-3390-801-1, X-3390-802-1, 1-541-427-11, and 1-541-745-11. The negative (minus) side of the replacement motors are internally connected to the motor case. The case ground may damage the negative power supply in a symmetrical +,- power supply configuration.

Use screw and washer kit, part number X-3371-447-1, when mounting a replacement motor in a model using a symmetrical +,- power supply.
