Hi-Fi Products Service Bulletin

Model: MDS-302

No. 475

Subject: Note when replacing an Optical Block

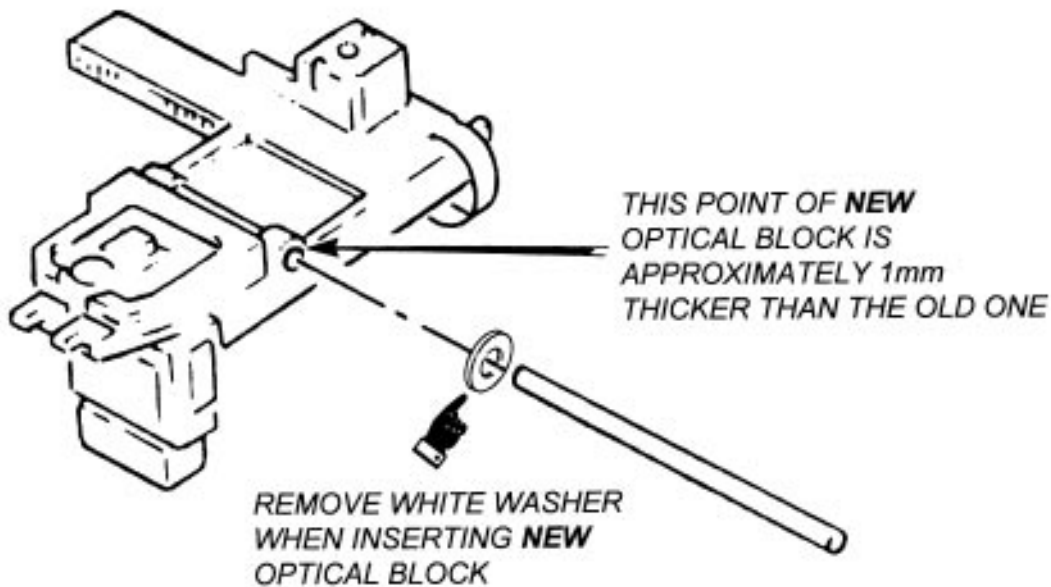
After replacing an optical block, two to three minutes into playing back a 74 minute MO disc, "Retry Error" will be displayed and the sound will skip.

There are two types of Optical block assemblies. In the old type a washer was added to limit the travel of the optics on the shaft. The new type of Optical block assembly has been improved and does not require the washer. Remove the white washer (see diagram below) from the shaft when replacing an older Optical block with the new type. To distinguish the difference between the old and new optical blocks see the diagram below.
