Sony Service Company  
National Technical Services  
A Division of Sony Electronics Inc.  
Park Ridge, New Jersey 07656

## Service Bulletin Hi-Fi Products

**Model:** GEN-CD

**Subject:** Countermeasure for 800Hz Disc Noise

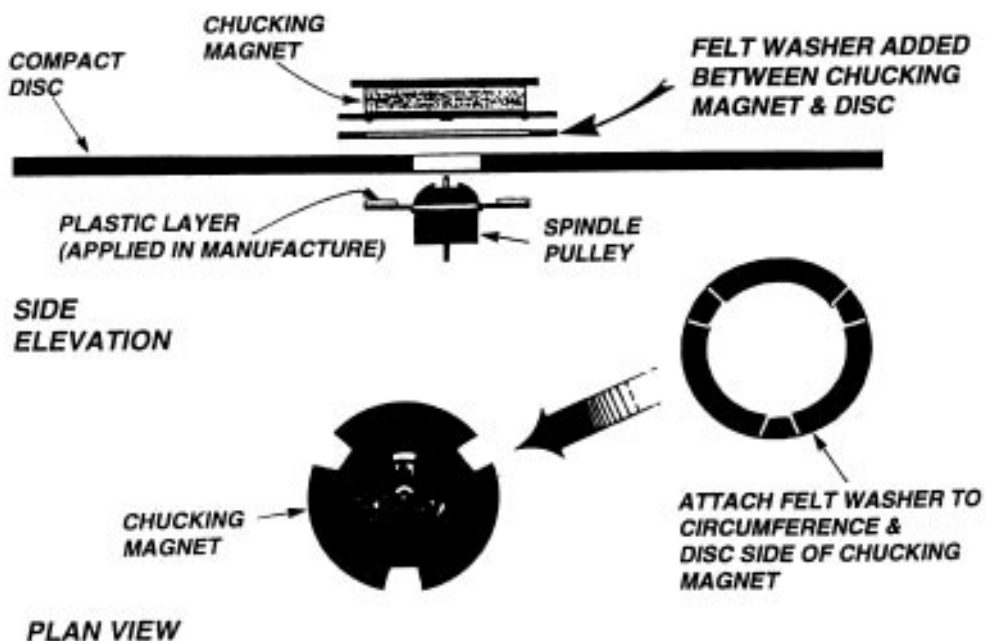
The customer complains of a whistling noise when playing certain Discs.

Add a Felt washer to the disc side of the chucking magnet. See diagram below.  
Note: The felt washer may be added together with the weight outlined in Service Bulletin CSA-13 HFP 428.

REF	DESCRIPTION	PART NUMBER
N/A	WASHER, FELT	4-986-769-01
