**Model:** MHC-C33, TC-WR445

**No. 493**

**Subject:** No Operation of Deck A

**Date:** August 29, 1996

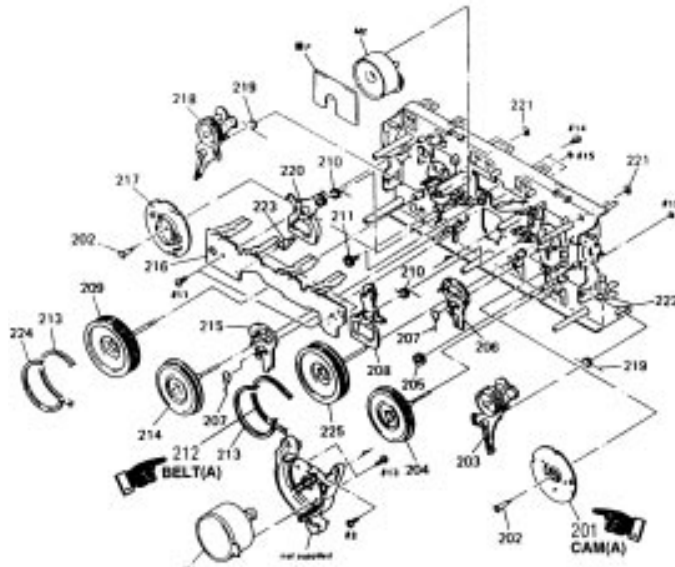
**(161)** The Capstan belt slips due to the excessive load exerted by Cam (A).

Replace Cam (A) with the improved part 3-908-597-05 and Belt (A) with the improved part 3-913-845-11.
