**Model:** STR-GA8ES, STR-GA9ESG**No.** 521**Subject:** Noise in Rear Channels**Date:** March 5, 1997**Symptom:****(154)**

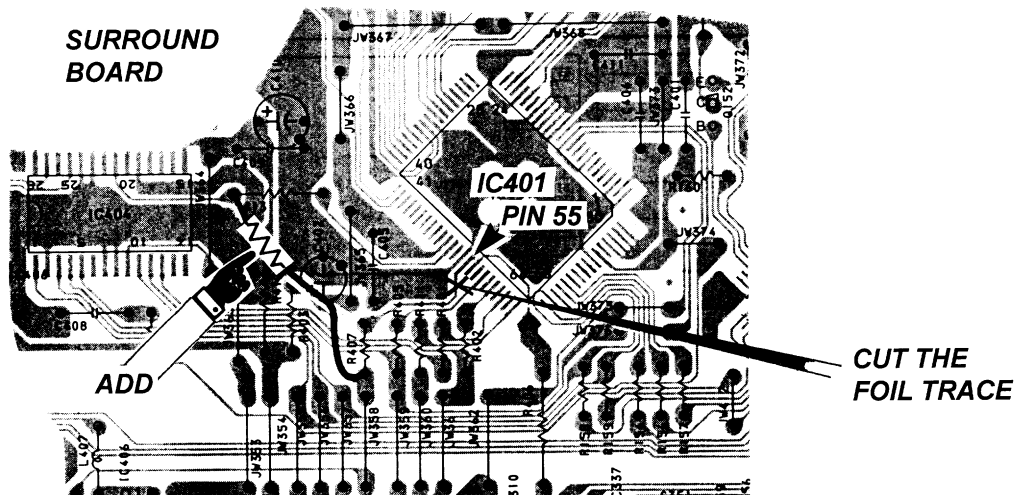
If the customer complaint is excessive noise in the rear channels perform the following procedure.

Add the 100 ohm resistor as described below.

Cut the foil trace between pin 55 of IC401 and R407. Add the 100 ohm resistor from R413 (the side closest to IC401) to JW358. See diagram below.
