Service Bulletin Hi-Fi Products

Model: HCD-H550, HCD-H550M, HCD-H771, HCD-H881,

No. **527**

Subject: High Wow & Flutter Counter Measure

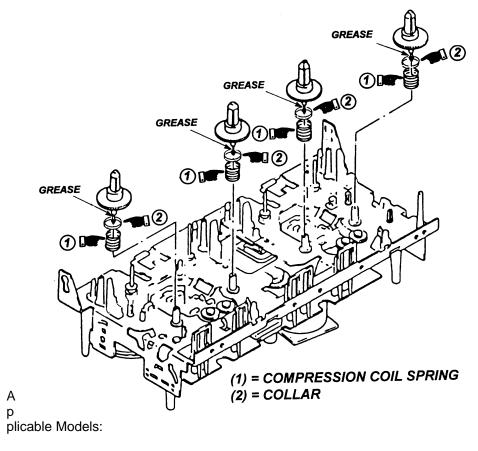
(53) The customer may complain of high wow & flutter when playing tapes.

Replace all compression coil springs and add a collar to each reel shaft as indicated in the diagram below. The necessary parts are available as a Spring Kit (X-3373-874-1). Apply a drop of grease where indicated.
