**Model:** WM-D6C

**No.** 395

**Subject:** Caution When Replacing M901

**Date:** April 29, 1996

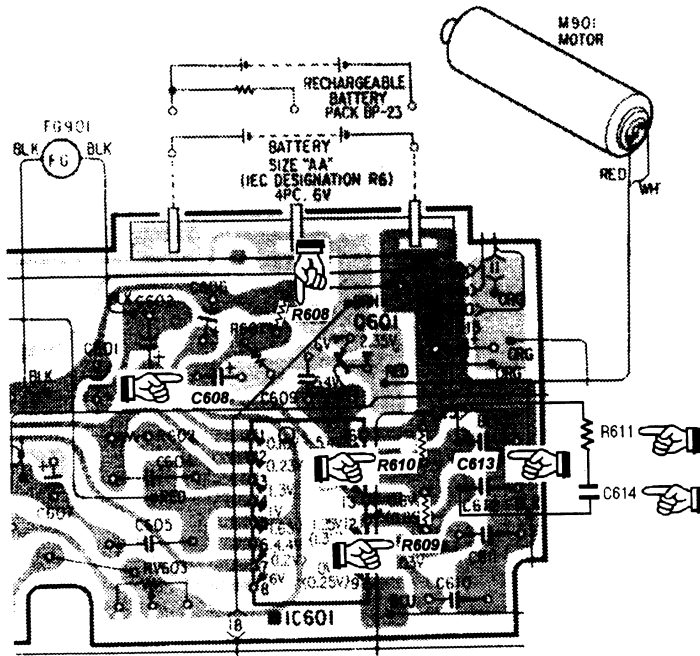
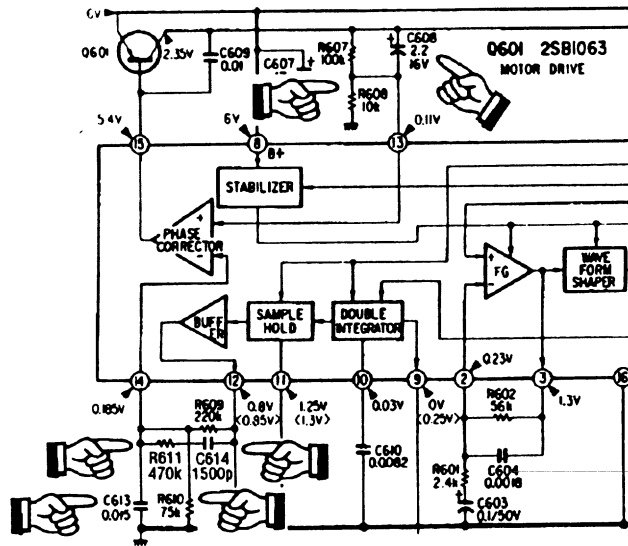
The original Motor M901 (X-3305-830-1) is no longer available, a replacement is supplied instead.

Because the new motor is not fully compatible, the Motor Drive Circuit must be modified as indicated below. The Motor Kit includes all the components necessary to perform the modification. Proceed as follows.

1. Mount the new Motor using the supplied Brackets. Discard the original Motor Brackets (#343, 385, 387).
2. Change the values of the following on the Main Board.
3. Connect R611 and C614 in series, and solder them between pins 12 and 14 of IC601.

REF	FORMER	NEW	PART NUMBER
R608	10K	4.7K	1-249-425-11
R609	220K	470K	1-247-895-00
R610	75K	68K	1-249-439-11
R611	ADD	470	1-247-895-00
C608	2.2UF/16V	3.3UF/16V (T)	1-131-350-00
C613	0.015UF	0.0047UF (M)	1-130-479-00
C614	ADD	0.0015UF (C)	1-161-041-00
