**Model:** TA-E9000ES**No.** 628**Subject:** No Sound**Date:** April 3, 2000**Symptom:**  
**(1510)**

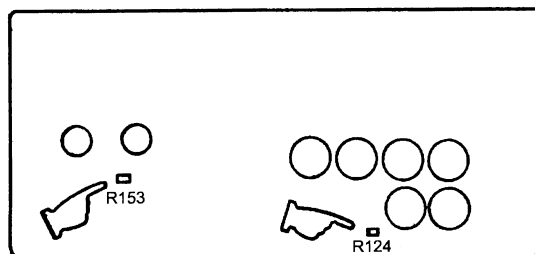
[Power Board ]

The customer complaints of no sound. Q108 on the powerboard may be overdissipated.

**Procedure:**Replace any defective components. Add the 100pf capacitor in parallel to R153.  
Replace R124 with the 4.7K ohm 1W resistor.
