Service Bulletin

NO:HIFI1-99-028R1

SUBJECT: No Sound

MODEL (S): TA-E9000ES

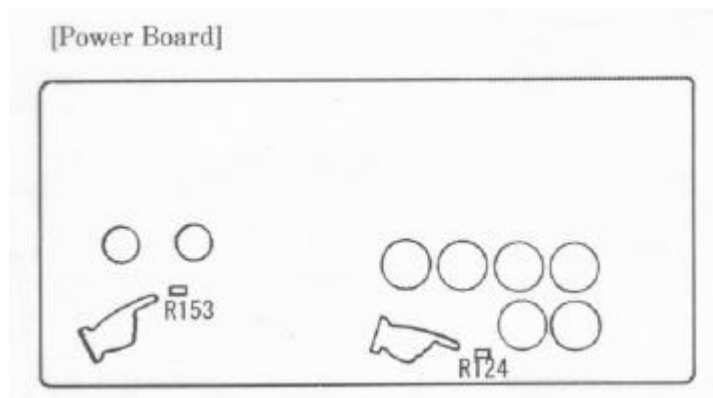
Symptom : No Sound.

Cause : Oscillation may cause Q108, Q109 and R124 to break down.

Solution : Apply the following changes on the Power Board.

1. add a 100pF capacitor (1-163-117-11) in parallel with R153.
2. Replace R124 with 4.7k, 1W resistor (1-215-873-11)
