**Car Stereo
Service Bulletin**

Model: XR-4400/5600/U110

No. 316

Subject: Does Not Receive Radio Broadcasts

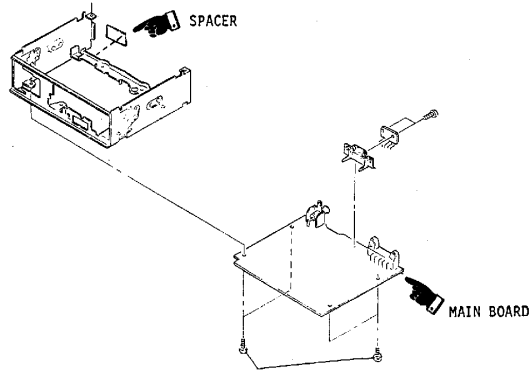
In some units, the antenna plug shorts to the chassis, causing the unit to not receive radio broadcasts.

Solution: If the customer complains of this problem, install a spacer on the chassis as shown below.

REF	DESCRIPTION	PART NUMBER
-	SPACER	3-564-759-01
