Service Bulletin Multi-Disc Players

Model: DVP-S360, DVP-S560D, DVP-S570D, DVP-C660, No. 68R1 DVP-C670D

Subject: PLAYER MAY NOT PLAY CD/DVD OR VCD Date: February 4, 2002

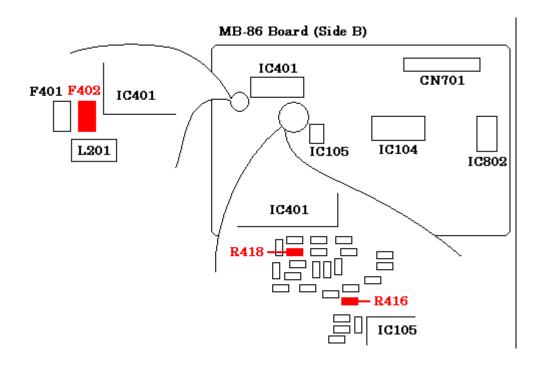
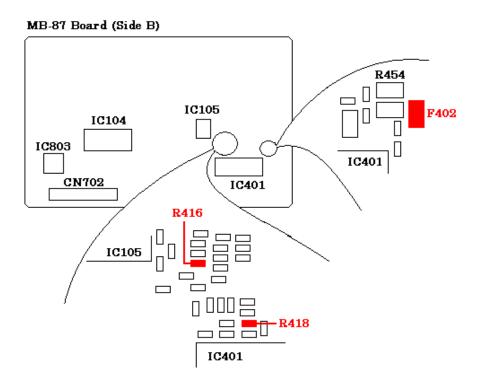
(111A) The DVD player may not play disc. The display may indicate "No Disc "or C:13:00"

Solution: Please remove fuse F402 and replace with 0-ohm resistor on MB board (side B). Exchange the resistors R416 and R418. The original values are 150K; change them both to 82K ohms

- NOTE: A problem can occur if caution is not taken during the installation of the resistors. They are slightly larger than the originals and if not installed properly, can easily short with another trace. Once a short occurs, it places a heavy DC bias across the tracking coil accompanied by a little puff of smoke. To insure a greater probability of success, the resistors R416 and R418 need to be soldered in absolutely straight. If they are turned in any way, the risk of a short becomes much greater. Also it is important to use as little solder as possible.
 - 1. Measure the resistor between Pin # 21 & Pin # 22 of the Flexible Cable, which is connected with the OPT. (See the figure below.) If the resistance between Pin # 21 & Pin # 22 is below 6 ohms, replace the OPT with a new one.
 - 2. Perform servo adjustment after replacing components and/or optical.
