# SONY® Service Bulletin

NO: ME3-99-003

**SUBJECT: MECHANICAL DECK GETS LOCKED**

**MODEL (S): MDX-61**

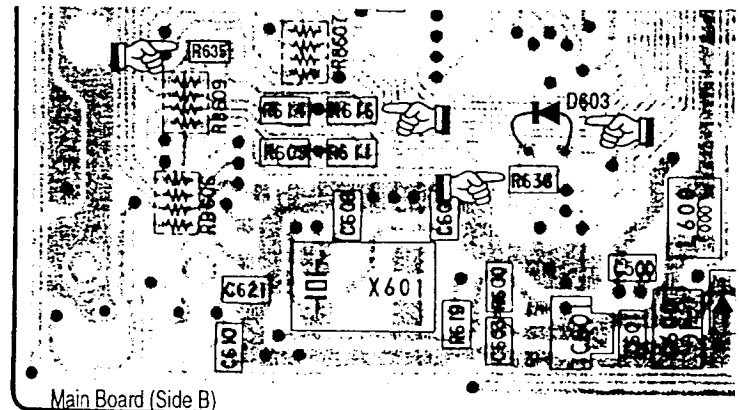
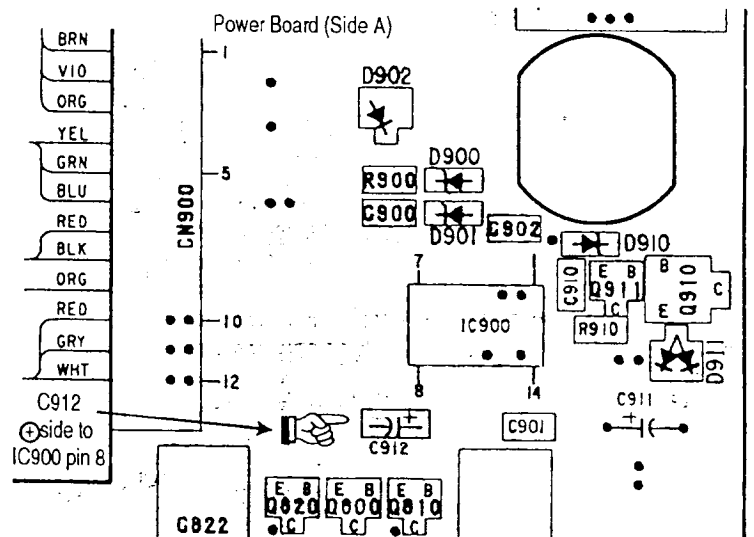
**SYMPTOM:** Pushing the Reset Button during disc changing may cause the mechanical deck to get locked.

Apply the following changes on the Main Board.

- Replace IC600 CXP84340-043 with CXP84648-005 (8-752-882-95)
- Remove R616.
- Add R635 0 Ω Metal Chip (1-216-295-11).
- Remove R636.
- Add D603 MA728 (8-719-421-27).

Apply the following changes on the Power Board.

- Remove C909.
- Add C912 2.2μF 10V Tantalum (1-135-149-21).  
Two versions of Power Board exist, one with and one without solder lands for C912.  
Mount C912 at the mounting location of C909 if no separate solder lands are available.
