# SONY® Service Bulletin

NO: HIFI2-00-001

**SUBJECT:** REPLACEMENT OVERWRITE HEAD

**MODEL (S):** MDS-302

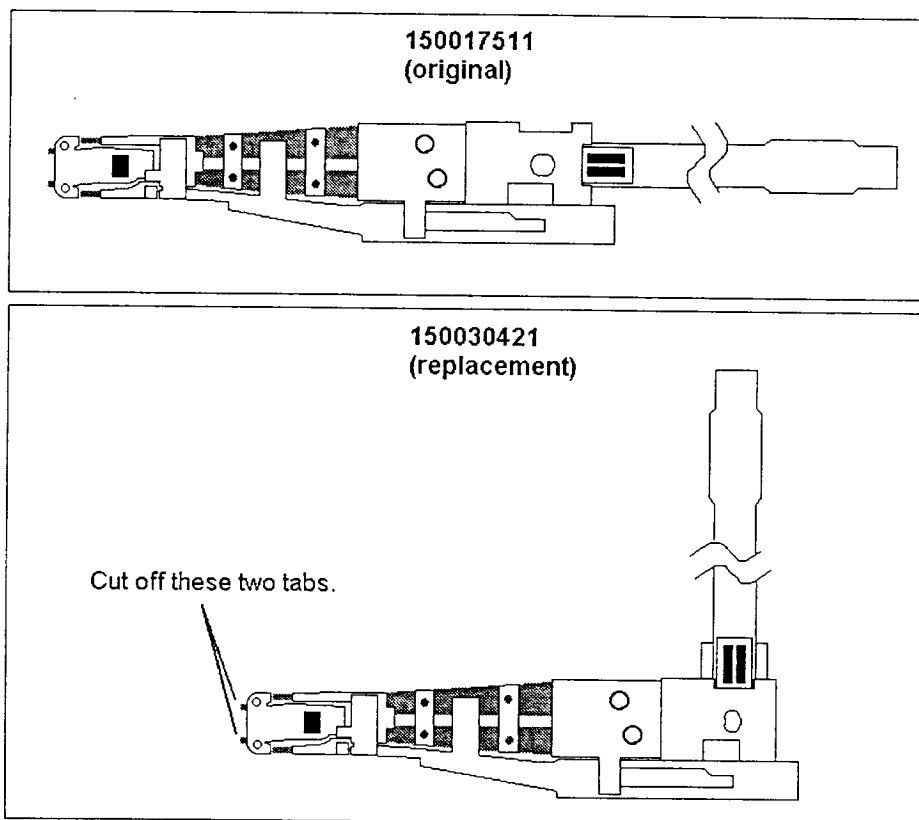
**SYMPTOM:** The replacement overwrite head contacts the mechanism frame.

**SOLUTION:** Remove the two protruding tips of the overwrite head P/N 150030421 before it is installed (see diagram).
