SONY® Service Bulletin

NO: HIF12-99-004

SUBJECT: CAUTION WHEN REPLACING BD BOARD

MODEL (S): MDS-JE320/JE510/PC1/S38/S39

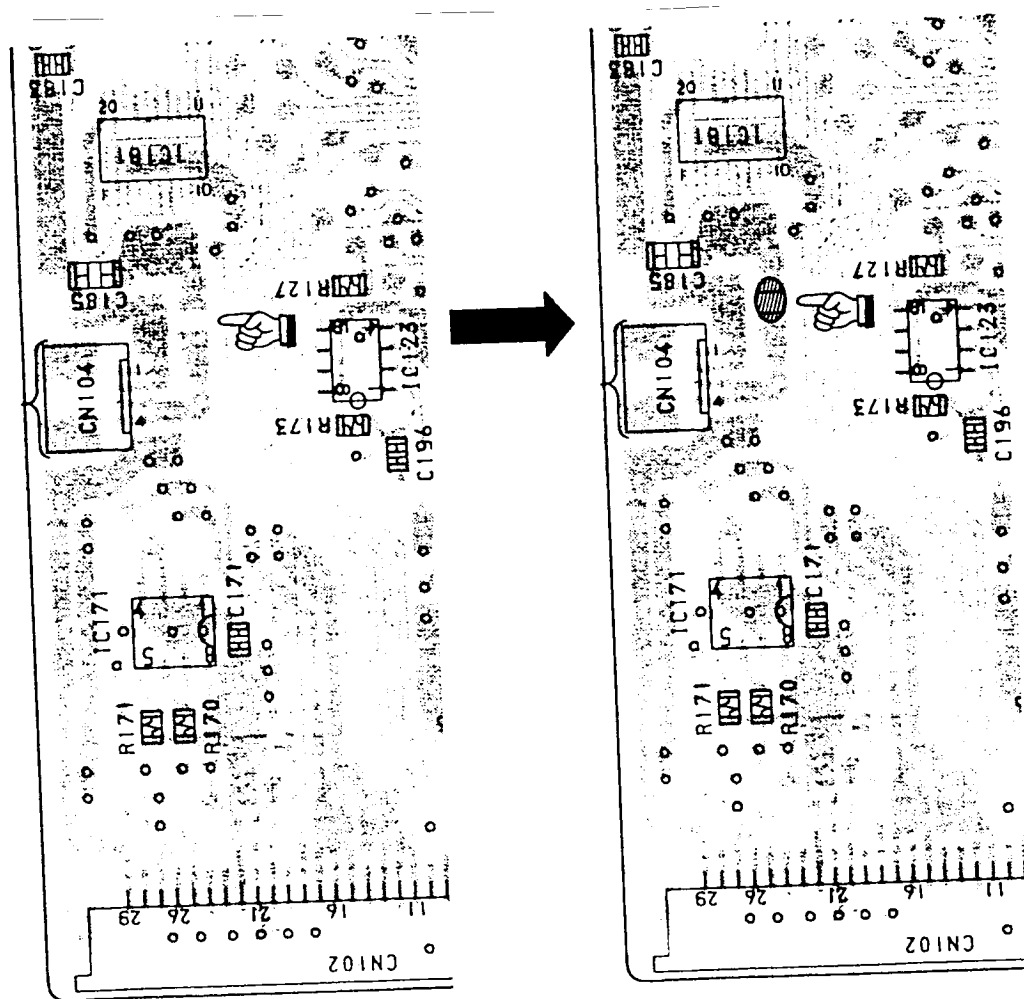
On the BD Board (A-4699-770-A) supplied, a solder bridge may be missing between TP26 and TP27.

Check side B of the supplied BD Board and, if necessary, add the missing solder bridge before mounting the board. A missing solder bridge will prevent the set from recording properly.
