# SONY® Service Bulletin

NO: HIFI2-99-010

**SUBJECT:** DIM LIGHT/LOADING MOTOR MALFUNCTION

**MODEL (S):** DHC-MD7, MDS-M9

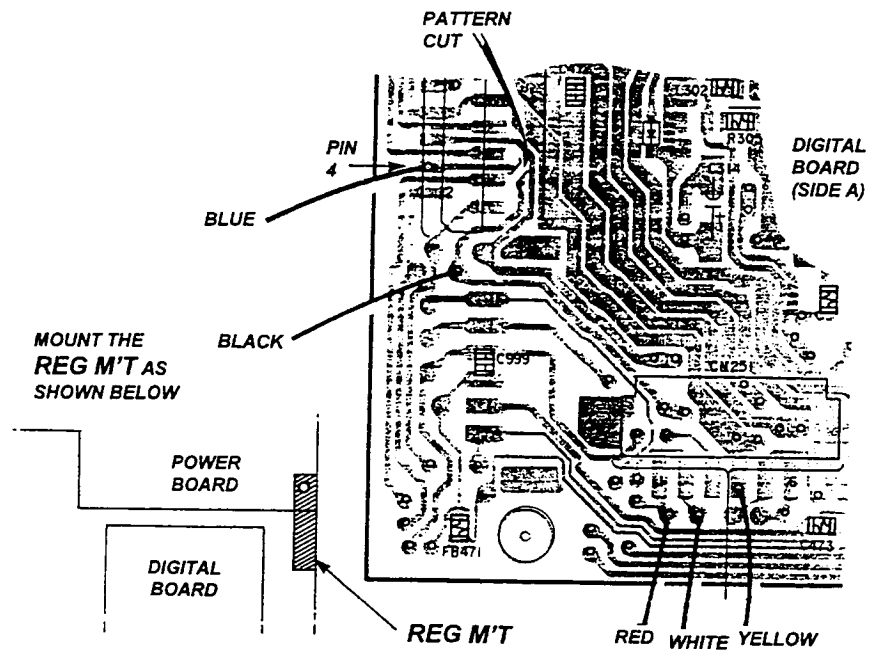
**SYMPTOM:** The customer complains of a dim light or the unit arrives with a loading motor IC malfunction.

Cut the foil pattern from CN223 (see diagram). Attach the wires from the REG M'T to the digital board as shown.
