SONY® Service Bulletin

NO: HIFI2-99-012

SUBJECT: ERROR MESSAGE "C-13 DISC ERROR" WHEN USING A NEW DISC

MDS-JB920/JE520

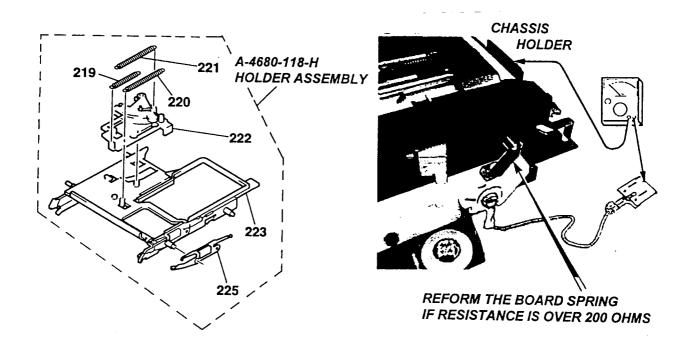
SYMPTOM: The customer complaint states the unit displays error message "C-13 Disc Error" when

using a new disc.

SOLUTION: Replace the holder assy P/N (A-4680-118-H). After replacing the holder assembly test the

continuity between the chassis at the holder Assy and the main board ground. (must be less than 200 ohms). If continuity reading is higher than 200 ohms reform the board spring (see

picture).
