Service Bulletin

NO:HIFI2-01-001

SUBJECT: Noise Recorded in Analog Recording Mode

MODEL (S): MDS-JE330, MDS-S40

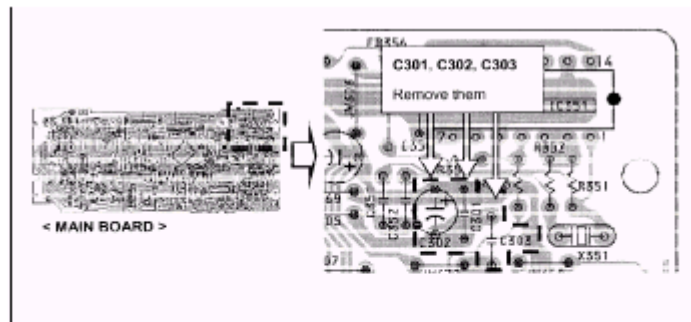
Symptom: The customer complains of noise in the audio when recording in analog recording mode.

Remove capacitors C301, C302 and C303 from the main board.
