Service Bulletin

NO:PV2-01-016

SUBJECT: MDX-M2000 Change LS Cam Plate Adjustment

MODEL (S): MDX-M2000

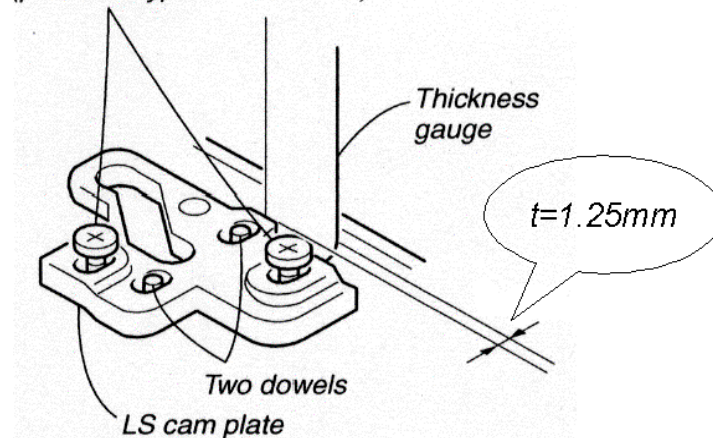
4-9. LS Cam Plate Position Adjustment

Symptom: When a tape UL, it can be malfunction for UL operation that caused by guide base (T) assy. Then, we have change in LS cam plate position adjustment.

Two screws
(precision type3 +P1.7 × 1.8)

- 1) Perform loading of the LS chassis block assembly ① until the tip of the guide base (S) assembly reaches the drum base assembly.
- 2) Loosen the two screws (precision type3 +P1.7 × 1.8) ② of the LS cam plate and slide the LS chassis block assembly to the drum side so as to remove play.
- 3) Insert the thickness gauge 0.6 mm (Ref. No. J-16) between the LS cam plate and the LS chassis block assembly. Push the LS cam plate in the direction opposite to the drum to remove play.
- 4) Fix the two screws (precision type3 +P1.7 × 1.8) ②.
Tightening torque: $0.108 \pm 0.01 \text{ N}\cdot\text{m}$ (1.1 kgf·cm)

- 2)slide LS chassis block assy 1. to opposite of drum so as to remove play.
- 3)the thickness gauge (Ref. No.J-16)
correct $t=0.6\text{mm}$ to $t=1.25\text{mm}$, as follows.
