# Computer Monitors Service Bulletin

CSI-111

**Model:** GDM17SE1, GDM20SE1

**Subject:** Circuit Improvement

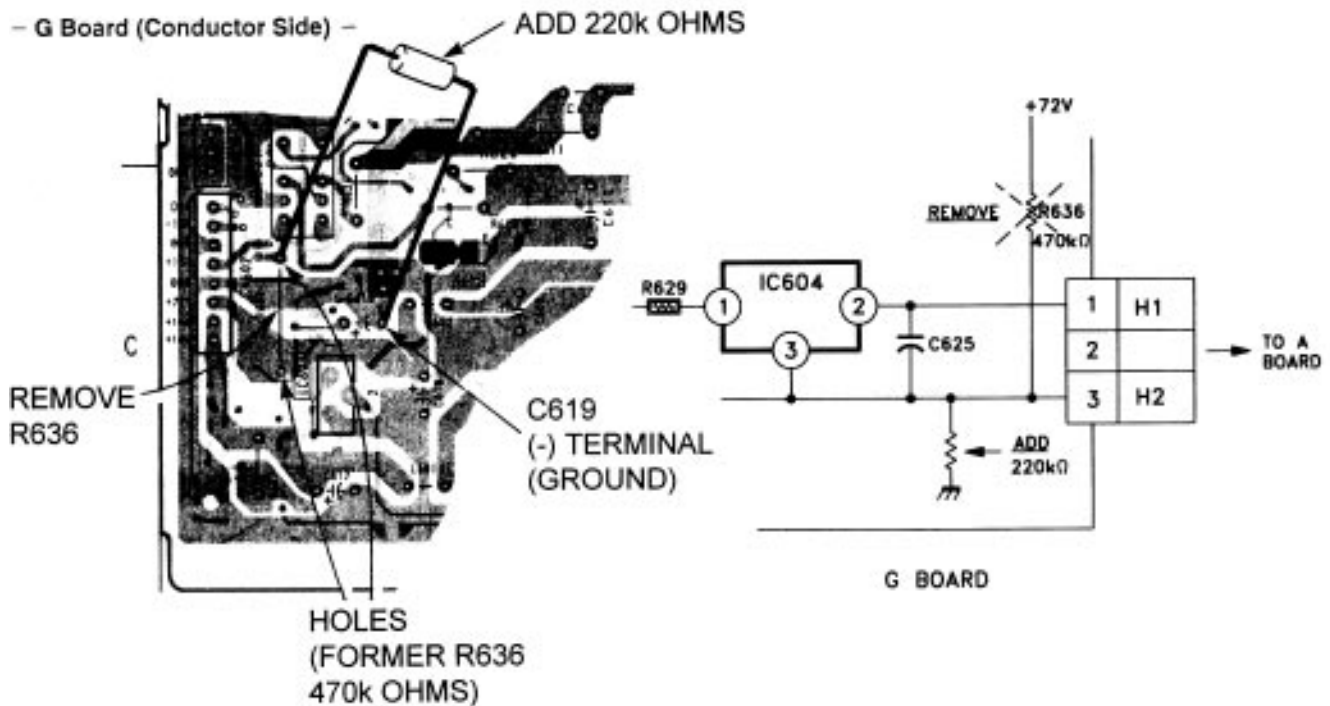
**Symptom:**  
(231) Countermeasure against possible arcing

1. Remove R636 from the G-Board.
2. Add new Resistor (220K $\Omega$ , 1/2 Watt, P/N: 1-202-842-11) between R636 and C619 lands as illustrated below.
3. Fix resistor in place by applying RTV.
