Computer Monitors Service Bulletin

CSI-111

Model: GDM17SE1

Subject: Countermeasure for dimming picture

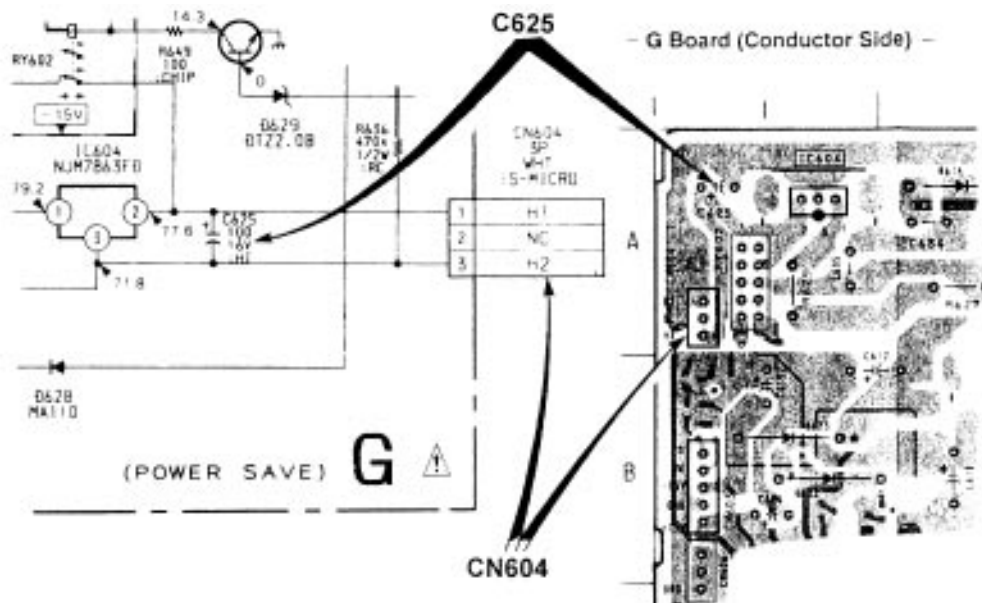
After a while, the picture dims and eventually disappears completely

C-625 is located on the G-board and it is the main filter for the CRT heater voltage. In some rare cases visual inspection will reveal an inward indentation on the top of the capacitor. This indentation causes the heater voltage across the CRT to drop due to cap failure. Replace the Capacitor.

Do not replace the Picture tube nor the Power Supply board (G-Board). Instead please check C-625 first.

If this is not the case, check the heater circuit for normal operation. CRT confirmation may be done by disconnecting CN604 (heater voltage) and applying an external regulated 6 volts DC directly to H1 and H2 on the A-Board.
