Computer Monitors Service Bulletin

Model: GDM20SE1, GDM17SE1

No. 89R1

Subject: Failure of Q511 on D Board due to CRT Arcing Date: August 8, 1995

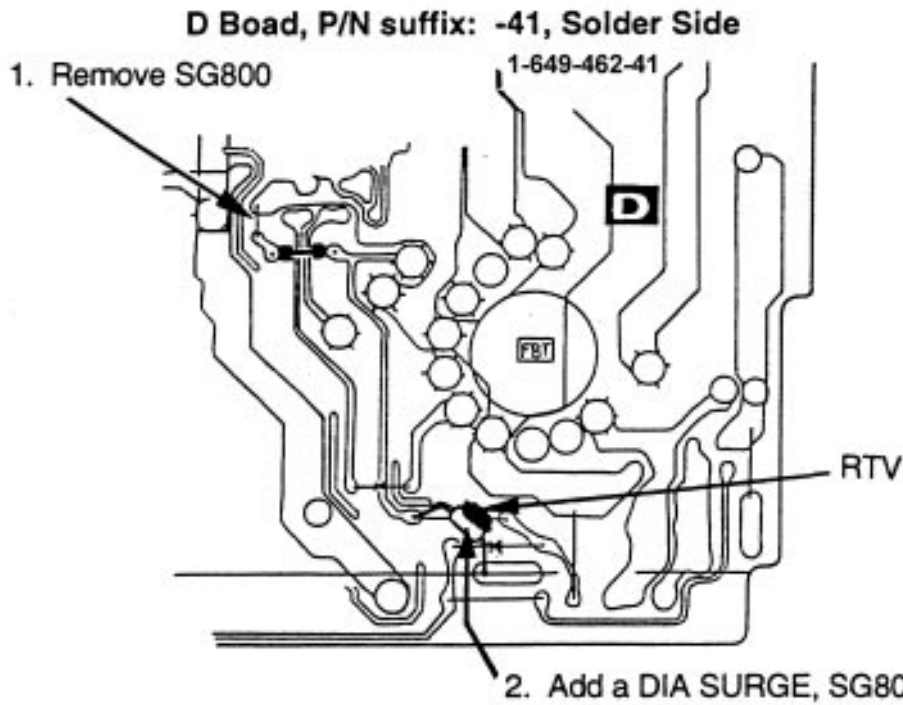
Board, Part No. Suffix -11 to -42

Symptom: (131) No picture. Scan failure. Q511 failure on D Board .

Perform modifications as shown according to the applicable foil pattern.

1. Remove SG800 Spark Gap.
2. SG801 will be soldered on the Soldering side of the D Board. Cut the leads of the SG801 as necessary. Solder one lead of SG801 to the land of R825. Solder the other lead of SG801 to the land of the Heatsink as shown.
3. Fix the body of SG801 to the D Board on the board near the FBT ground with RTV or similar adhesive.

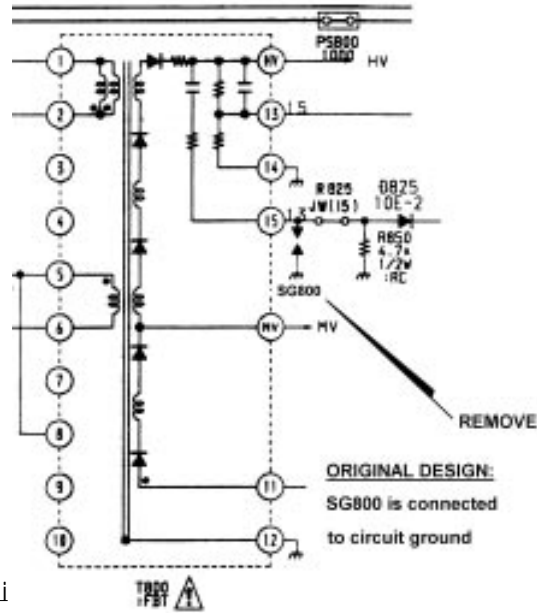
Original Design: SG800 is connected to circuit ground.

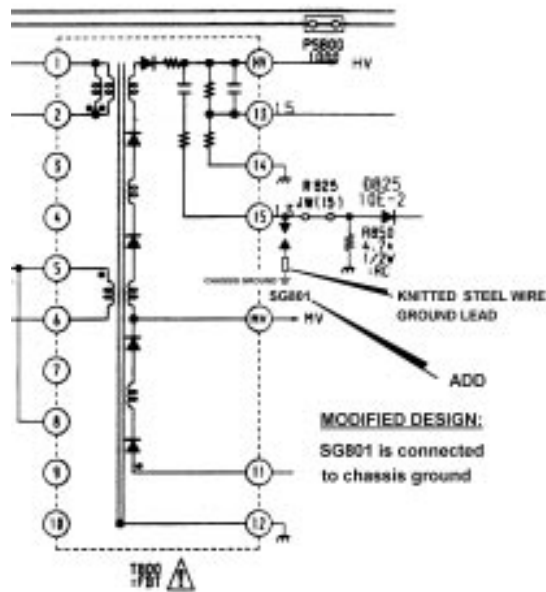
Modified Design: SG801 is connected to chassis ground.

For other foil patterns, perform modifications according to the schematic changes described as follows. cont.
