Service Bulletin Computer Monitors

Model: GDM-17SE1, GDM-20SE1

No. 125

Subject: No Picture due to loss of CRT Heater Voltage

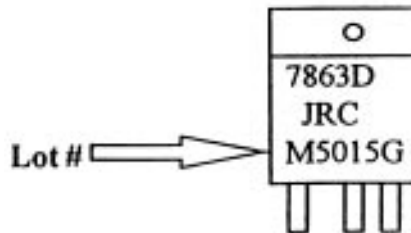
IC604 MARKINGS

If the screen is dark, this may be due to loss of CRT heater voltage caused by IC604 failure on the G Board. Effected units have IC604 marking shown in the illustration below. Units with IC604 corrected have green labels affixed to the G Board shield case and to the information label on the rear panel.

1. Check the Lot No. on IC 604. See illustration below.

2. If the Lot No. of IC604 is "**M5015G**", then replace IC604 with the new component.
3. If IC604 was replaced, then mark the unit by affixing a small (6-10 mm) green label to the G Board shield case. Also, affix a small (6-10 mm) green label to the information label on the rear panel of the unit.
