# SONY® Service Bulletin

NO: CTV-98-001

**SUBJECT:** VERTICAL JITTER; R504 AND/OR R521 DAMAGED

**MODEL (S):** KV-9PT50, KV-9PT60

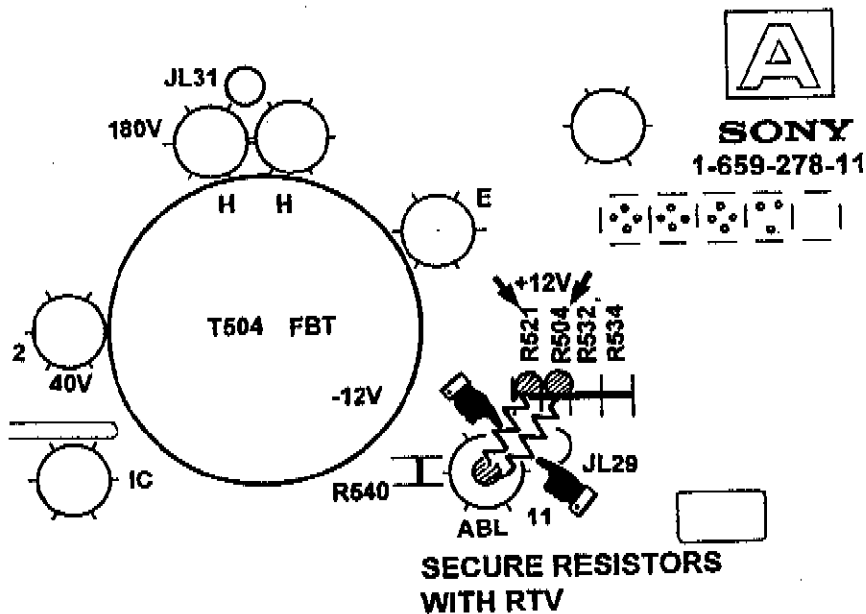
**Symptom:** The picture exhibits vertical jitter. This problem may occur if R504 and/or R521 are damaged.

**Solution:** If the above symptom is found to be caused by damaged R504 and/or R521 on the A-board, replace both resistors with the parts shown below.

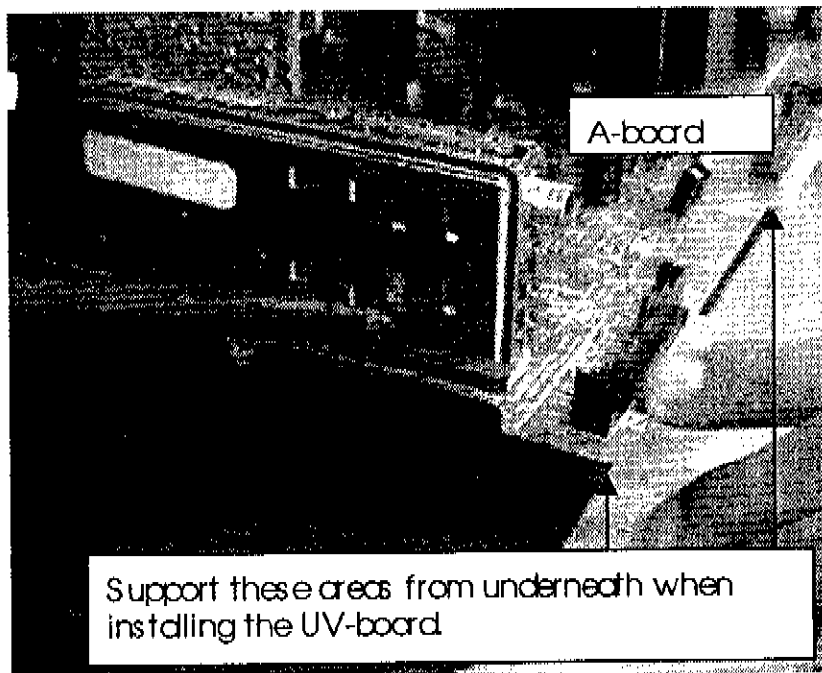
**Symptom:** The rear portion of the A-board extends beyond the circuit board support rails of the front cabinet. Consequently, cracked or broken solder joints, lifted lands, or board breakage may occur if pressure is applied to the rear portion of the A-board during servicing. This is especially true when installing the UV-board onto the A-board, which may result in the aforementioned damage in the area of the tuner.

**Solution:** Prevent A-board damage by carefully handling the board during servicing. Be sure to support the A-board from the underside when installing the UV board to prevent any undue stressing of the A-board.

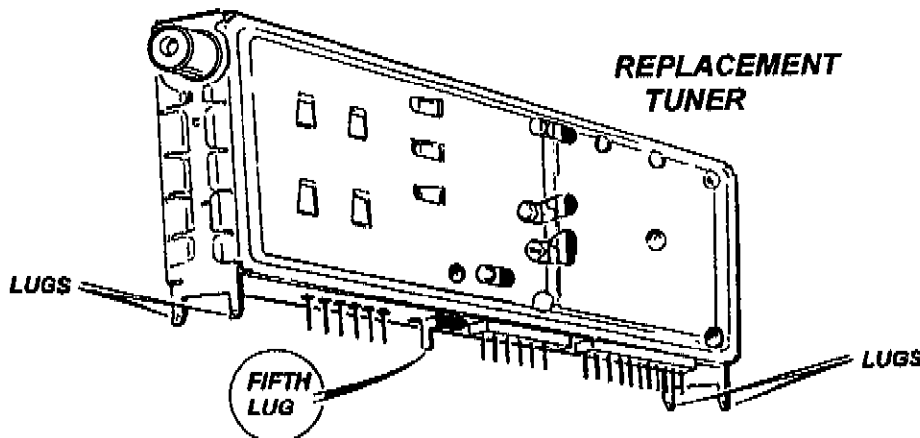
**Symptom:** New replacement tuner has five ground lugs compared to four on the original tuner. Board does not have a hole to accommodate the fifth lug.

**Solution:** When replacing the tuner with the new replacement tuner it will become necessary to remove the fifth lug, located in the middle of the tuner.

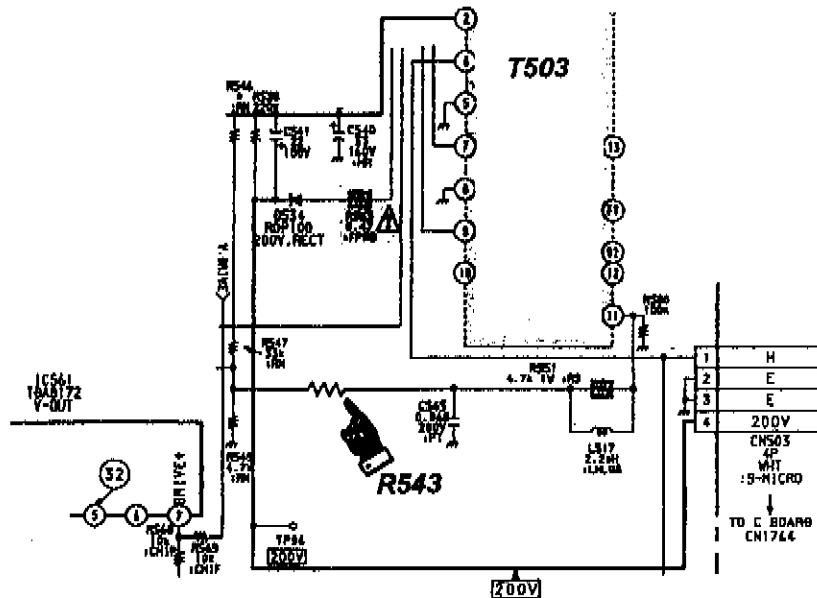
**A BOARD SCHEMATIC GRID LOCATION L-20**

**Symptom:** The part number for Ref # R543, 0.47 Ohm 1/4W, located on the A board, was not shown in the schematic or listed in the parts list.

**Solution:** Please add the following part number to the Service Manual.

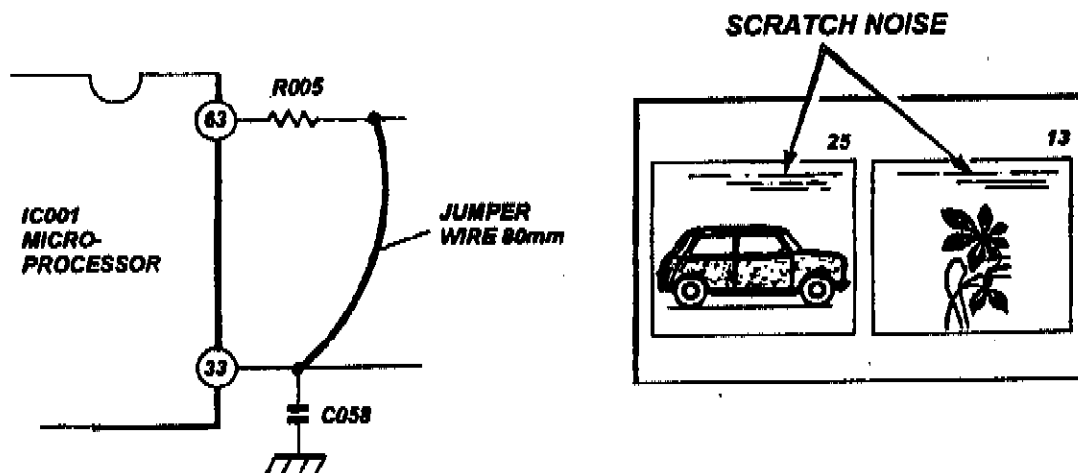
**Symptom:** If two different signal sources are displayed when in the PIP mode is selected, a scratch noise (lines in picture) may appear in the picture.

- 1.The PX board must be replaced with *PIN 1-666-471-XX*.
- 2.Replace the Microprocessor (-001S)CXP85856A-001S (labeled for PIP scratch Noise)
- 3.Modify the A board (suffix -11): connect the lands of C058 and R005 using a jumper wire (80mm)
