Video8

B-mechanism know-how

8 MECHANISM DECK

SONY®

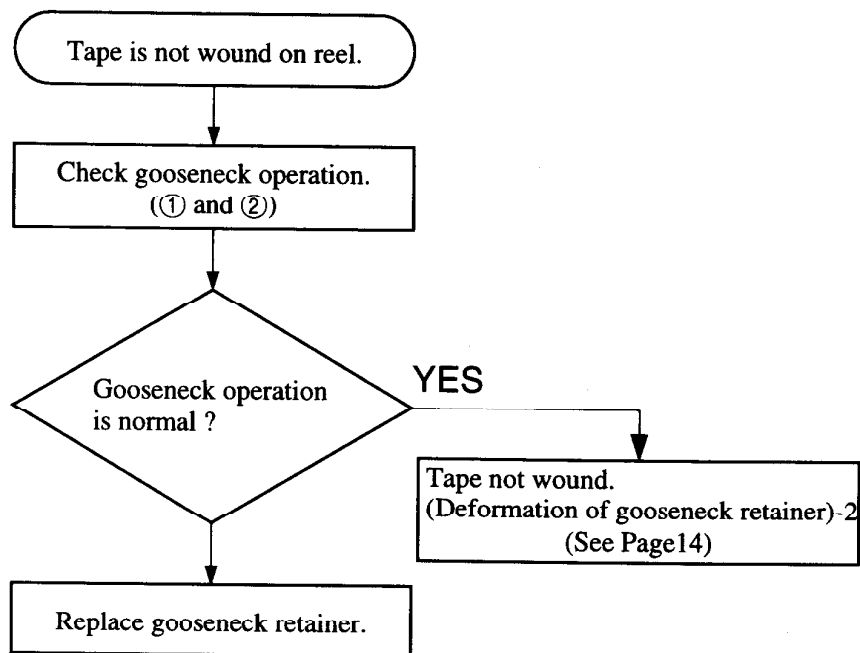
A. Gooseneck gear ass'y is not operating due to deformation of gooseneck retainer. Tape is not wound on reel table.

Gooseneck gear ass'y touches the gooseneck retainer due to warp of the retainer, so gooseneck gear does not operate properly and is not meshed with the gear of reel table.

Mounting screw No.2 3-976-055-01
Gooseneck retainer (2) 3-989-479-01

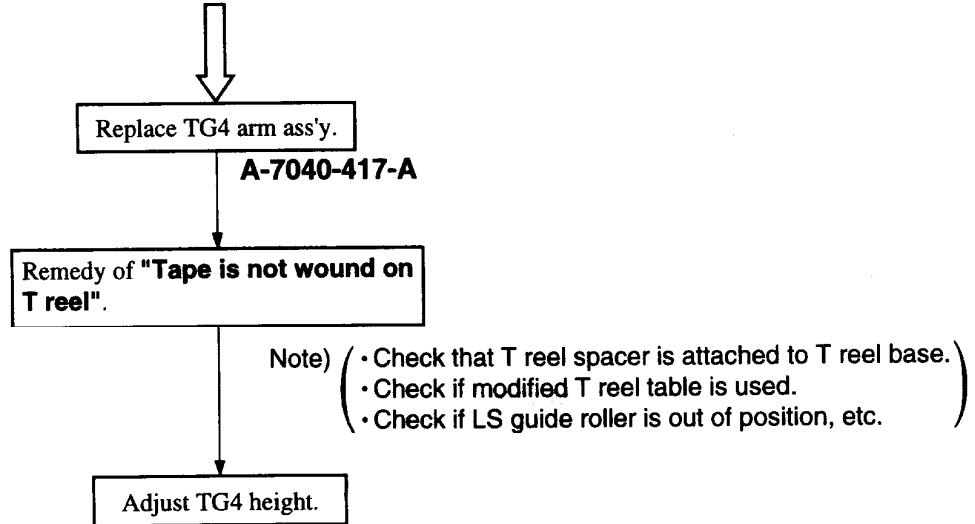
**Tape is not wound correctly and cannot be removed.
Tape is entangled at TG4. TG4 arm ass'y is deformed
by the force of pulling tape.**

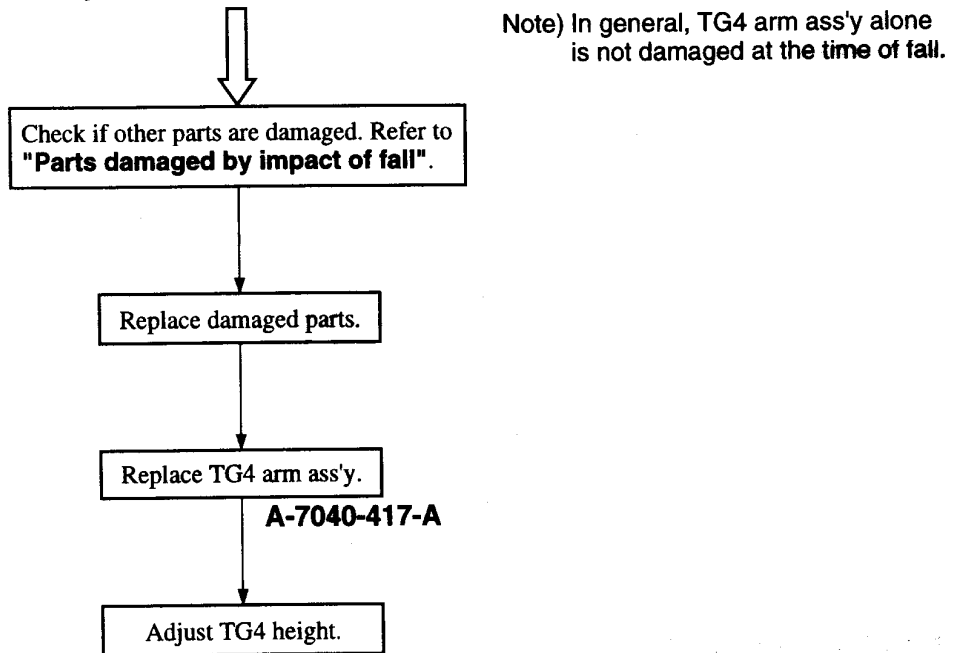
B. Deformation due to impact of fall.

TG4 arm ass'y is deformed by impact of fall.

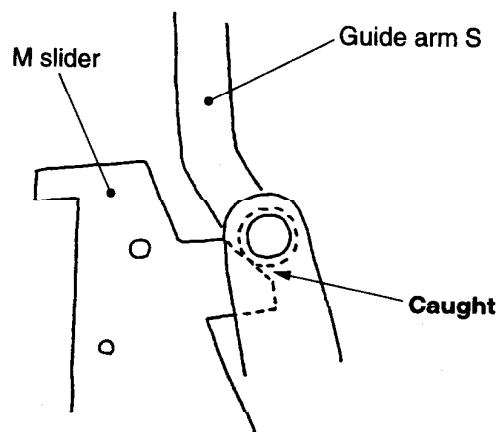
The caulked portion of guide arm S is caught in the edge on the end face of M slider, causing unloading failure.

The end face "C" of M slider is small and the caulked portion of guide arm S was caught in the end face.

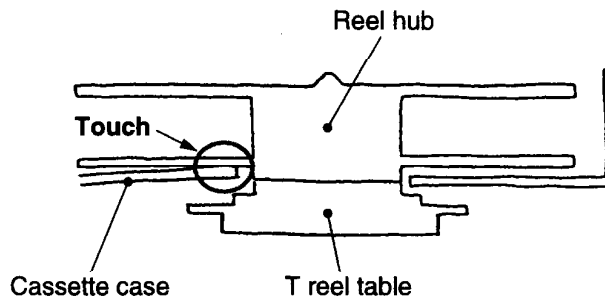
Reel hub touches the bottom of the case of video recording guide tape cassette, and tape cannot be wound due to failure of reel rotation.

1. Flatness of video recording guide tape cassette is NG.
2. The height of T reel is low due to deformation of chassis at cassette compartment DOWN with the spring force of cassette compartment, causing a fall of T reel shaft.

1. Change the verticality tolerance of T reel shaft.
2. Correct the flatness of video recording guide tape cassette.
3. Change the height of T reel (spacer can be used temporarily).

- Replace video recording guide tape cassette.
- Check T reel shaft for bending.

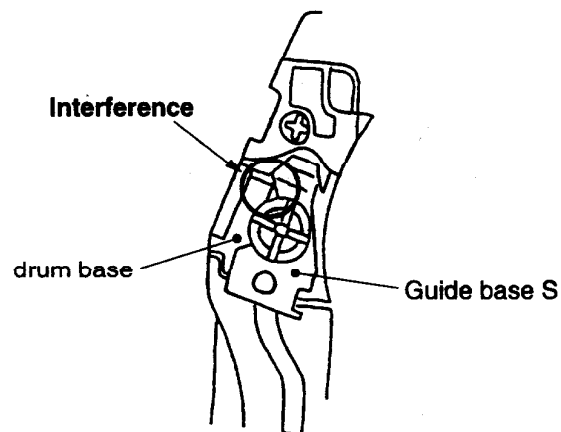
The corner of drum base groove is caught in the V-shaped guide base S at unloading, causing unloading failure.

Interference due to variations of the corner of drum base groove and the shape of edge of guide base S (insufficient margin).

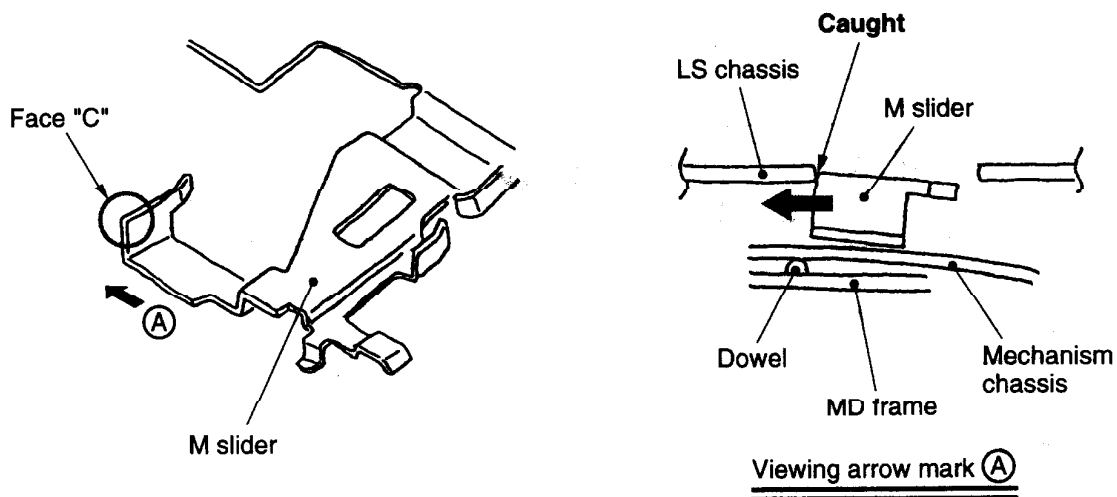
The corner of M slider is caught in the hole of LS chassis, causing deformation of M slider and loading failure.

MD frame was mounted when the dowel was floating. The posture of M slider was changed due to warp of mechanism chassis, and the corner of M slider entered the hole of LS chassis.

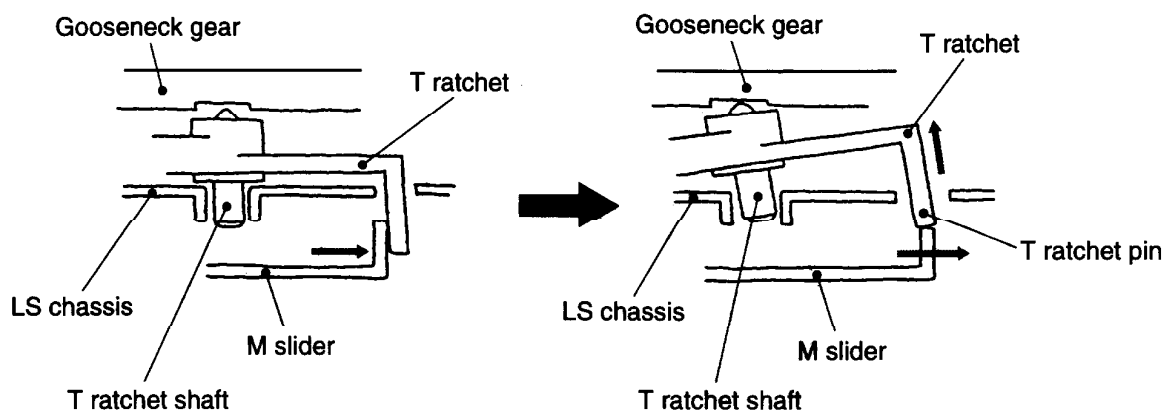
T ratchet pin rides over M slider and is caught at loading/unloading, causing failure of resetting T ratchet.

T ratchet shaft is loosened in the hole of LS chassis, and M slider is pushed to M slider at change of mode, so T ratchet is tilted. The pin rides over the wall of M slider and cannot be reset.

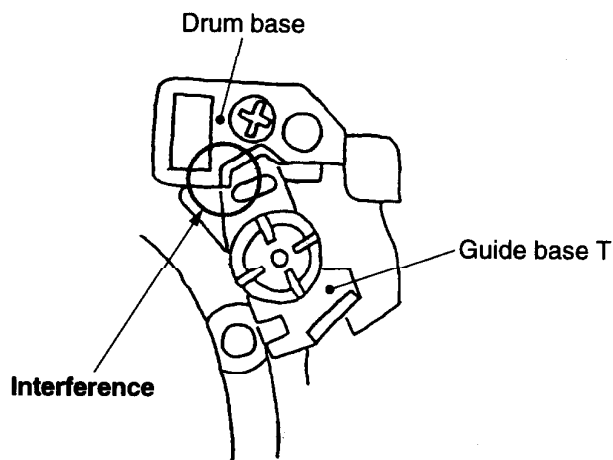
The drum base touches the guide base T at loading, causing failure of tape threading.

The drum base touches the guide base T at the position marked "O".

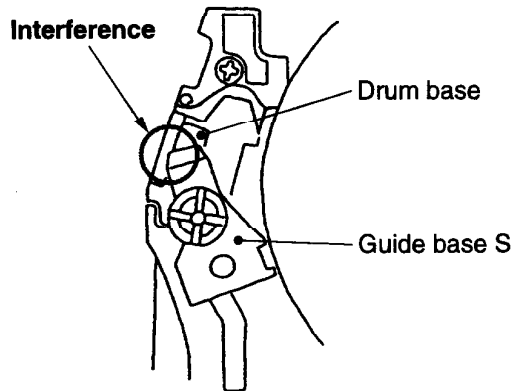
Tip of guide base S is caught in the triangle rib at the entrance of drum base, causing loading failure.

Tip of guide base S caused interference due to variations of position and thickness of drum base rib (insufficient margin).

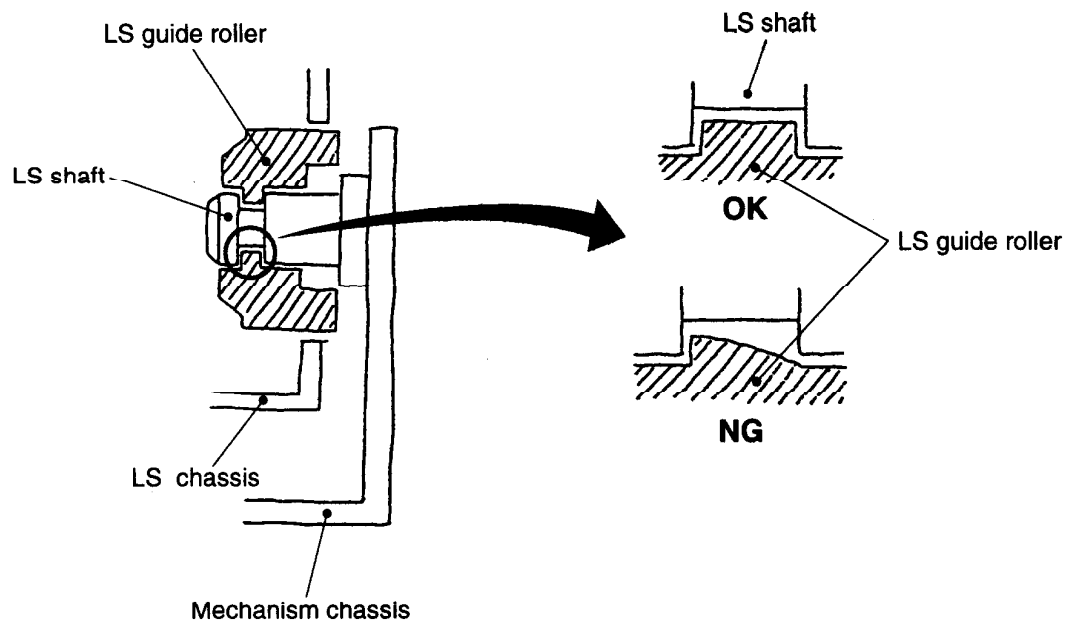
LS guide roller is separated, causing loading /unloading failure. Tape is not wound on reel (cassette gets out of position).

Releasing force of LS guide roller is small due to improper shape of claw that is caught in the groove of LS shaft.

Correct the shape of LS guide roller.

- Replace LS guide roller.
- Do not use the dismantled roller.

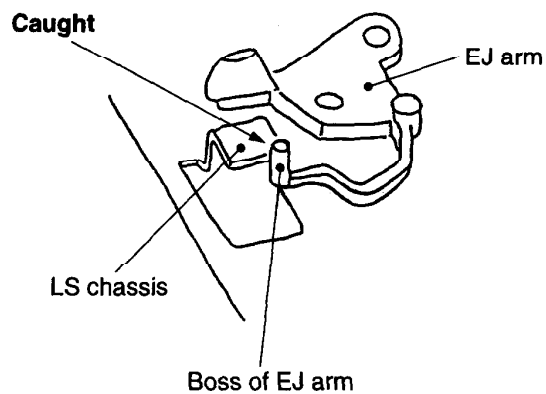
EJ arm is deformed at the time of assembling and the boss on the spring is caught in LS chassis, and SW is kept pressed.

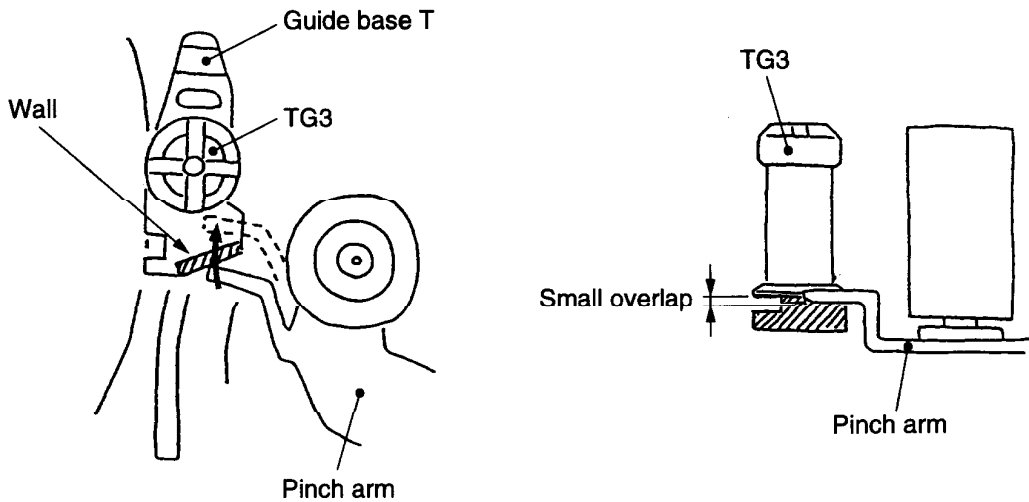
The tip of pinch arm gets over the wall of guide base T and enters between guide base T and TG3, causing loading failure.

The amount of overlap of the tip of pinch arm and the wall of guide base T is small.

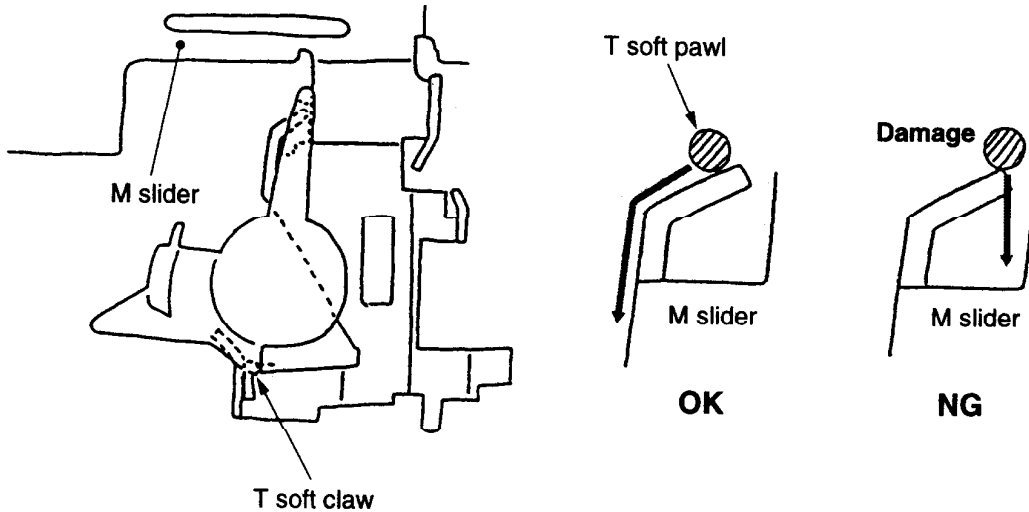
The shaft at tip of T soft claw is caught in the bent portion of M slider and damaged at the time of unloading. T soft brake is not working or is caught at loading/unloading.

Insufficient margin due to variation of the position of bent portion of M slider.

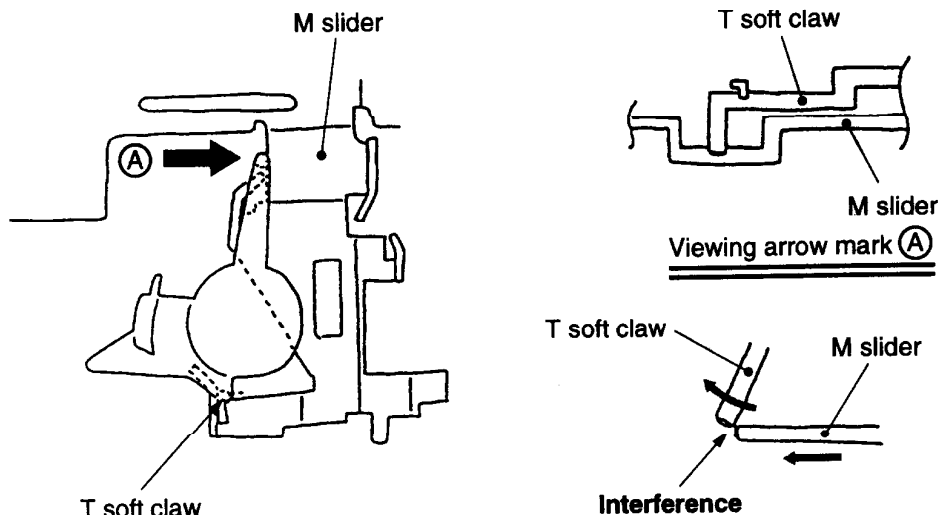
The tip of T soft claw interferes with the corner of M slider at loading, and T soft brake torque (failure of T soft brake) becomes small.

Insufficient margin of clearance between the tip of T soft claw and M slider in the direction of height.

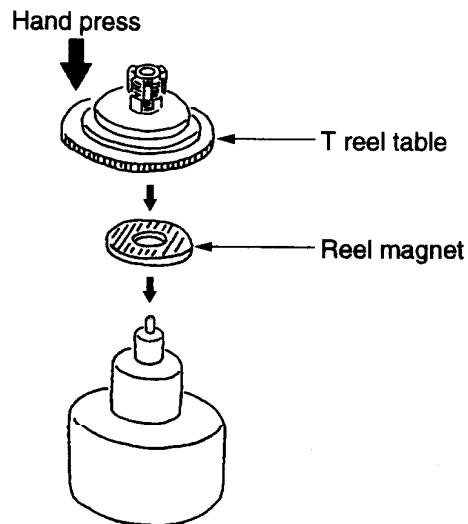
Adhesive force of S/T reel table rotation detect magnet seat is insufficient, causing separation of magnet and resulting in caution (reel table rotation cannot be detected) or rotation failure.

Magnet seat was stuck by a press of reel table boss with hand, causing variation in adhesive pressure and separation of reel table magnet.

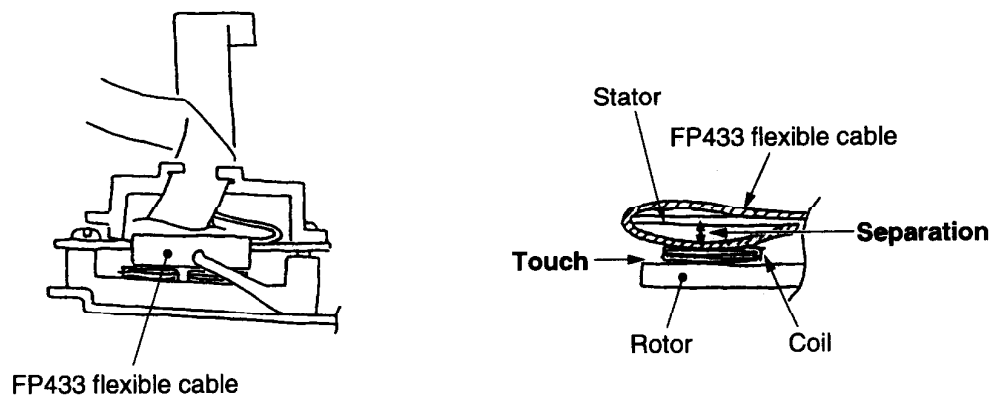
Adhesive power of FP433 flexible cable is reduced due to oil which was left at the time of pressing the capstan motor to the stator.

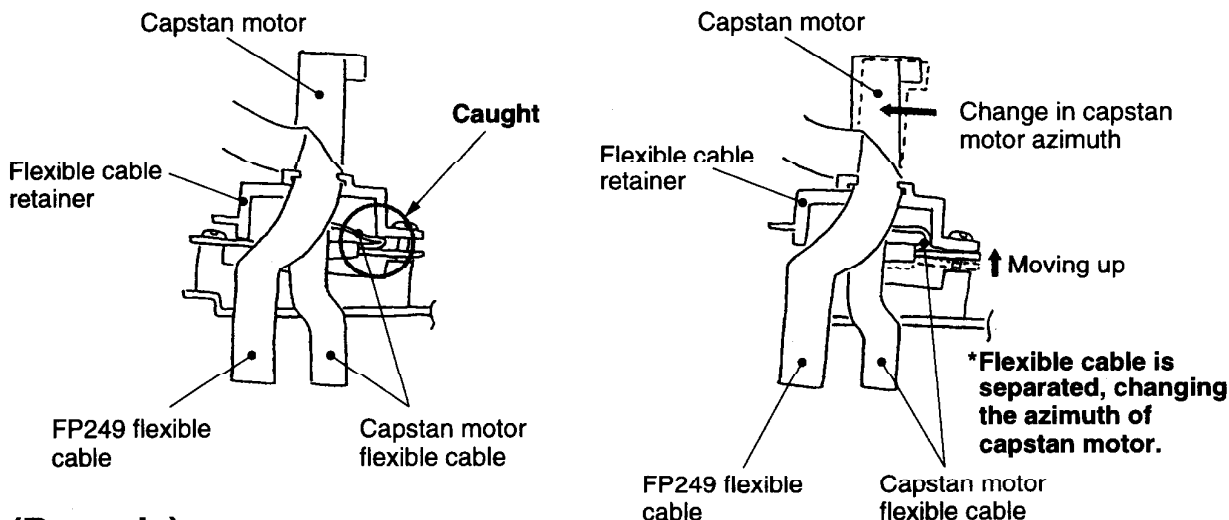
Tape damage/wrinkle due to change in capstan motor azimuth.

The folded portion of capstan motor flexible cable is caught and released at the time of assembling the flexible cable retainer, causing tape wrinkle or damage due to change in capstan azimuth and bending of tape.

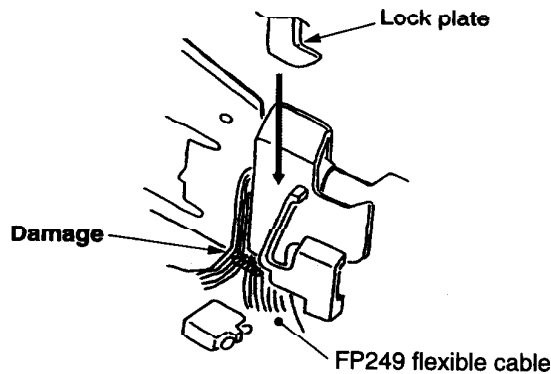
FP249 flexible cable is damaged by cassette compartment lock plate, causing failure in the sensor system for reel rotation detection, C.C. LOCK, etc.

Cassette compartment lock plate was pressed to FP249 flexible cable due to over-stroke at cassette compartment DOWN, and FP249 flexible cable was cut off by pressure.

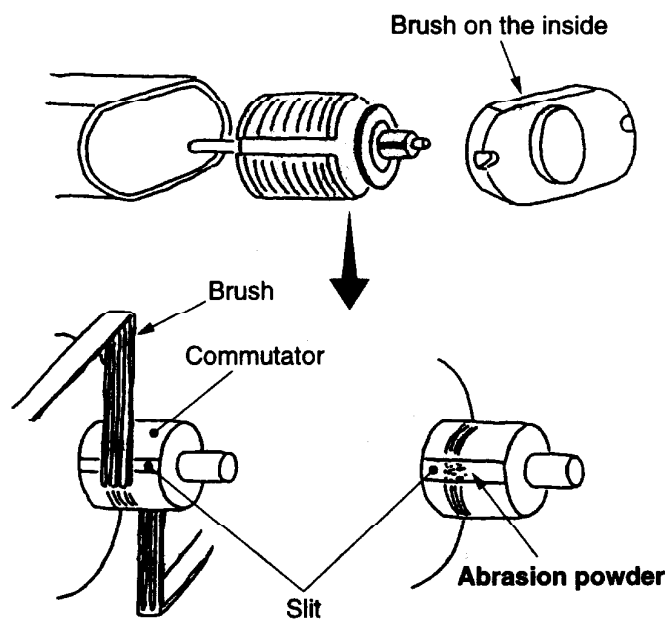
The slits were shorted by abrasion powder from worn commutator of loading motor and the paint chips on lapping tape dropped off at the time of lapping the commutator, so the brush was contaminated with the mixture of paint chips and contact grease, causing in increase of wear of commutator and short-circuit between slits with the abrasion powder from the worn commutator.

Replace loading motor.

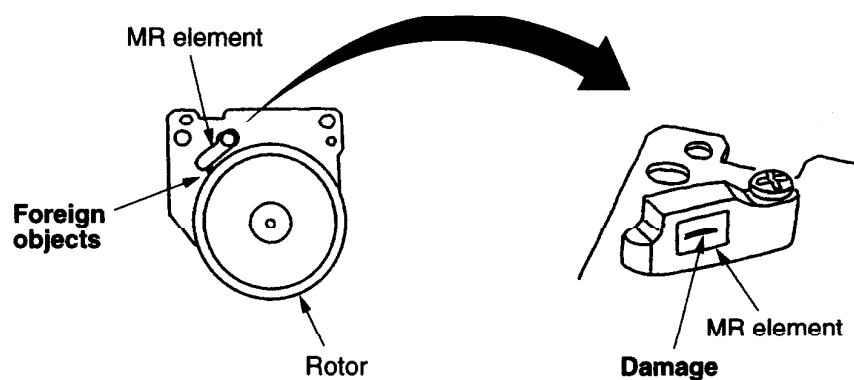
Capstan motor rotor is caught and does not rotation due to entry of foreign objects between the rotor and the MR element, causing damage to the surface of MR element, failure of servo operation and runaway of capstan motor.

1. Metallic objects entered from the opening of cassette compartment or small stones or sands deposited between the rotor and the MR element.
2. Metallic powder from a tap deposited on the rotor when tightening the MD frame screw.

1. Clean the area between capstan motor and MR element.
2. When MR element is damaged, replace capstan motor.

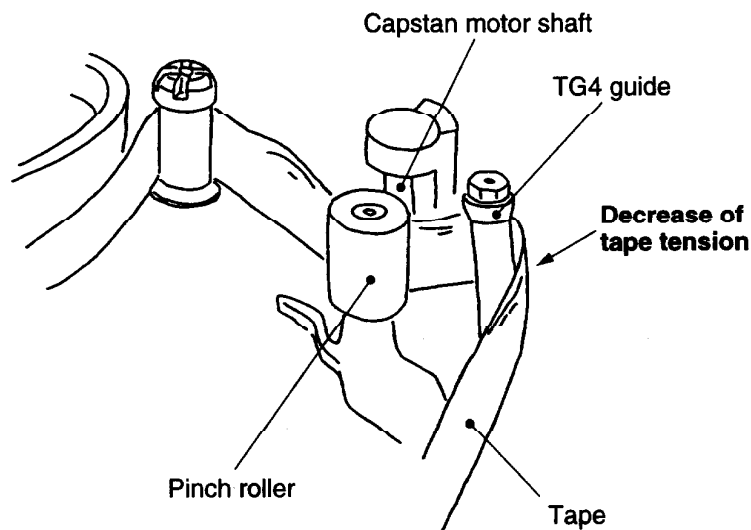
1. Tape does not travel smoothly over the capstan motor shaft and cannot follow the sudden change in the height of tape in tape travel mode.
2. Tape tension decreases at the upper side near the exit side TG4 guide, causing irregular tape travel.

- Re-adjust tape path according to the technical news which has been issued.
- Replace TG4 arm ass'y.

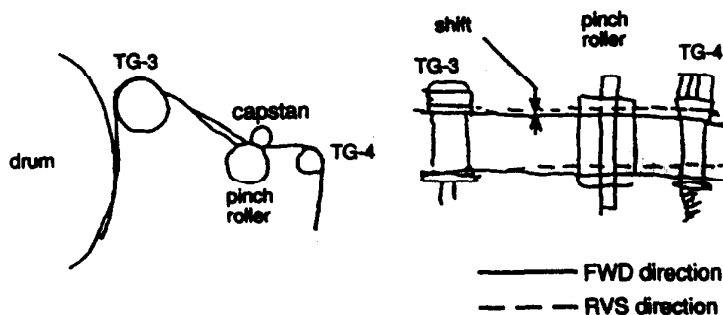
Fig. 2

Discrepancy in the TG-4 height adjustment leads to more deviation of the height of tape running between the capstan and TG-3 in the FWD and RVS directions. This results in tape warp causing tape wrinkle to be produced by the pinch rollers. (Fig. 2)

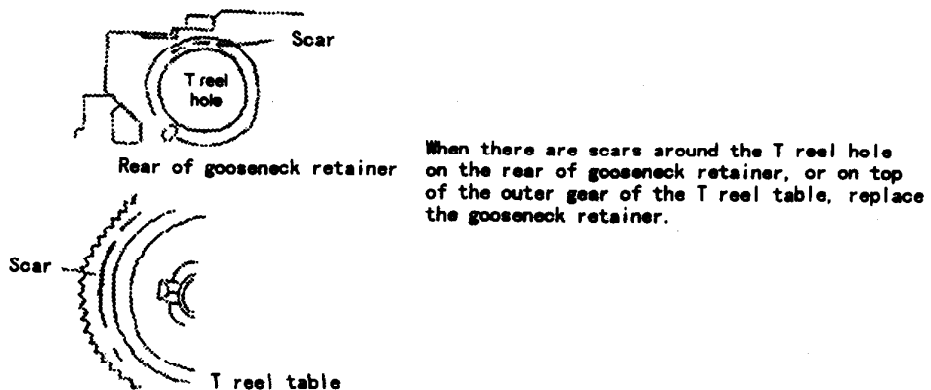
[Fig. 2 Gooseneck retainer is bent]

When there are scars on the gooseneck retainer and T reel table as shown in Fig. 2, the gooseneck retainer interferes mechanically with the T reel due to bending of the gooseneck retainer. When there are scars, replace the gooseneck retainer.

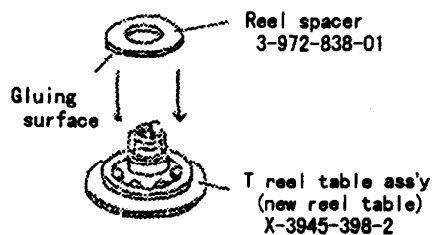
[Fig. 3 T reel height is low]

If tape slack occurs even though the FWD torque and gooseneck retainer are normal, it is anticipated that the T-reel height is low. Therefore, add one piece of reel spacer.
