Date: 5 June 1991
Re: GPIB (IEEE-488) interface problems.
Affected instruments: SR510 Single Phase Lock-in,
SR530 Dual Phase Lock-in,
SR245 Boxcar Computer Interface
Symptoms: Error indications when used with fast GPIB controllers

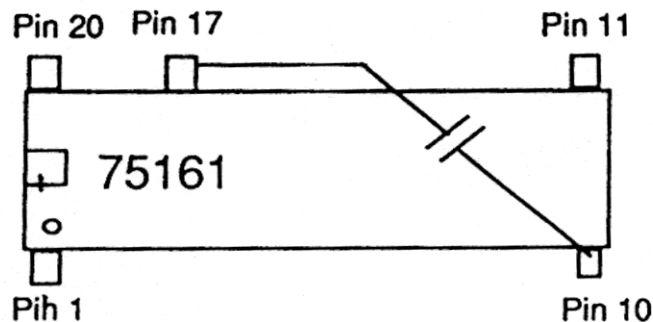
The GPIB controller which is used in these instruments (Motorola MC68488) will acknowledge data acceptance about 100 ns prior to actually reading the data. Very fast GPIB controllers can change the data to the next value during this interval, causing errors.

The data acceptance signal, DAC or NDAC must be slowed by about 100 ns. This may be done by placing a 270 pF capacitor between pin 10 (ground) and pin 17 (DAC) on the GPIB bus driver (Part Number 75161) which is adjacent to the MC68488 controller.
