STUDER

Service Information

STUDER D820 MCH
Modifications
and
Software Update V2.2

SI 154/91 Order No. 10.85.7300 (Ed. 0791)

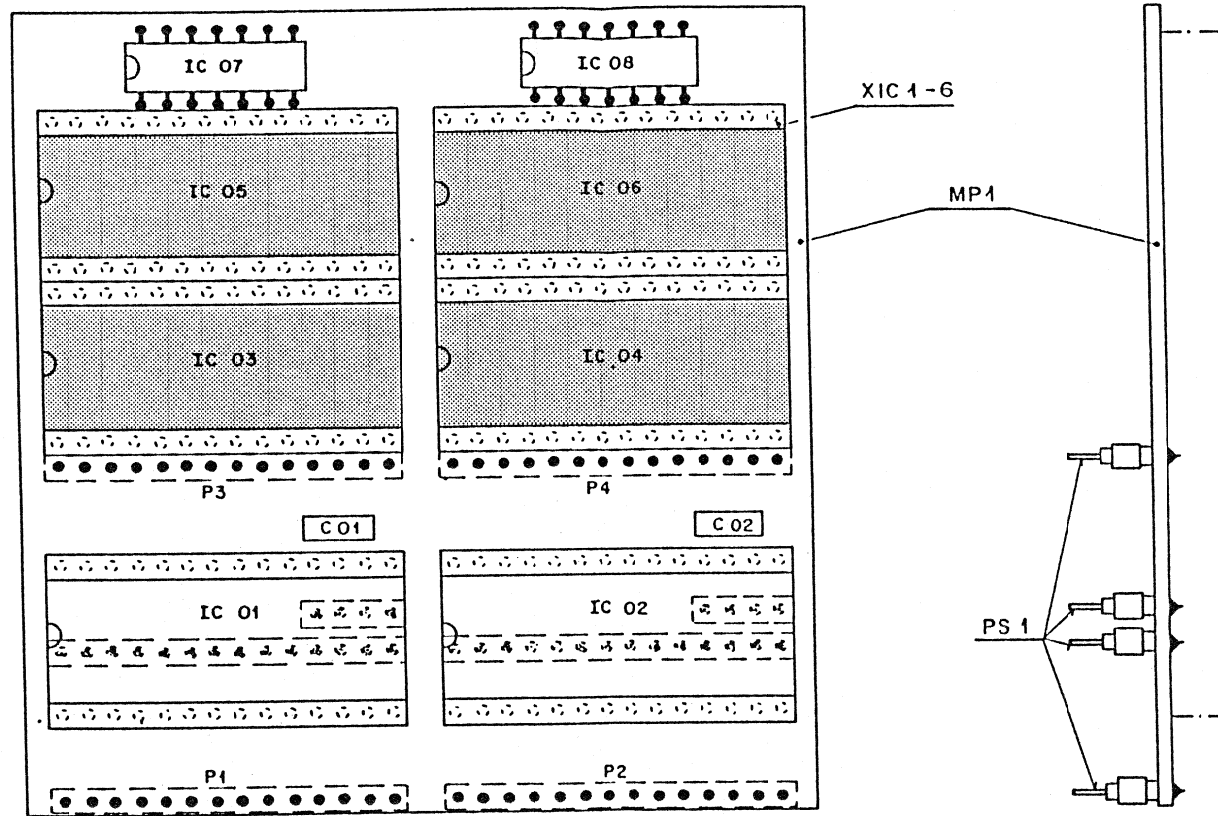
Modification CPU Piggy Back 1.862.686.21

New Master software V2.2 (28/91).

- Replace IC3 - 6 (old software number 1.862.926.21) by new software 1.862.926.22.

Change board index to new 1.862.686.22 .

Change also board index of CPU Force to new 1.862.655.22 .

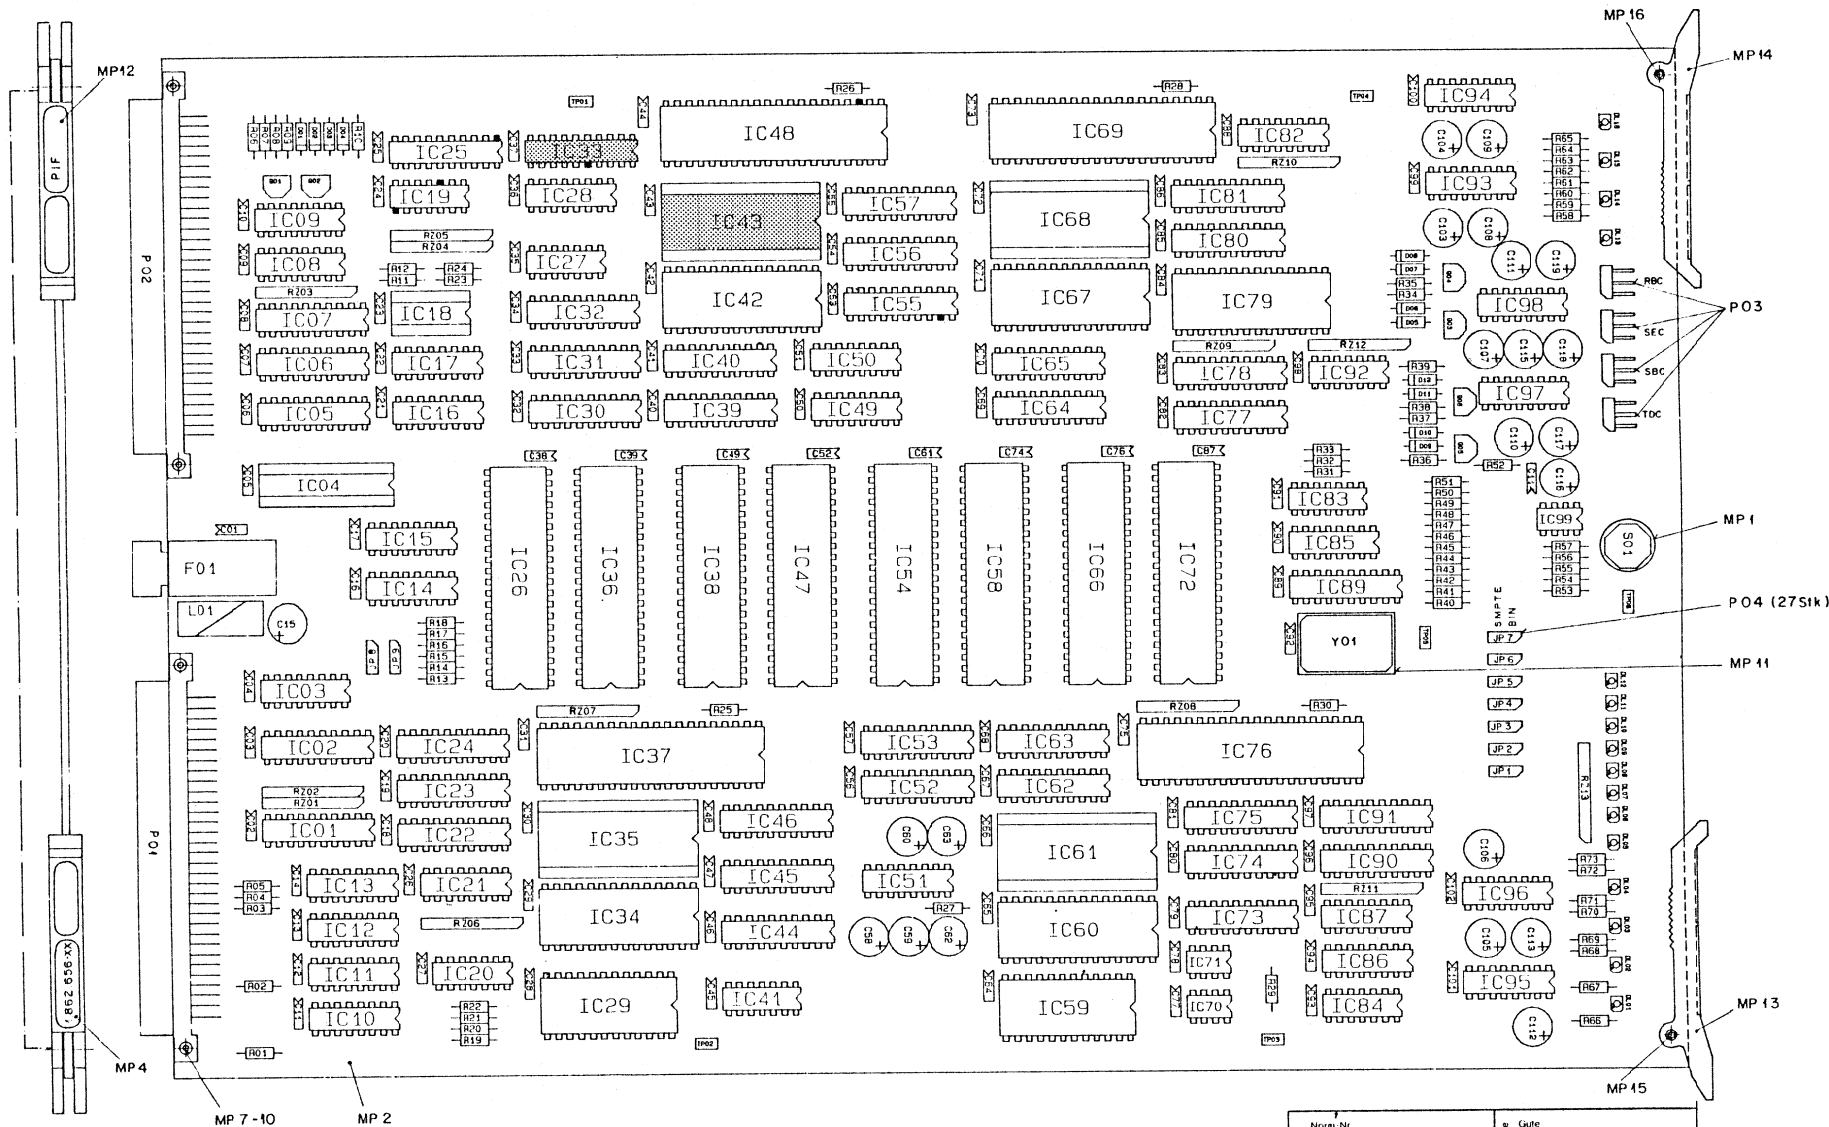
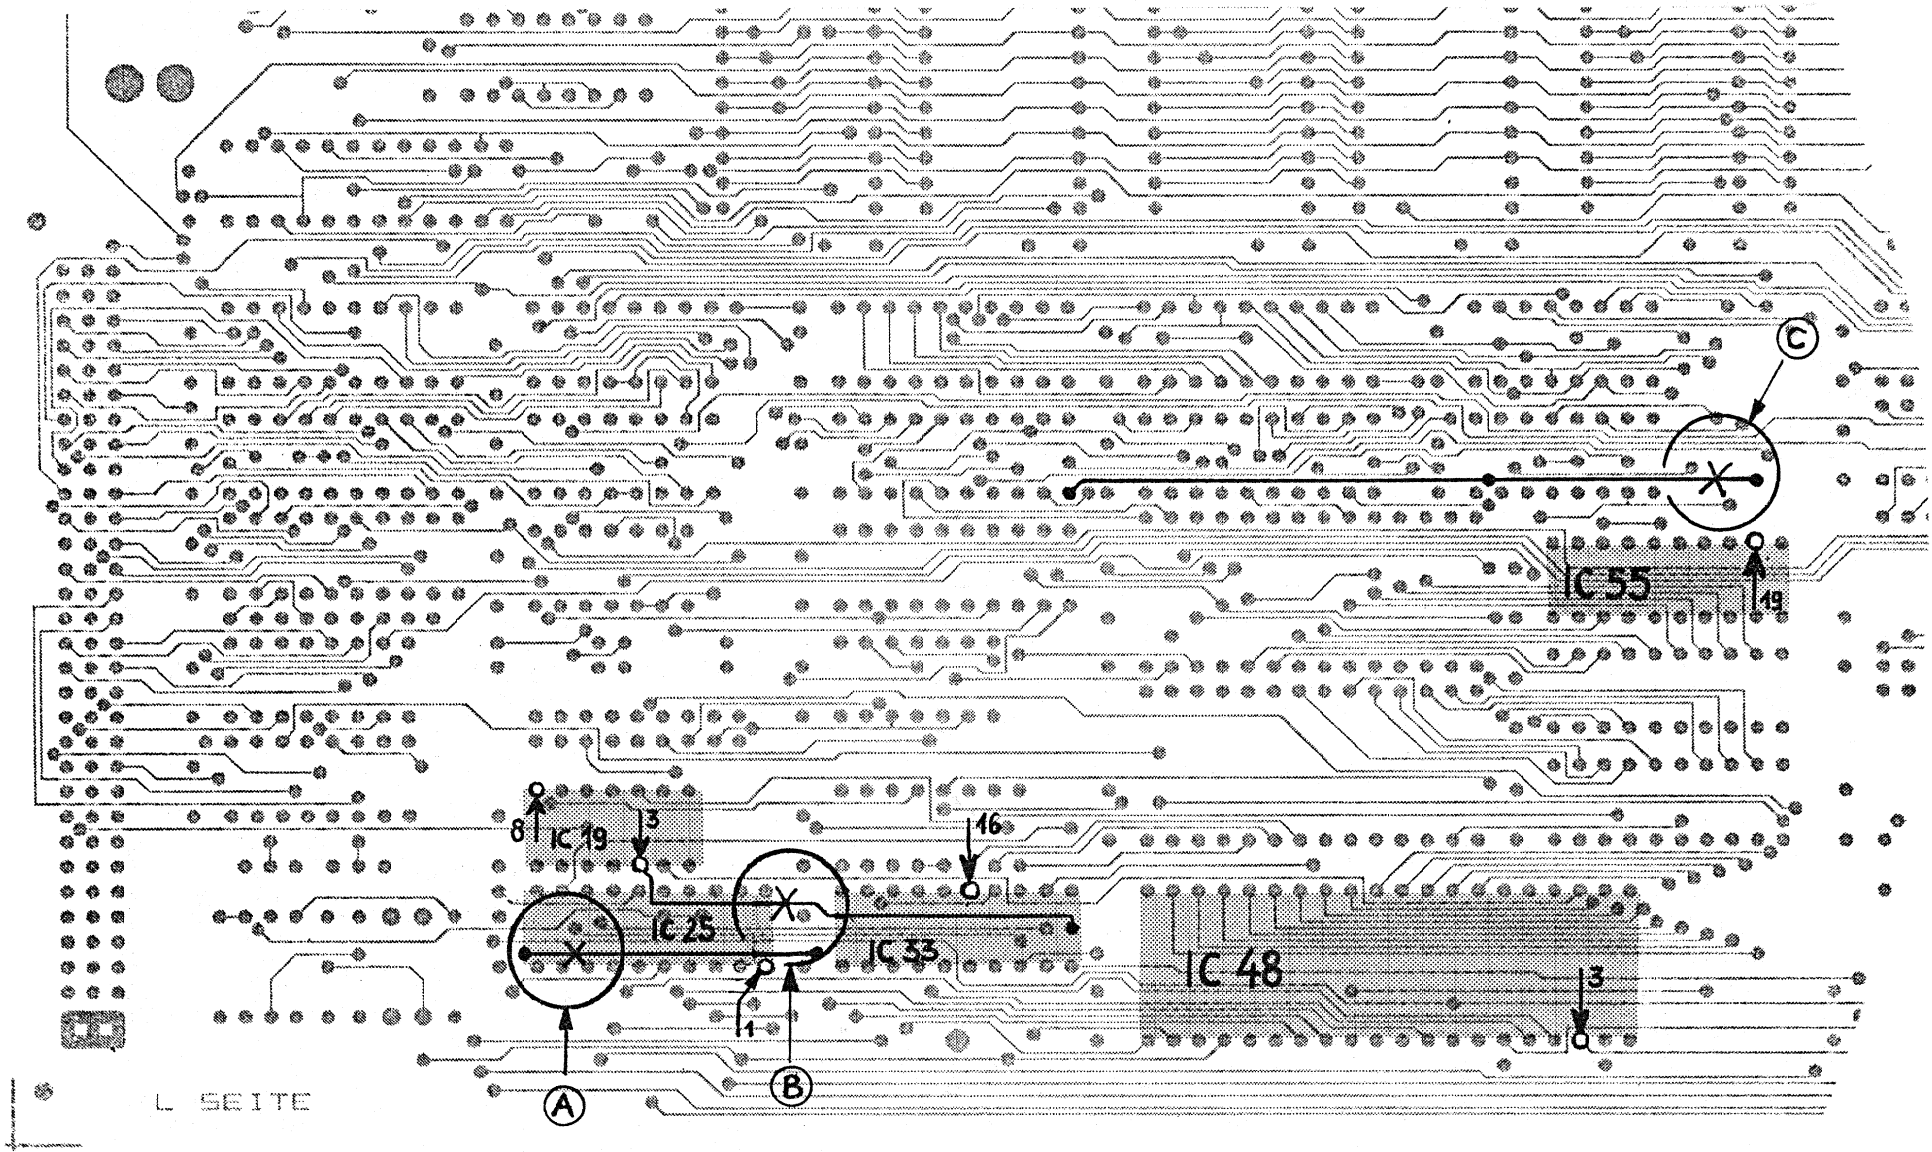
MODIFICATION PIF-BOARD 1.862.656.22

<u>Modification</u>	<u>Peripheral IF</u>	<u>1.862.656.21</u>
---------------------	----------------------	---------------------

- Faulty SERBUS-transmission under several circumstances due to timing problems with new components specifications.
- Implementation of new Master software V2.2 (28/91).

- Replace IC33 (old software number 1.862.932.20) by new software 1.862.932.21.
- Replace IC43 (old software number 1.862.938.21) by new software 1.862.938.22..
- Cut three conducting paths (marked "A", "B" and "C") as indicated on wiring plot.
- Add a wire from IC19, pin 8 to IC55, pin 19.
- Add a wire from IC48, pin 3 to IC19, pin 3.
- Add a wire from IC33, pin 16 to IC25, pin 1.

Change board index to new 1.862.656.22 .

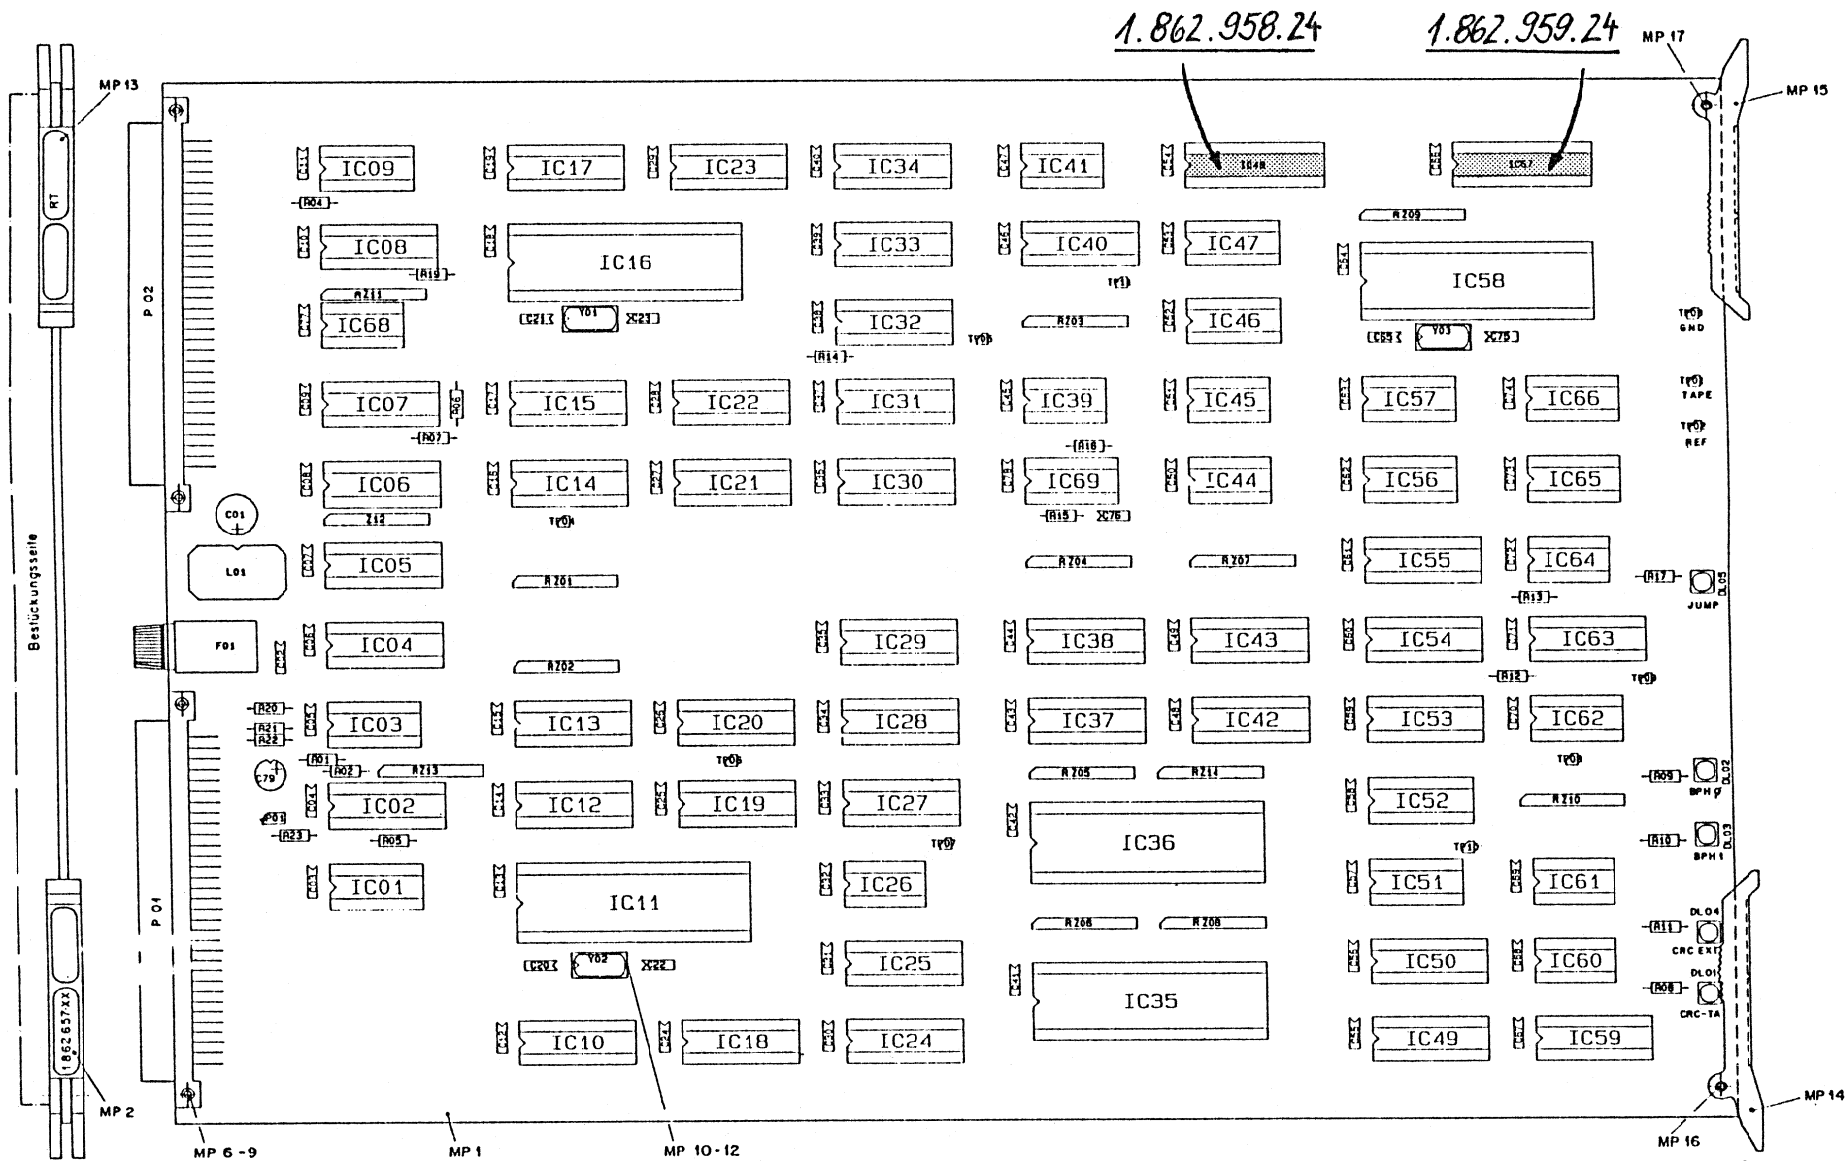
Version DIN Bez. Abmessung	Numm. Nr. DIN Bez. Abmessung	Umfang Quantität Beh.	
Zugfertiger (Mitarbeiter) PL, BV 640	Firmenabteilung Maffstab 4,3:1	Anzahl 28.8.89	28.8.89
Ersatz für	Ersetzt durch	Körper Nr.	
STUDER REGENSDORF ZÜRICH	REFERENCE TRACK ESE	1.862.657-24

Modification Reference Track Board 1.862.657.23

New Master software V2.2 (28/91).

- Replace IC48 (old software number 1.862.958.23) by new software 1.862.958.24.
- Replace IC67 (old software number 1.862.959.23) by new software 1.862.959.24.

Change board index to new 1.862.657.24 .

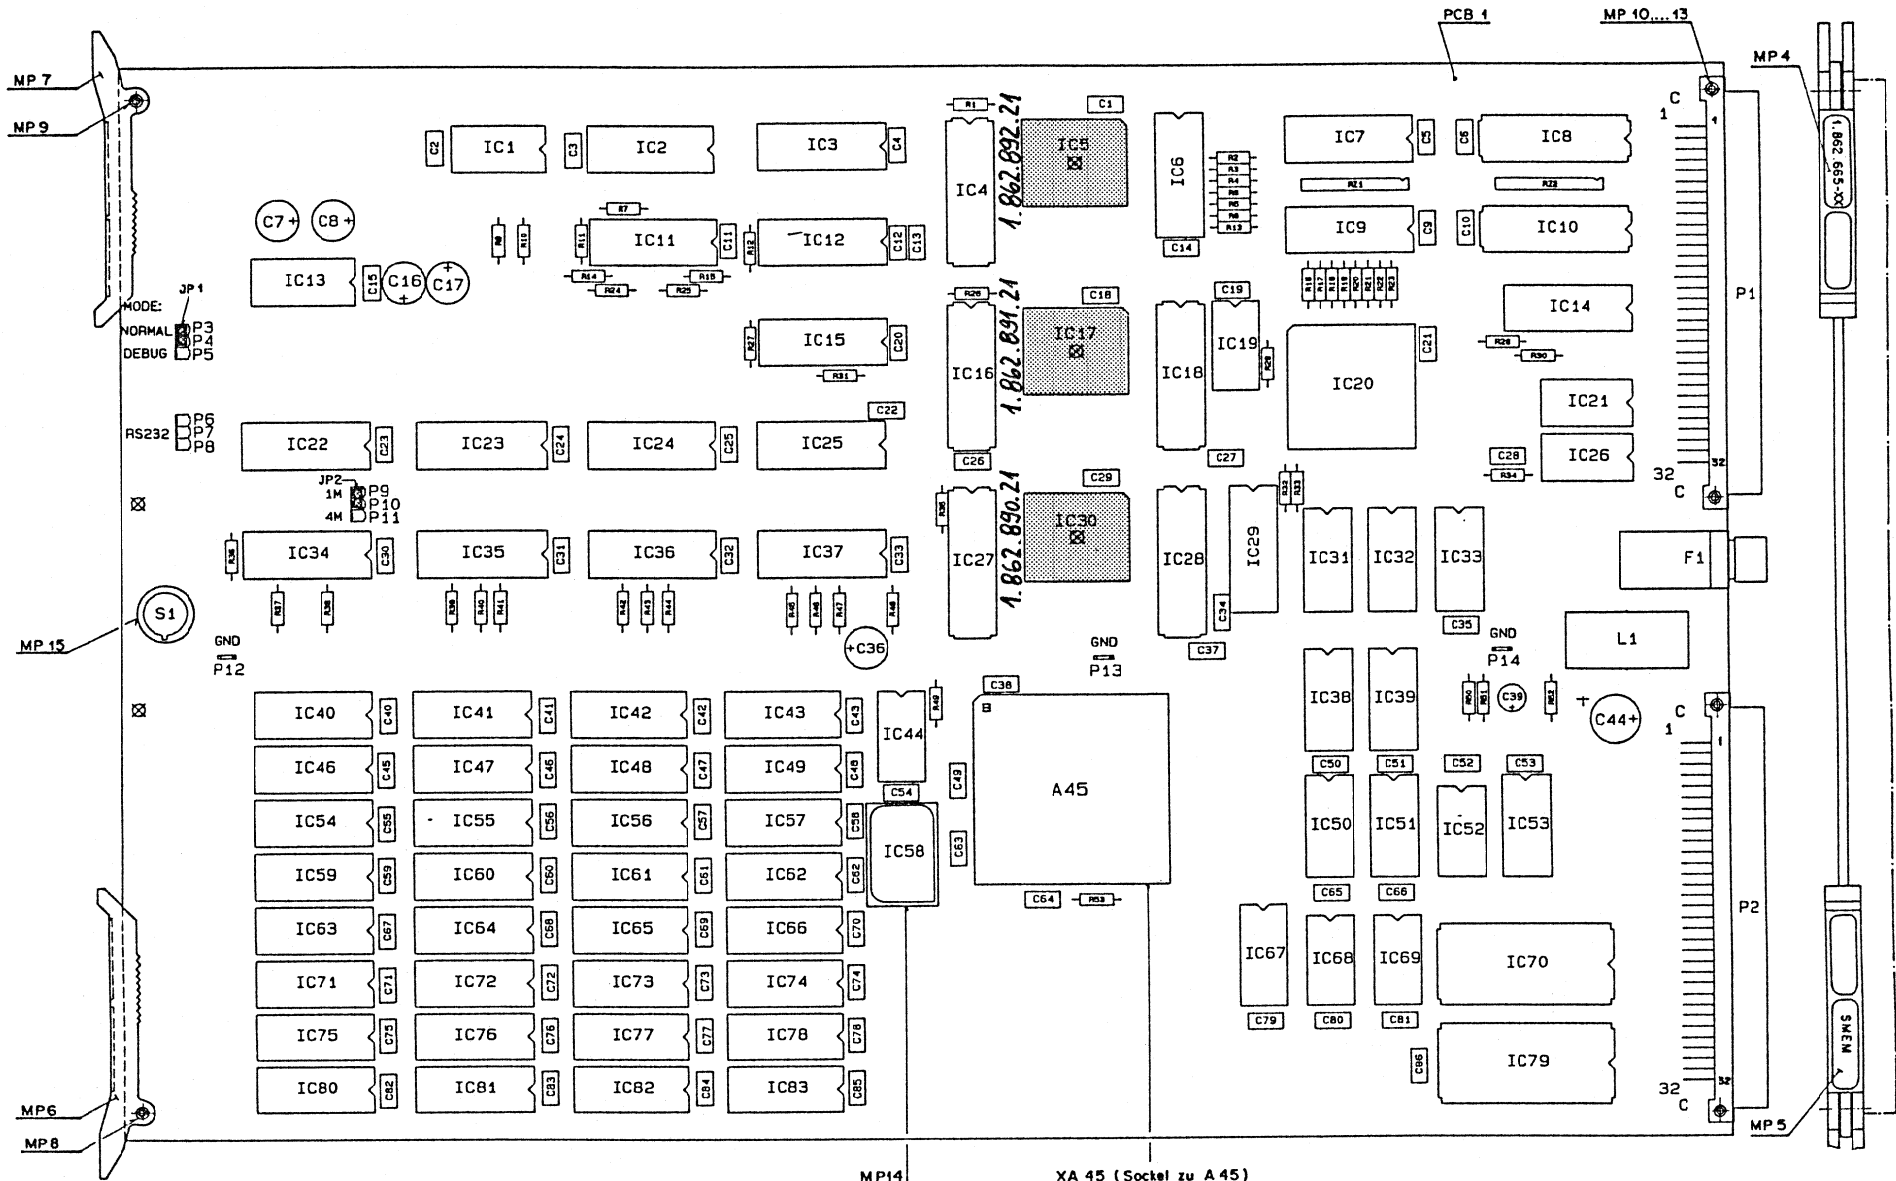
SOUND MEMORY 1.862.665.21

Modification Sound Memory 1.862.665.20

New Master software V2.2 (28/91).

- Replace IC05 (old software number 1.862.892.20) by new software 1.862.892.21.
- Replace IC17 (old software number 1.862.891.20) by new software 1.862.891.21.
- Replace IC30 (old software number 1.862.890.20) by new software 1.862.890.21.

Change board index to new 1.862.665.21 .

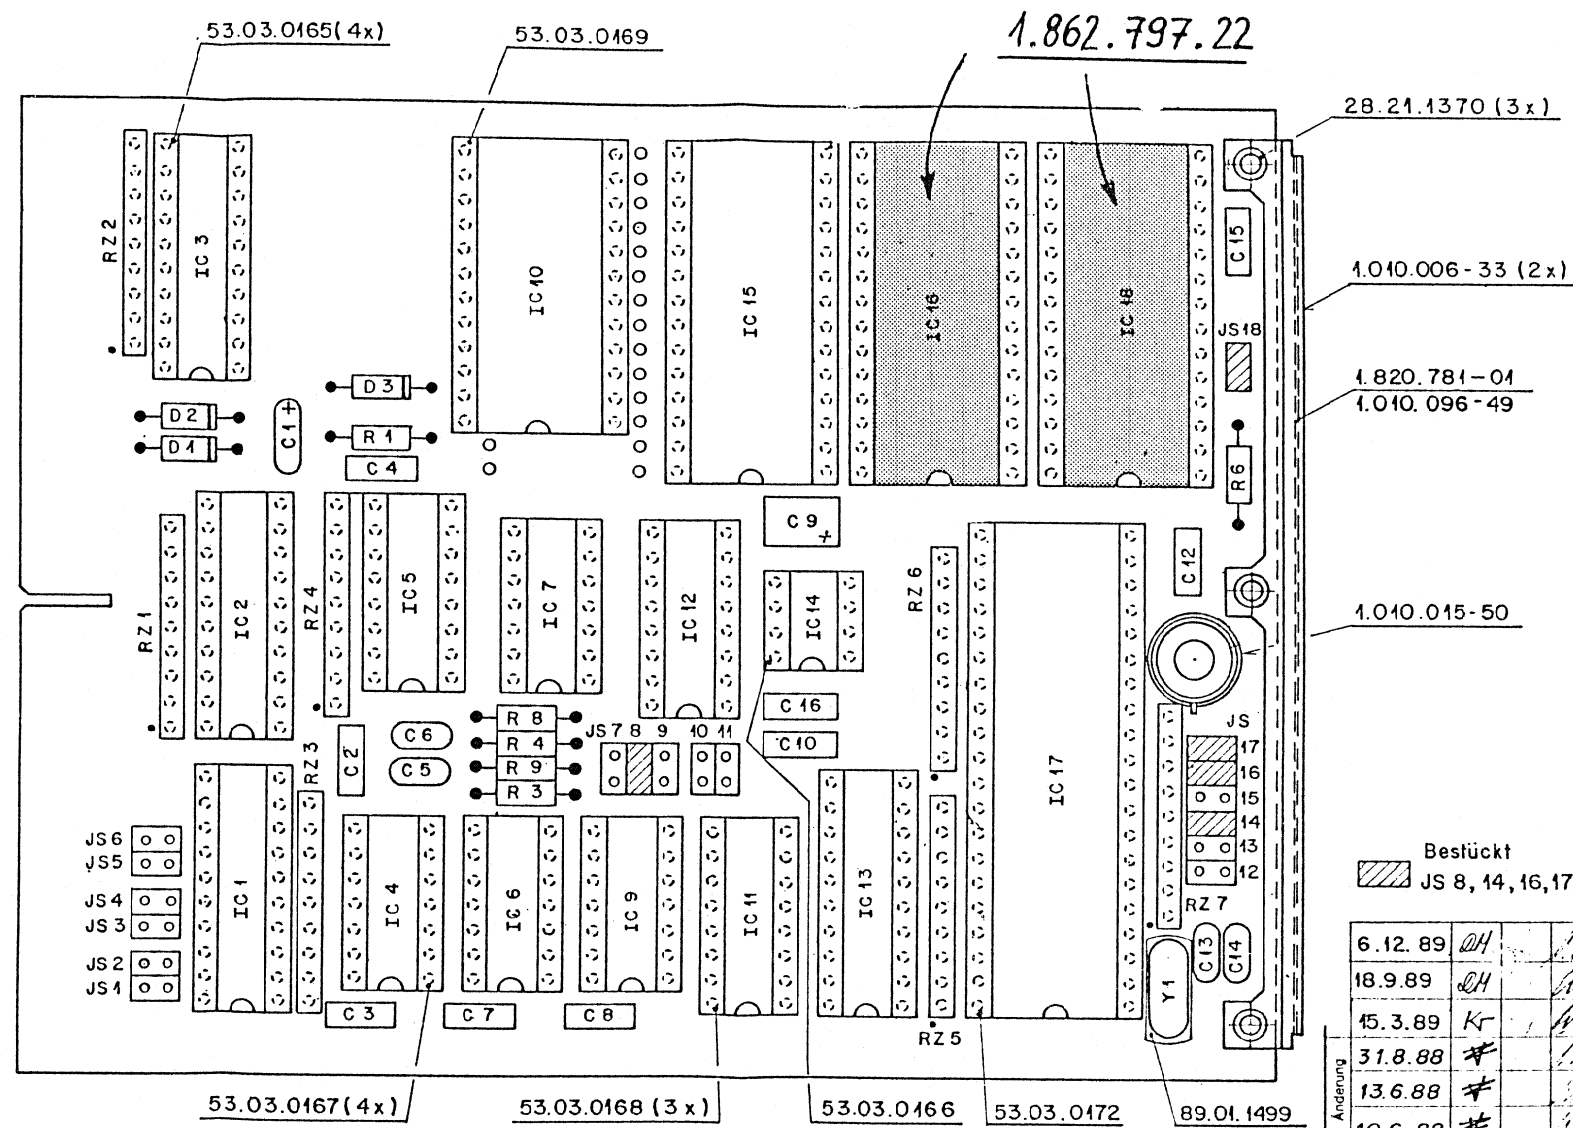
MP-UNIT TD CONTROL MCH 1.862.781-XX

Modification MP Unit Tape Deck Control 1.862.781.21

New Master software V2.2 (28/91).

- Replace IC16 and 18 (old software number 1.862.797.21) by new software 1.862.797.22.

Change board index to new 1.862.781.22 .

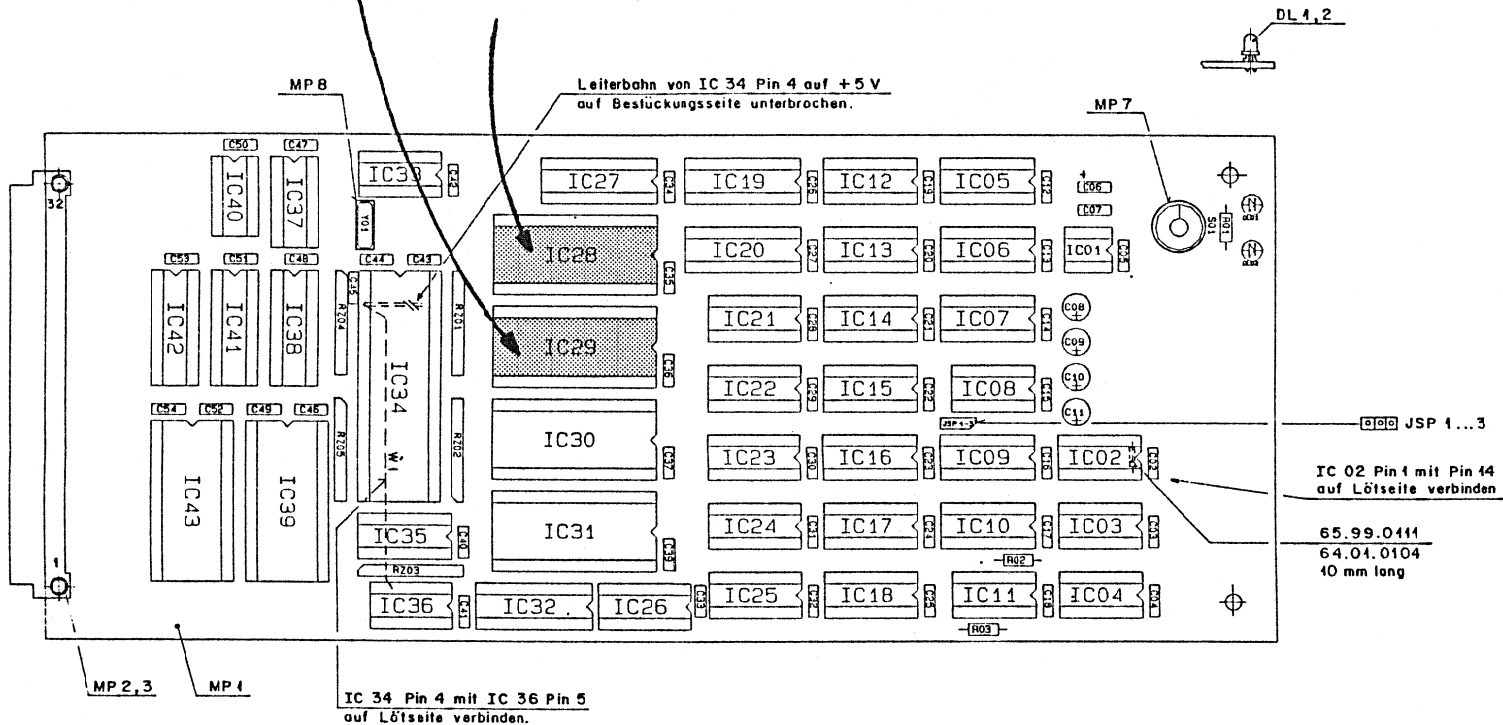
Modification Display Panel uP-Board 1.862.815.21

New Master software V2.2 (28/91).

- Replace IC28 (old software number 1.862.825.21) by new software 1.862.825.22.
- Replace IC29 (old software number 1.862.826.21) by new software 1.862.826.22.

Change board index to new 1.862.815.22 .

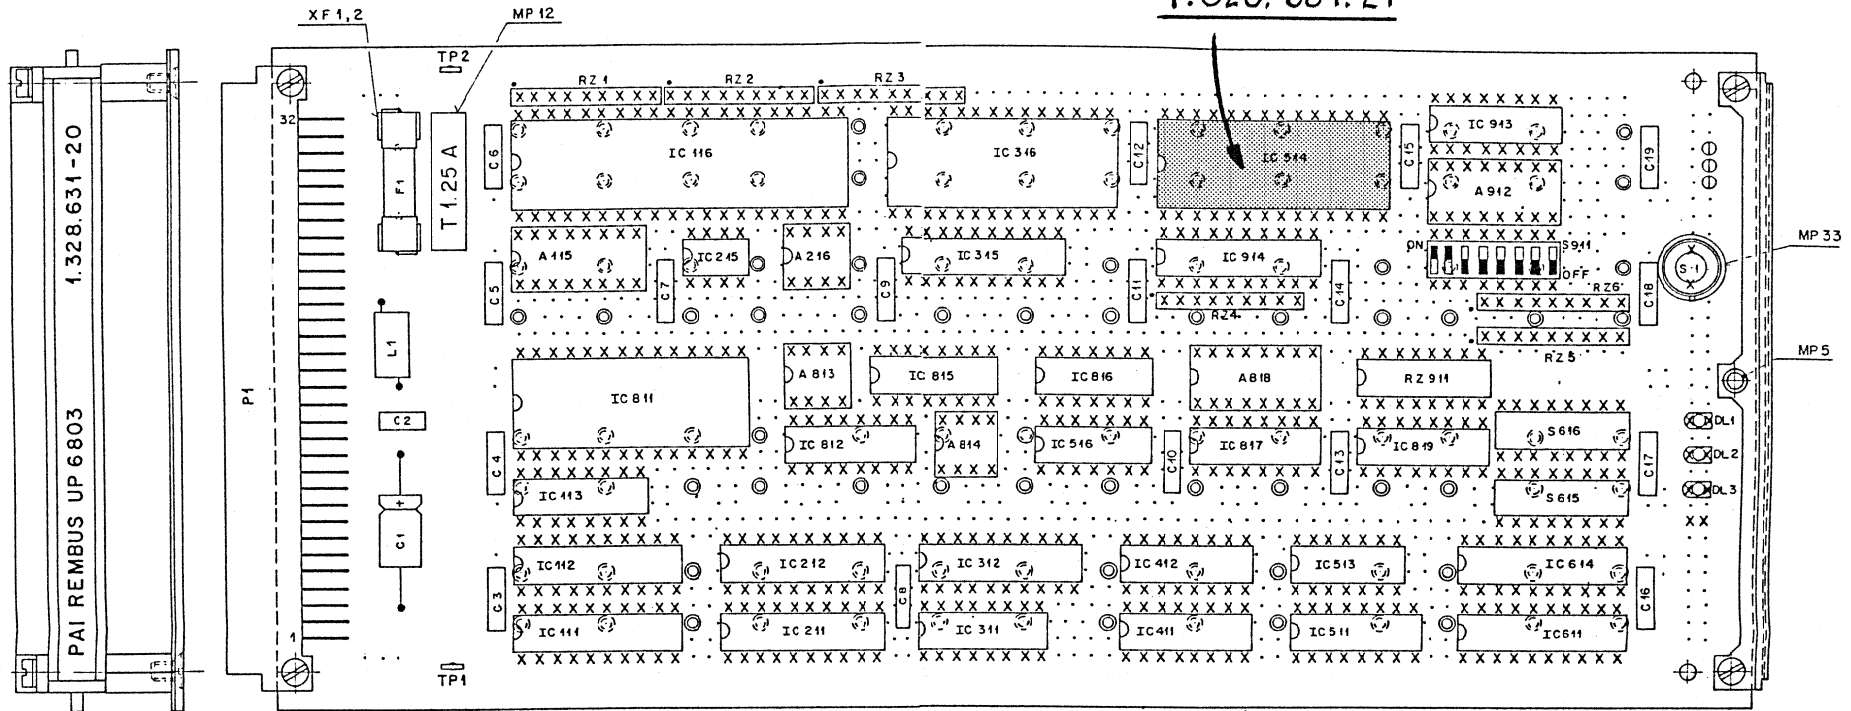
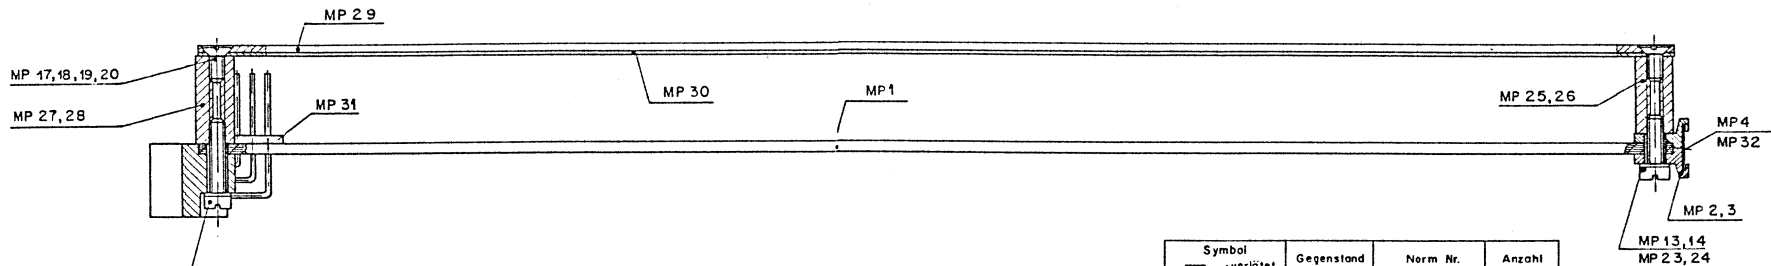
Modification PAI Rembus uP6803 1.328.631.20

New Master software V2.2 (28/91).

- Replace IC514 (old software number 1.328.896.20) by new software 1.328.896.21.

Change board index to new 1.328.631.21 .

Mark also index "21" on backside of case.

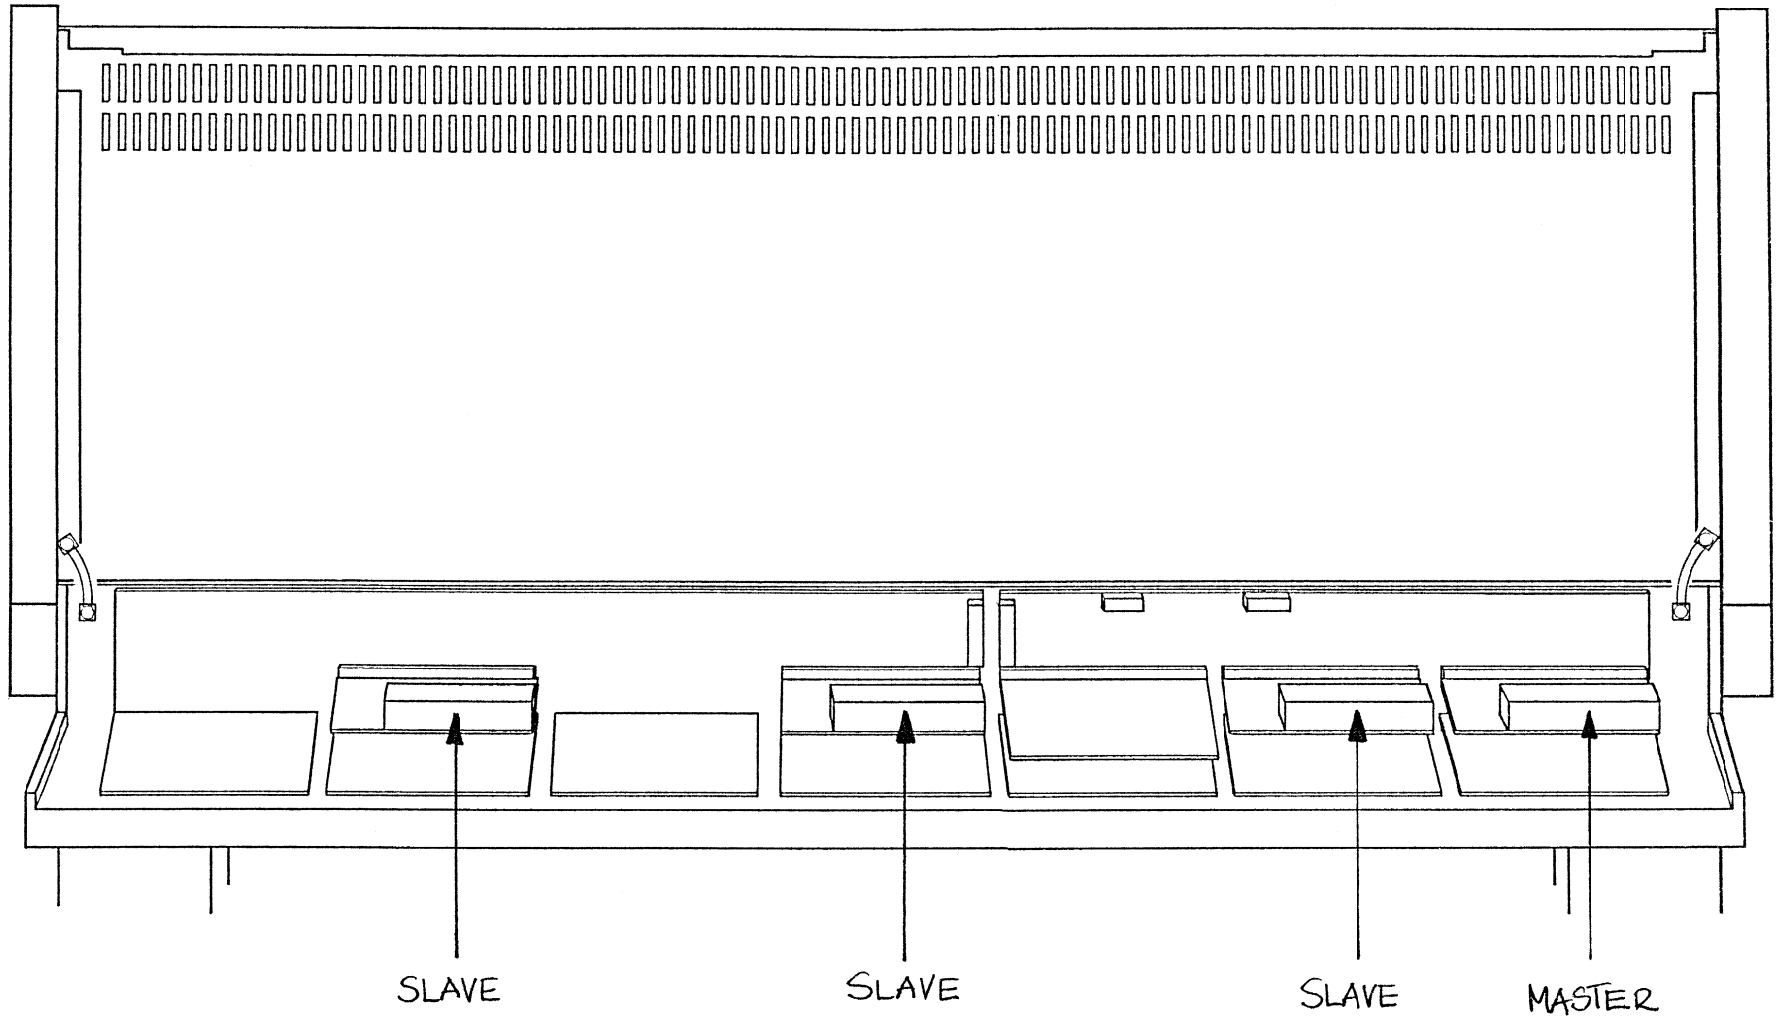
DISPLAY PANEL D820-48 (BOARD ARRANGEMENT)

Synchronous power-down of all four power supplies not possible.

Critical dimensioning under certain temperature conditions.

Please check for correct Jumper setting for MASTER / SLAVE operation as indicated on the boards (refer to board arrangement).

Change board index for SLAVE-Boards to new 1.862.812.81.

Change board number for MASTER-Board to new 1.862.814.00.

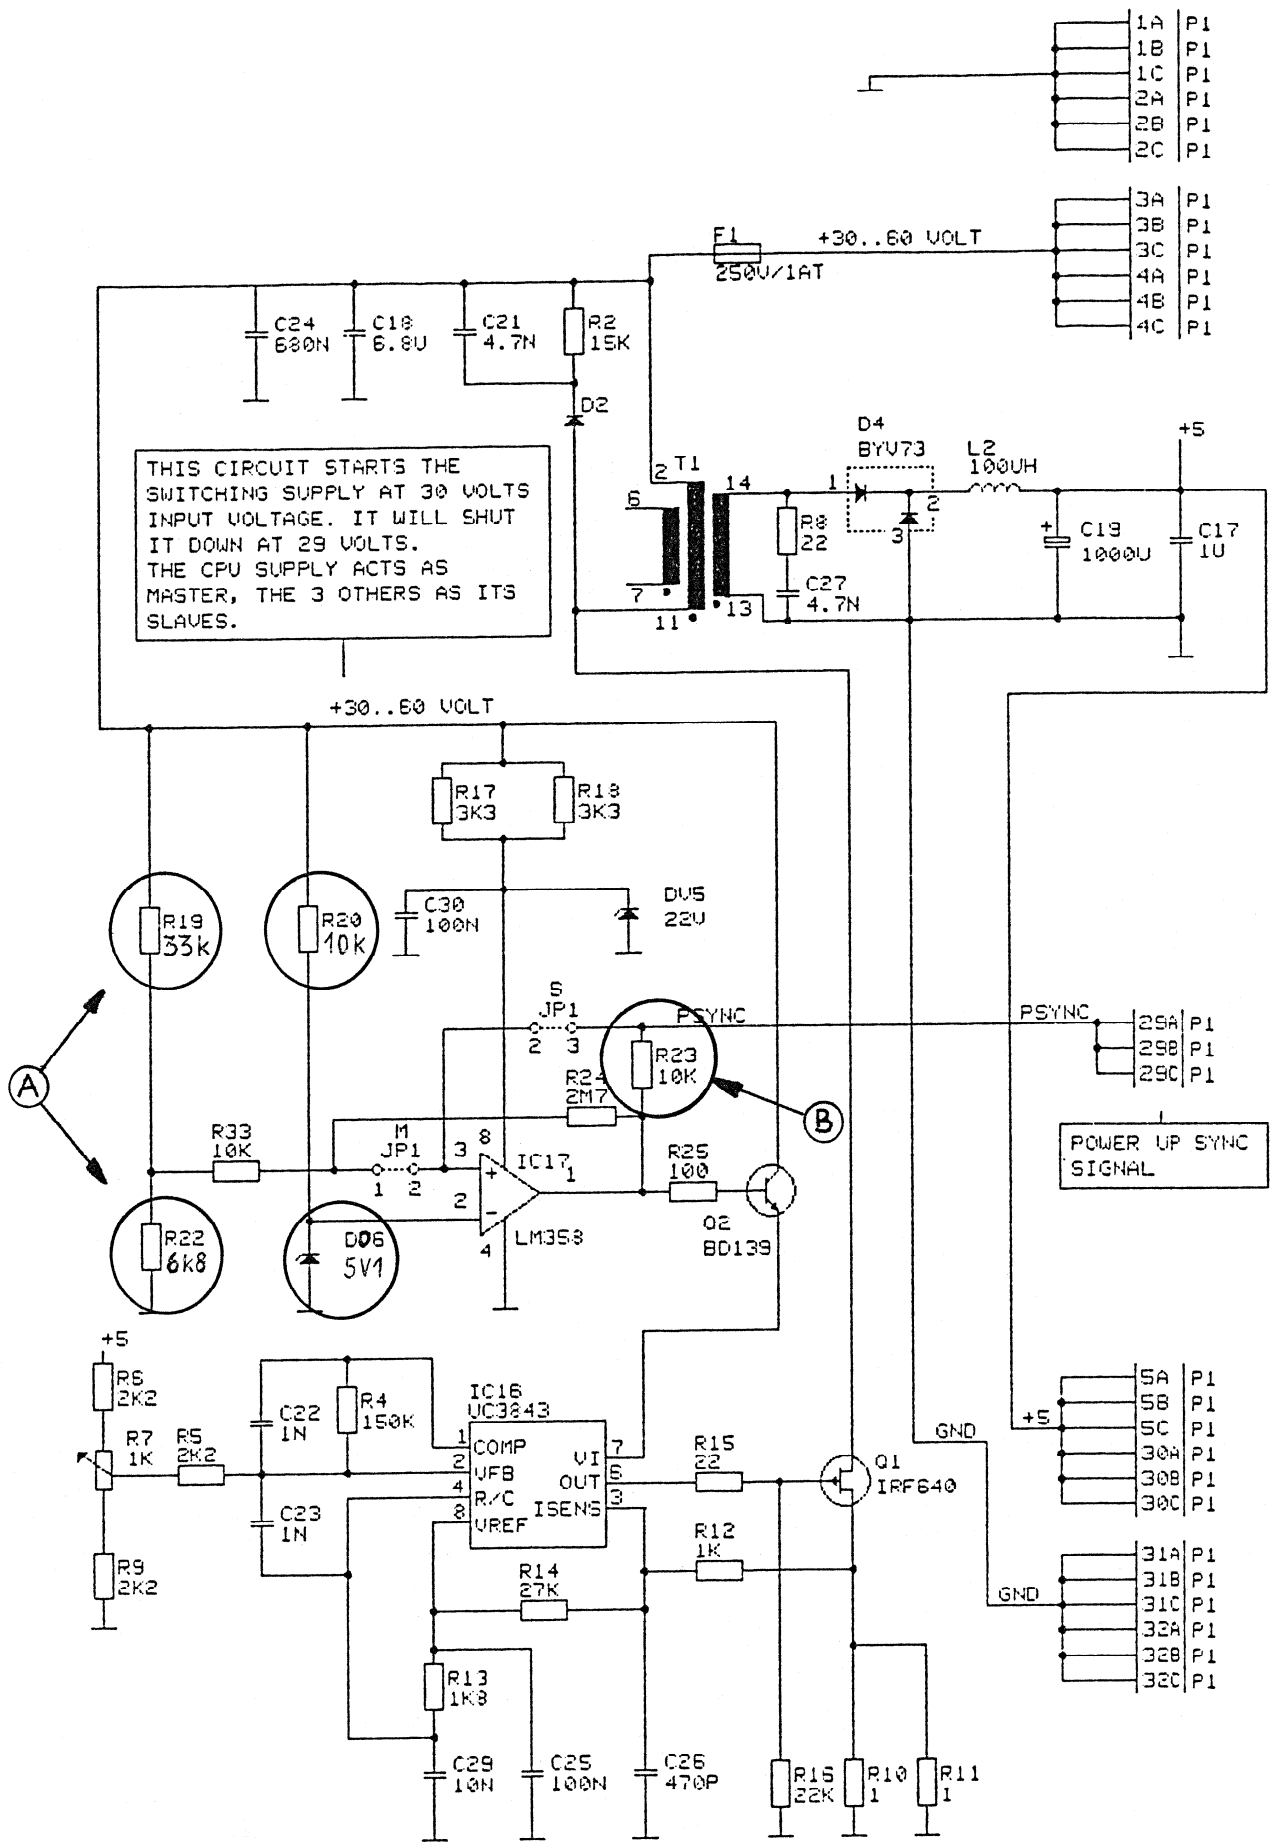
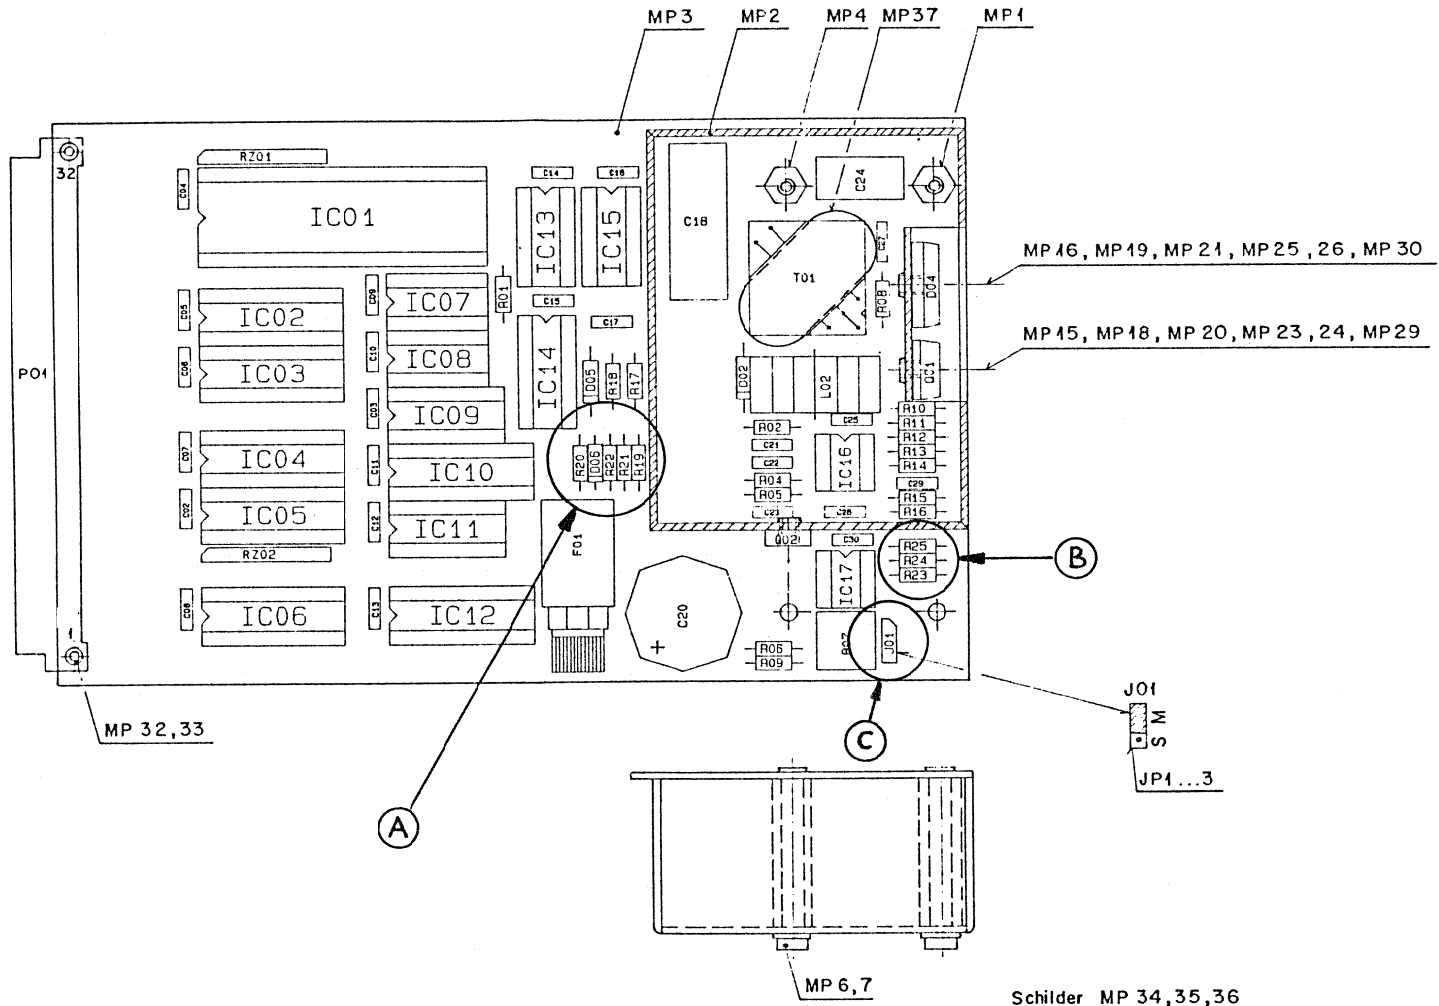
Modification Display Panel Aux Key Detection 1.862.812.00Problem:

Replace R19 (47k Ohm, 57.11.3473) by 33k Ohm (57.11.3333).

Replace R20 (47k Ohm, 57.11.3473) by 10k Ohm (57.11.3103).

Replace R22 (4.2k Ohm, 57.11.3422) by 6.8k Ohm (57.11.3682).

Replace D06 (2.4 V, 50.04.1131) by 5.1 V (50.04.1112).

Remove R23 (10k Ohm, 57.11.3103).
