Tek2712 repair

January 2015, Koos Bouwknecht

Since 2009, I have a Tek2712 spectrum analyser, made in 1994 by Tektronix Beaverton. The analyser was used incidentally the first 15 years without problems.

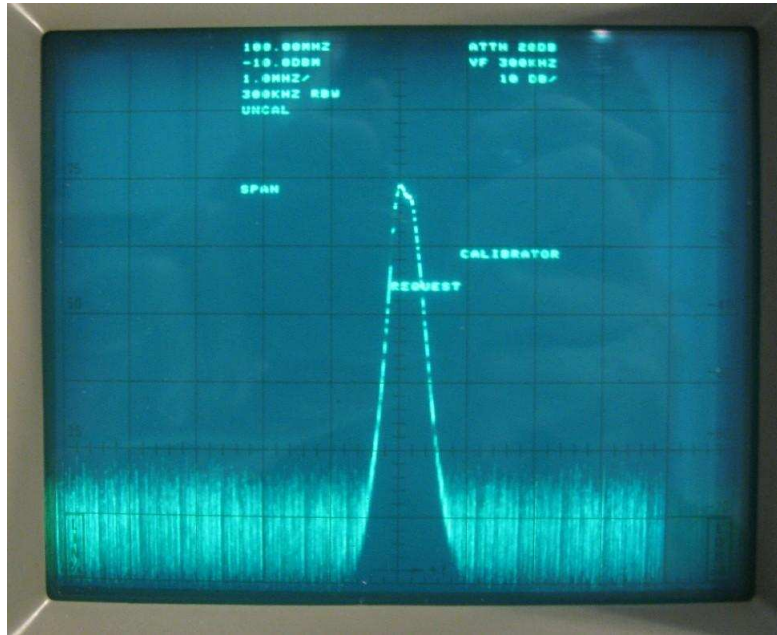
When I got the analyser, the first problem was a gradually shrinking of the display, including the on-screen display (OSD). The display in direct view mode (non storage, button "D" pushed) was normal, so it was not the CRT or HV supply.

The OSD data did shrink to half the normal size in this mixed display. The size reduction fluctuates between 20 and 80% of the normal size.

The problem is in the display storage board A9. This board did not correspond with the 2712 service manual (1992?) but was the A9 board as in the service manual of the Tek2715.

The problem was clear: the reference (VR=5V) which is the only component in common for both the X and Y DAC at the output of the display storage board was too low and fluctuated.

After replacing several components, the culprit was a leaky elco near 0.1uF SMD capacitor (C9) across the reference IC. The fluid caused between 200 ohm and 2k leakage. Troubleshooting was hard without an extenderboard at that time.

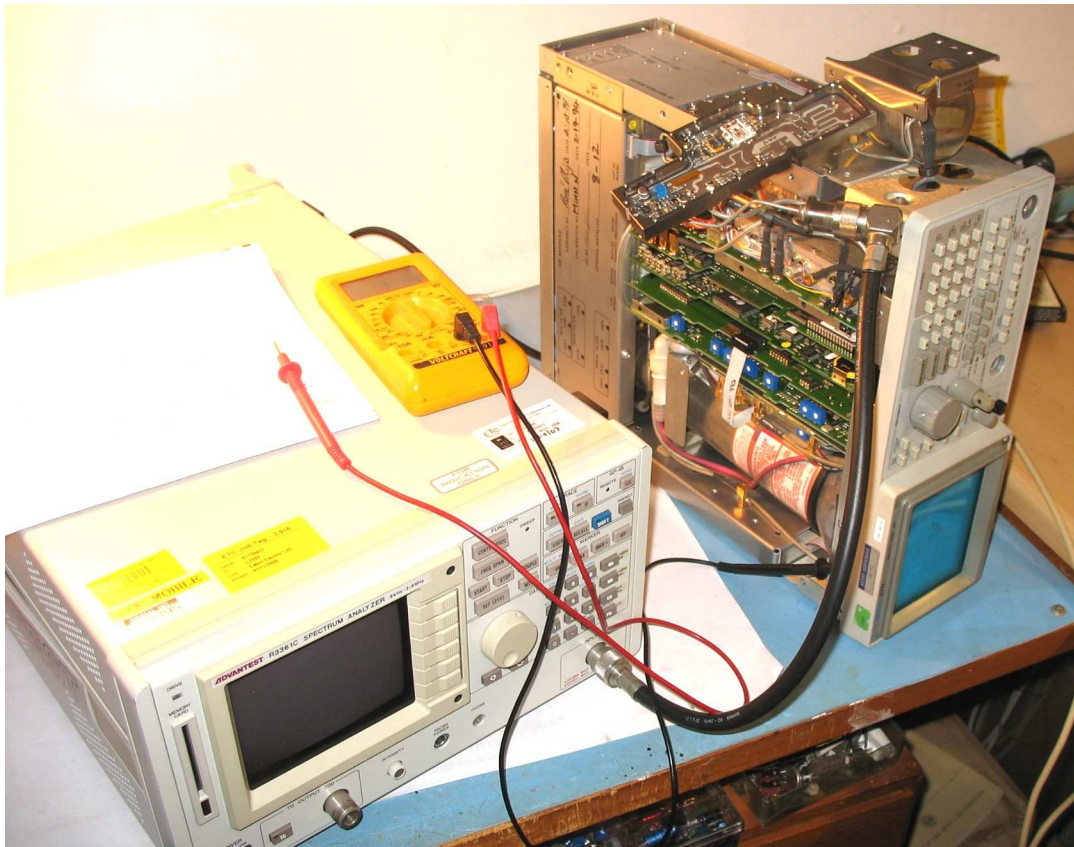
So I dismantled about any RF module and opened the LO buffer module. See the picture below. The input of the buffer module is still connected to the YIG oscillator, hanging on the right side outboard. The LO buffer stage is still powered by its flat cable from the Tek2712 mainframe.

The buffer is a single stage GaasFet, with stabilized output power. Stabilisation is done by rectifying the RF output, an opamp compares this with a blue potmeter reference. The opamp drives the drain voltage of the Gaas FET via a transistor.

Both opamp inputs and the opamp output are at -7V, so the transistor was off, and the FET got no drain voltage, explaining the very low output of the buffer stage. Connecting the drain to +8V via 100 ohm produced the normal +13 dBm RF output, so the FET itself was OK.

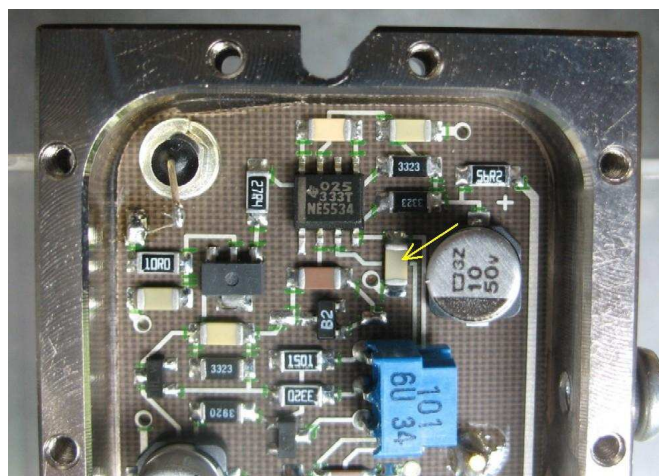
The culprit was another leaking electrolytic cap, the fluid creeps under the blue pot and the 0.1uF smd capacitor (C 292) (see yellow arrow). This track went to the plus input of the opamp, pulling the + input to -7V, and the - input to -6.6V via a diode. After cleaning, reassembling and adjusting the LO level to +13 dBm (with the blue pot), everything was OK.

I hope the detector diode is not damaged by the 7V reverse voltage. This type of schottky diodes has a maximum reverse voltage of 4V, but there are no signs even after 2 years, only a higher 0Hz peak.

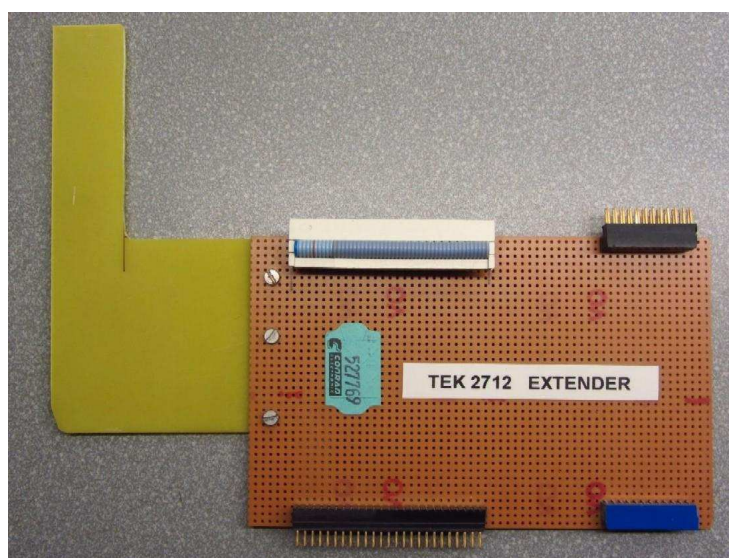
These faults could only be found with an extended display storage board. With connectors and flat cable from the junk box, I made a very useful extender.

The 50-pole flat cable and connectors are quite common, but the 24-pole connectors for the power supply lines is not. I have cut these from long connectors.
