# Instrument Panel Side Cover Adjustment

<b>Classification</b>	Repair Bulletin	<b>Section/Group</b>	14 - Instrument Panel & Pedals	<b>Country/Region</b>	North America
-----------------------	-----------------	----------------------	--------------------------------	-----------------------	---------------

<b>Year</b>	2012-2013	<b>Model</b>	Model S	<b>Version</b>	All
-------------	-----------	--------------	---------	----------------	-----

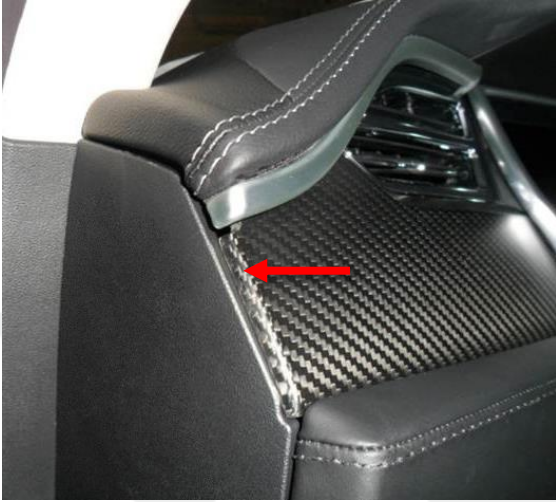
✓ **Figure 1 (Proper fit)**

1. Check the fit of the left instrument side panel (Figures 1 and 2). If the instrument panel fits properly, discontinue this procedure; no more work is required. If the instrument panel has an excessive gap, continue with this procedure.

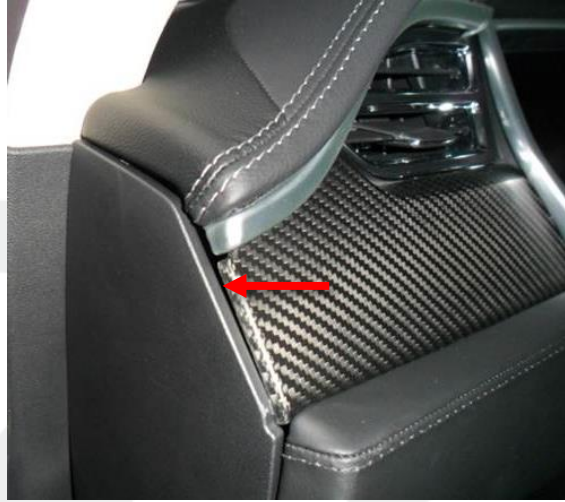
✗ **Figure 2 (Excessive gap)**

Some vehicles could have an excessive gap between the instrument panel side covers and the adjacent finisher panels.

Upon customer complaint, modify the clip towers to allow the instrument panel side covers to sit closer to the rest of the dash.
