# Front Bumper Carrier Bolt Replacement

**Classification** Campaign Bulletin    **Section/Group** 10 - Body    **Country/Region** All

**Year** 2012 - 2013    **Model** Model S    **Version** All

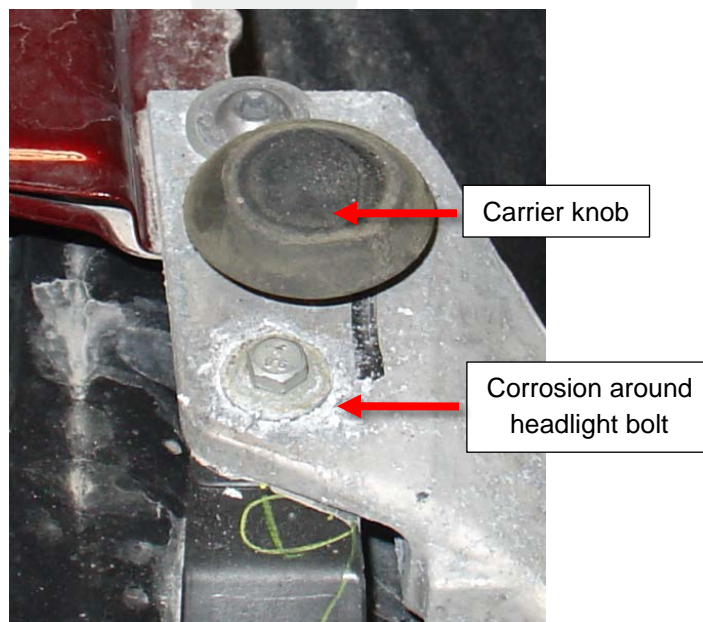
**Figure 2**

The bolts on the arms of the front bumper carrier might experience corrosion in extreme climates, causing a perceived quality issue. An upgraded set of aluminum bolts is now available.

3. Inspect the area around the bolt holes for signs of corrosion.
  - If corrosion is present (Figure 2), remove the carrier knob and clean the affected area(s) on the carrier surface and knob threads with a wire brush before continuing this procedure.
  - If corrosion is not present, continue this procedure.
