A-Pillar Lower Trim Panel Upgrade

Classification	Repair Bulletin	Section/Group	15 - Interior Trim	Country/Region	North America
Year	2012	Model	Model S	Version	All

This Service Bulletin supersedes SB-13-15-002 R1, dated 30-Jan-14. Each content change is marked by a vertical line in the left margin. Discard the previous version and replace it with this one.

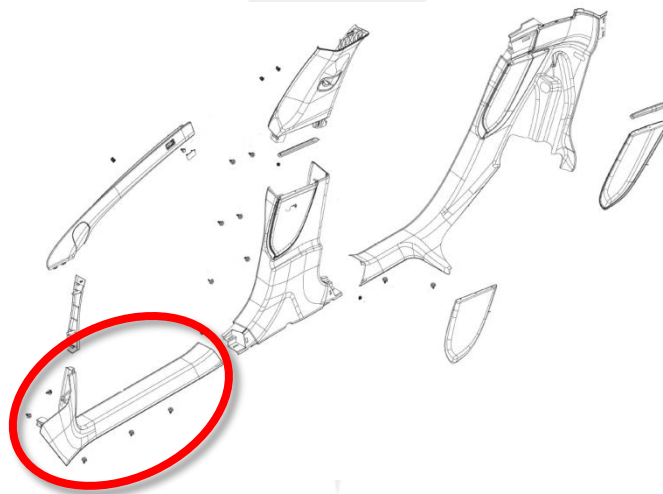
Figure 1 (RH side shown)

Upgraded A-Pillar lower trim panels are now available. These new panels are grained and fit better with the adjacent parts.

Upon customer complaint, replace the LH and RH A-pillar lower trim panels (Figure 1) with the upgraded parts.

1. Replace the LH and RH A-Pillar lower trim panels with the upgraded parts (refer to Service Manual procedure 15180102).
