Panoramic Roof Wind Noise, North America

Classification	Repair Bulletin	Section/Group	24 - Roof	Country/Region	North America
Year	2012-2013	Model	Model S	Version	All

This Service Bulletin supersedes SB-13-24-006 R2, dated 4-Jun-14. Each content change is marked by a vertical line in the left margin. Discard the previous version and replace it with this one.

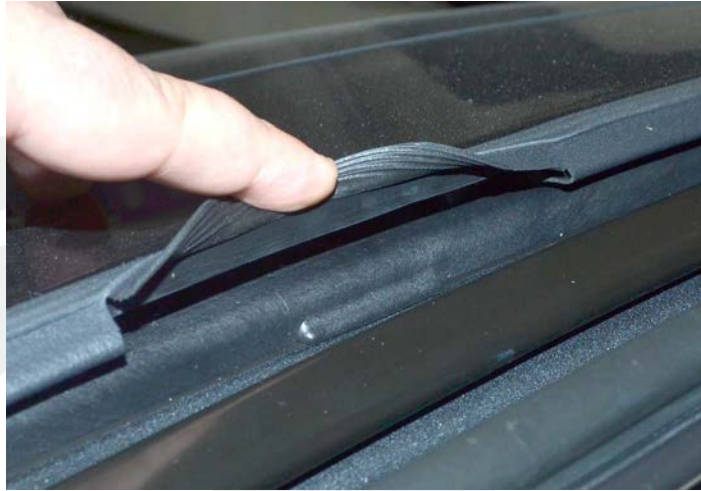
Figure 1

1. Fully open the moving glass.
2. Use a flashlight to look inside the hole in the front car cross seal (Figure 1). Inspect for an e-coated metal bracket that has black felt tape attached to the rear edge. If a bracket is present, do not continue with this procedure. If no bracket is present, continue this procedure.
