## Firmware Update for Automatic Charge Current Reduction

<b>Classification</b>	Recall Bulletin	<b>Section/Group</b>	00 - Inspection & Service	<b>Country/Region</b>	North America
<b>Year</b>	2012-2014	<b>Model</b>	Model S Charging Equipment	<b>Version</b>	All

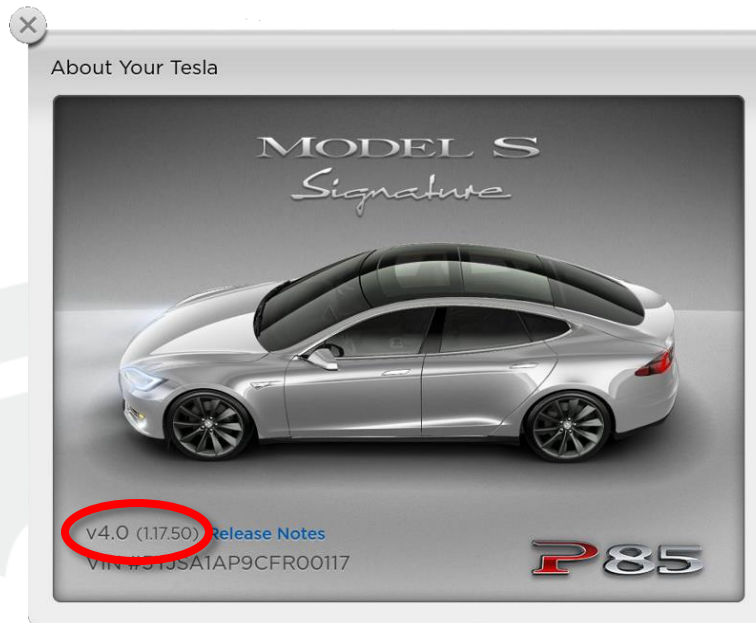
**Figure 1**

1. On the touchscreen, touch the Tesla logo. Check the version of the currently-installed firmware (Figure 1).

2. If the firmware version is 5.8.4 or later, the vehicle is up to date and no further work is needed. If the firmware version is earlier than 5.8.4, continue this procedure.
3. Connect a laptop with Toolbox to the vehicle.
4. In Toolbox, select Views > Firmware and ECU Programming > Vehicle Firmware Update, then follow the on-screen instructions.
