A/C Compressor Acoustic Cover and Bracket

Classification Repair Bulletin Section/Group 18 - Thermal Country/Region All

Year 2012-2014 Model Model S Version LHD

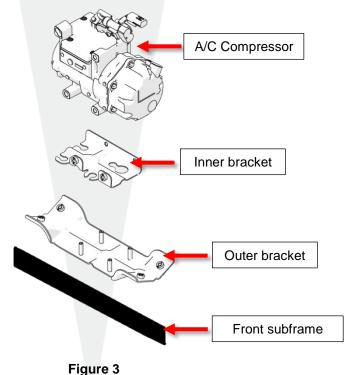
NOTE: The compressor mounts to an inner bracket, which attaches to an outer bracket. The outer bracket mounts to the front subframe (Figure 3). In this step, all 3 components are removed as one assembly.

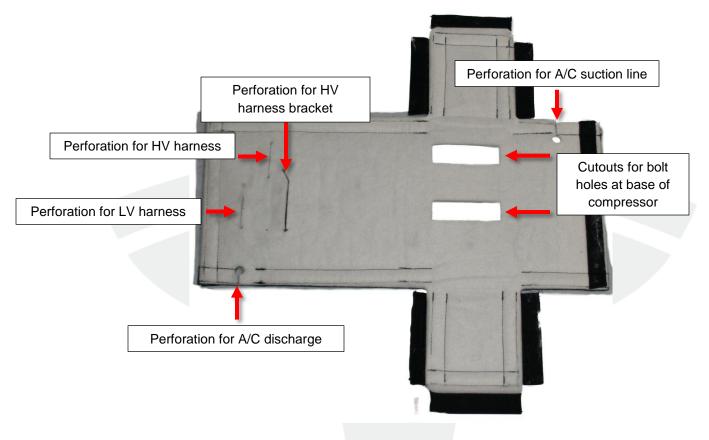
Figure 4

NOTE: The acoustic cover has cutouts for the bolt holes at the base of the compressor, as well as perforations for the A/C suction line, A/C discharge line, LV harness, HV cables, and HV harness.

- 3. Remove the compressor from the inner bracket (torque 24 Nm).
- Unfold the acoustic cover and lay it flat onto a workbench, with the white side facing up (Figure 4).
