Check HVJB Lid Insulator

Classification	Campaign Bulletin	Section/Group	44 - High Voltage System	Country/Region	All
Year	2014	Model	Model S	Version	All

Condition

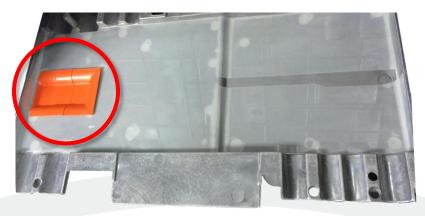
4. If there is no polyimide tape, check whether an orange plastic insulator is attached to the lid (Figure 2).

5. If there is no orange insulator, replace the lid with a new part. If there is an orange insulator, continue to the next step.
