Cold Draft or Wind Noise Coming From Fixed Glass

Classification Repair Bulletin **Section/Group** 11 - Closures **Country/Region** All

Year 2012-2015 **Model** Model S **Version** All

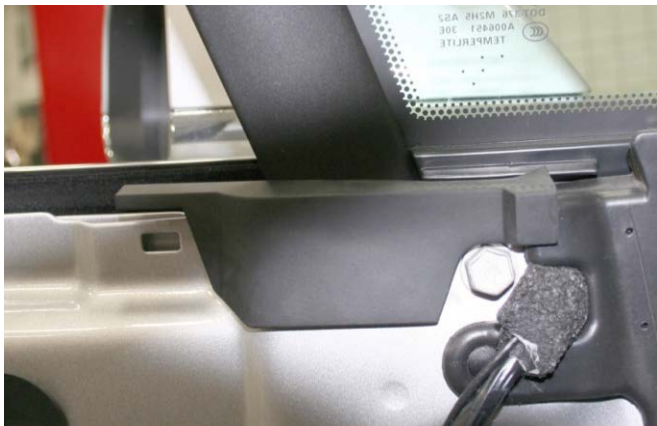
✓ **Figure 7 (Upgraded fixed glass seal)**

NOTE: If the vehicle is already equipped with the upgraded fixed glass seals (Figure 7), no more work is required on this side of the vehicle; reinstall the door panel and perform steps 1-7 on the passenger's side.

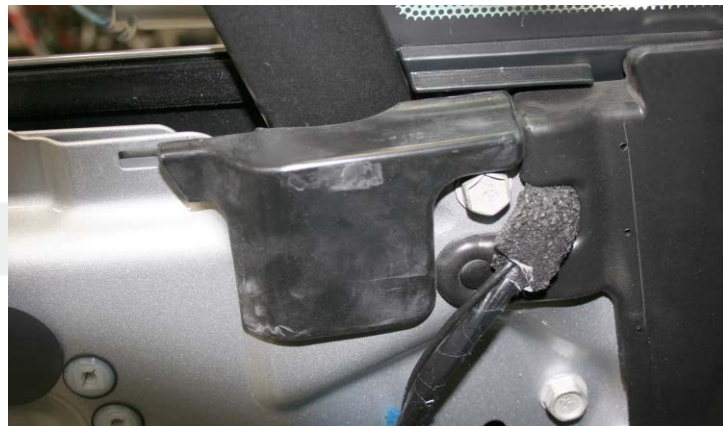
✗ **Figure 8 (Old fixed glass seal)**

8. If equipped, remove and discard the old fixed glass seal (Figure 8).

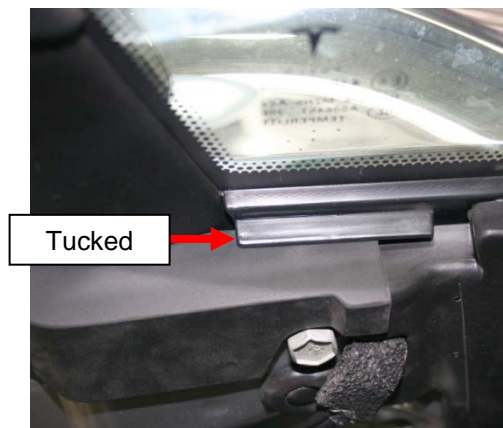
✓ **Figure 11 (Correct)**

10. Tuck the front portion of the fixed glass seal under the flap near the fixed glass (Figures 11 and 12).

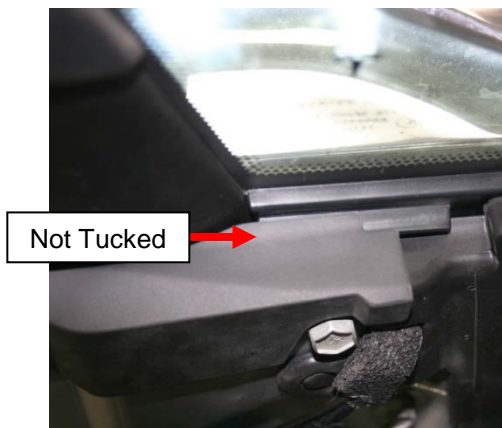
✗ **Figure 12 (Incorrect)**
