# Sun Visor Replacement

<b>Classification</b>	Repair Bulletin	<b>Section/Group</b>	15 - Interior Trim	<b>Country/Region</b>	All
<b>Year</b>	2012-2014	<b>Model</b>	Model S	<b>Version</b>	All

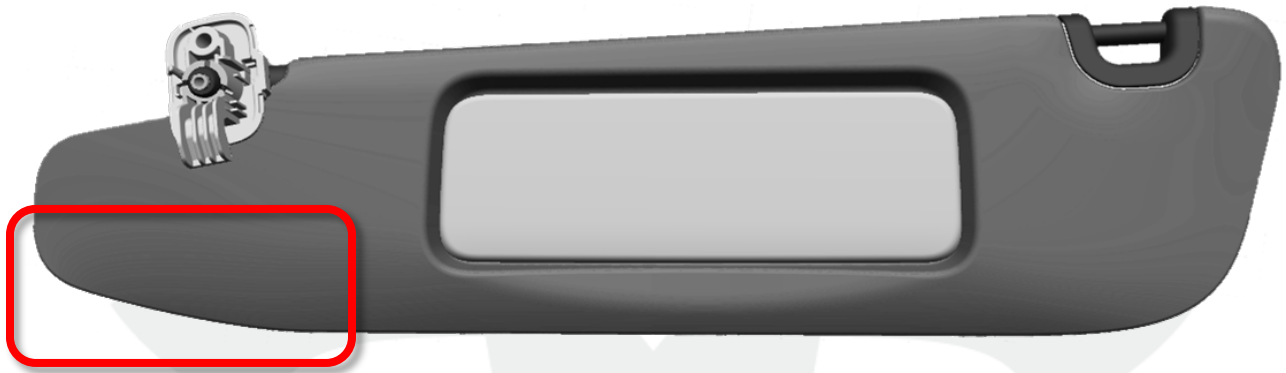
- If the corner is tapered (Figure 1), the second generation sun visors are already installed. Discontinue work on this procedure.
- If the corner is squared (Figure 2), continue to the next step in this procedure.

✓ **Figure 1 (Second generation sun visor)**

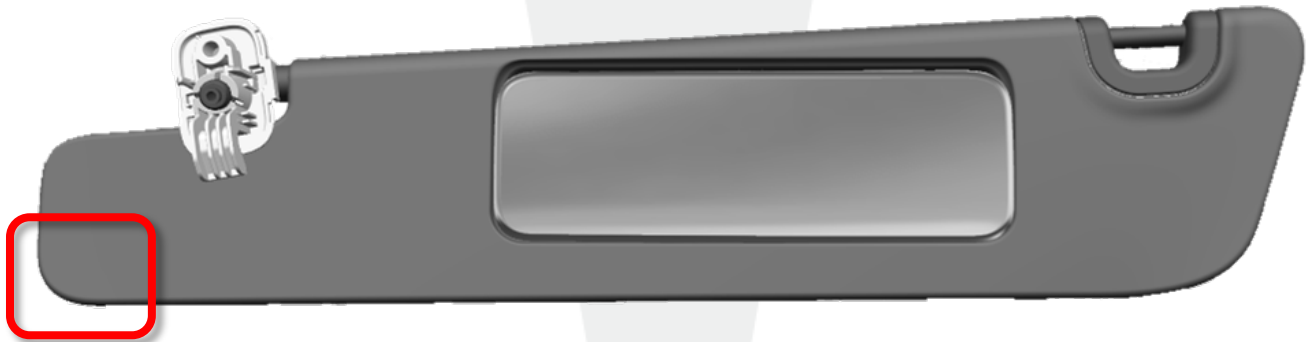
Vehicles built before approximately August 21, 2014 were equipped with first generation sun visors. The first generation sun visors and the attached mirrors are narrow, causing a perceived quality issue. Second generation sun visors are now available. The second generation sun visors have a smaller airbag warning label and are wider with larger mirrors.

✗ **Figure 2 (First generation sun visor)**

2. Remove and discard both first generation sun visors (refer to Service Manual procedure 15050602).

4. Install both second generation sun visors.
