Replace Aeroshield Support Tab, HV Battery 1.0/1.5

Classification	Repair Bulletin	Section/Group	16 - Battery System	Country/Region	All
Year	2012-2015	Model	Model S	Version	HV Battery 1.0/1.5

This Service Bulletin supersedes SB-15-16-002, dated 6-Nov-15. Each content change is marked by a vertical line in the left margin. Discard the previous version and replace it with this one.

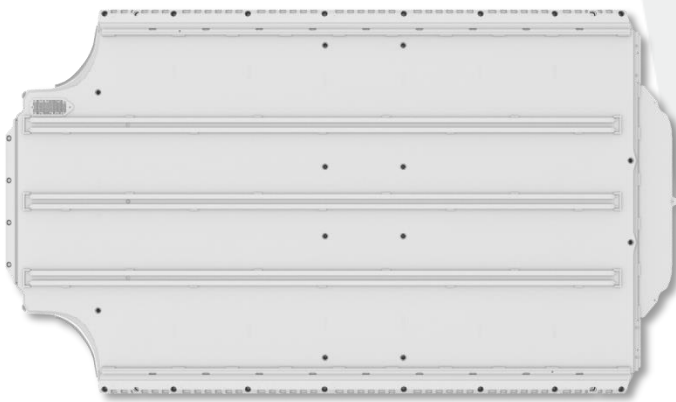
Figure 1 (Underside of HV Battery 1.0/1.5; no fuse cover or discharge port)

NOTE: This procedure applies only to HV Battery 1.0 and 1.5 (Figure 1). Refer to SB-15-16-003 for HV Battery 2.0 (Figure 2).
