Re-Torque 12V Fuse Box Nuts

Classification	Campaign Bulletin	Section/Group	17 - Electrical	Country/Region	United Kingdom, Asia Pacific
Year	2014-2015	Model	Model S	Version	RHD

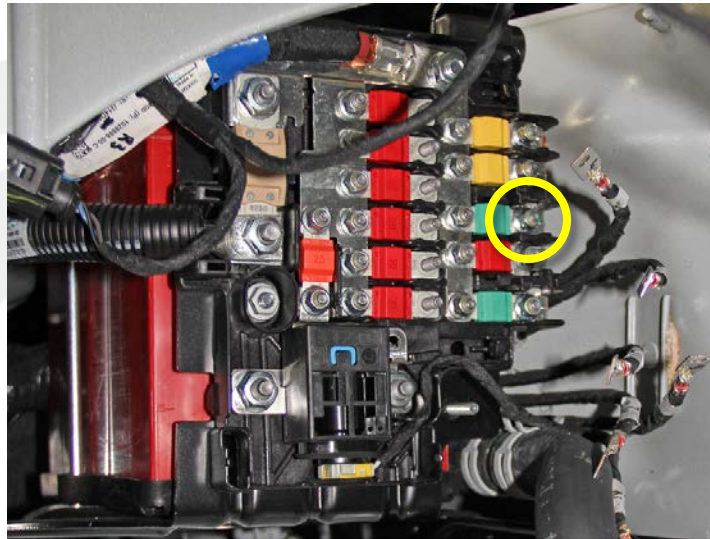
Figure 1

NOTE: The middle green fuse, fuse F82, is for the air suspension compressor (Figure 1). Vehicles with coil suspension do not have a nut or wire connected to the RH side of fuse F82.

1. Perform steps 1-7 in the "Removal" section in the RHD battery fuse box remove and replace procedure (refer to Service Manual procedure 17012302).
2. Re-torque the nuts that retain the inboard wires and fuses at the RH side of the fuse box (torque 5 Nm).
