## Retrofit Model S Fog Lamps

<b>Classification</b>	Campaign Bulletin	<b>Section/Group</b>	17 - Electrical	<b>Country/Region</b>	Canada, Europe
<b>Year</b>	2015	<b>Model</b>	Model S	<b>Version</b>	Premium Interior and Lighting Package

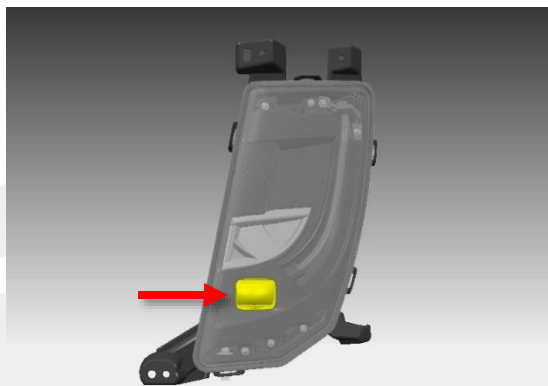
Some Canadian and European Model S vehicles were built without front fog lamps despite being configured with the Premium Interior and Lighting package.

1. Inspect the front lower lamp assemblies for fog lamp lenses (Figure 1).
  - If the lower lamps already have fog lamp lenses, discontinue this procedure.
  - If the lower lamps do not have fog lamp lenses, continue this procedure.

**Figure 1 (Fog lamp lens highlighted)**

2. Remove the front cornering lamps and replace them with fog lamps (refer to Service Manual procedure 17404002).

**NOTE:** Update the vehicle configuration, as described in Service Manual procedure 17404002.
