Install VIN Label on LH Rear Rail, China

Classification	Campaign Bulletin	Section/Group	19 - Labels	Country/Region	China
Year	2015	Model	Model S	Version	All

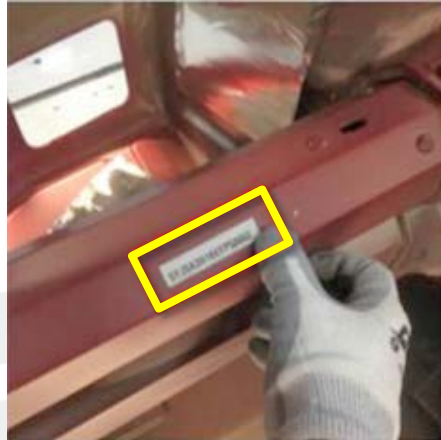
Figure 4

Some vehicles were shipped to China without a Vehicle Identification Number (VIN) label on the LH rear rail.

5. Secure the VIN label to the LH rear rail (Figure 4). Ensure that the label is centered and that there are no wrinkles or air bubbles.
