## Inspect Seat Belt Pre-Tensioner Rear Bracket Bolt, Model S

Classification	Campaign Bulletin	Section/Group	20 - Safety and Restraint	Country/Region	United States
Year	2015	Model	Model S	Version	All

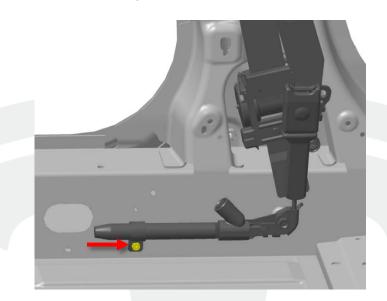
On some vehicles, the seat belt pre-tensioner rear bracket bolt might have been assembled using a higher torque than specified by the bolt grade. The bolt is not critical for pre-tensioner performance, but in order to ensure a bolt torque consistent with the bolt specification, these bolts should be discarded and replaced, if necessary.

- 1. Remove the LH lower B-pillar trim panel (refer to Service Manual procedure 15184401).
- 2. Inspect the bolt that secures the seat belt pre-tensioner support bracket to the body of the vehicle (Figure 1).
  - If the bolt is black, reinstall the LH lower B-pillar trim panel and repeat steps 1-2 on the RH side of the vehicle.
  - If the bolt is silver, continue to the next step.

3. Remove and discard the bolt.

NOTE: There is a push nut on the bolt. Discard the push nut and install the new bolt without a push nut.

- 4. Install a new bolt (torque 5 Nm).
- 5. Reinstall the LH lower B-pillar trim panel.
- 6. Repeat the procedure on the RH side of the vehicle.
