Install Ferrite Bead on Forward Junction Box Wires to Reduce Radio Noise

Classification	Repair Bulletin	Section/Group	21 - Infotainment	Country/Region	All
Year	2013-2015	Model	Model S	Version	All

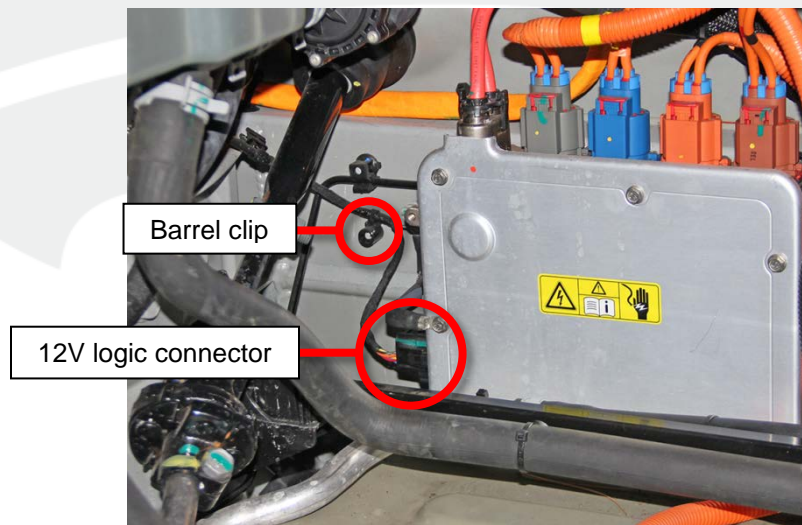
Figure 1

1. Disconnect 12V power (refer to Service Manual procedure 17010100).
2. Remove the underhood storage extension box (refer to Service Manual procedure 15240902).
3. Disconnect the 12V logic connector (X040) from the forward junction box (FJB) (Figure 1).

TIP: It might be helpful to release the barrel clip that secures the harness to the stud on the bulkhead (Figure 1).

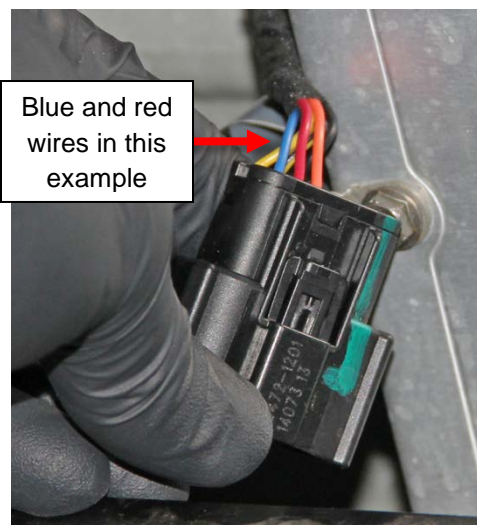
Figure 2

4. Identify the affected wires (Figure 2) attached to pins 5 and 6 (Figure 3) on the FJB logic connector.

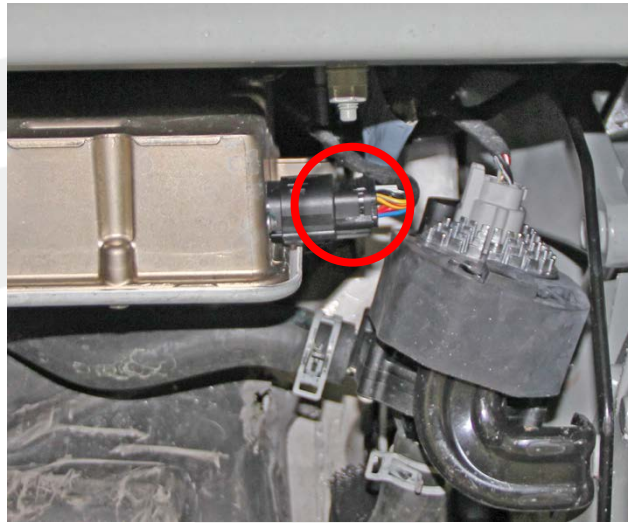
Figure 6

1. Remove the HV Battery (refer to Service Manual procedure 16010101).
2. Working underneath the vehicle, disconnect the 12V logic connector (X040) from the forward junction box (FJB) (Figure 6).

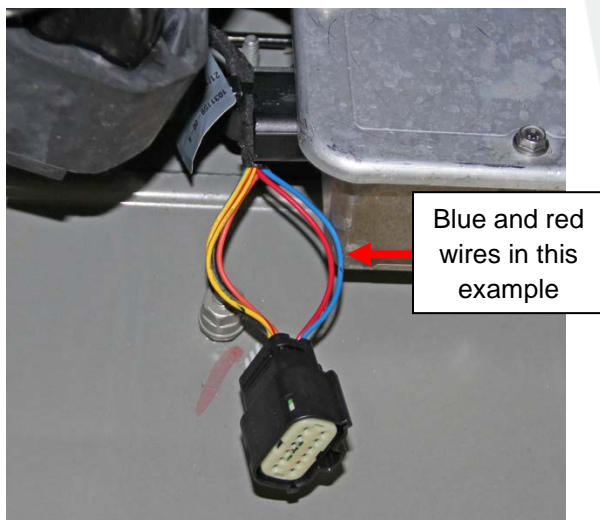
Figure 7

5. Identify the affected wires (Figure 7) attached to pins 5 and 6 (Figure 8) on the FJB logic connector.
