High Speed Suspension Retrofit, Germany

Classification	Parts and Accessories Bulletin	Section/Group	31 - Suspension	Country/Region	Germany
Year	All	Model	Model S	Version	RWD

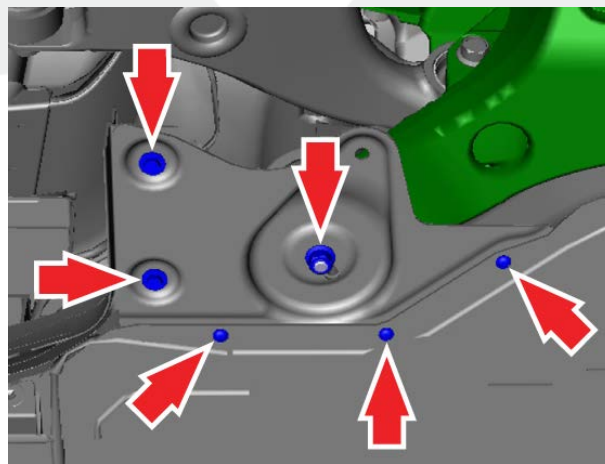
Figure 1

3. Remove the rear arch liners (refer to Service Manual procedure 12011102).
4. Remove the rear aero shield (refer to Service Manual procedure 12030501).
5. Remove the subframe shear plates by removing the nut (torque 35 Nm), 2 clips, and 3 screws (torque 4 Nm) that secure each shear plate to the subframe (Figure 1).

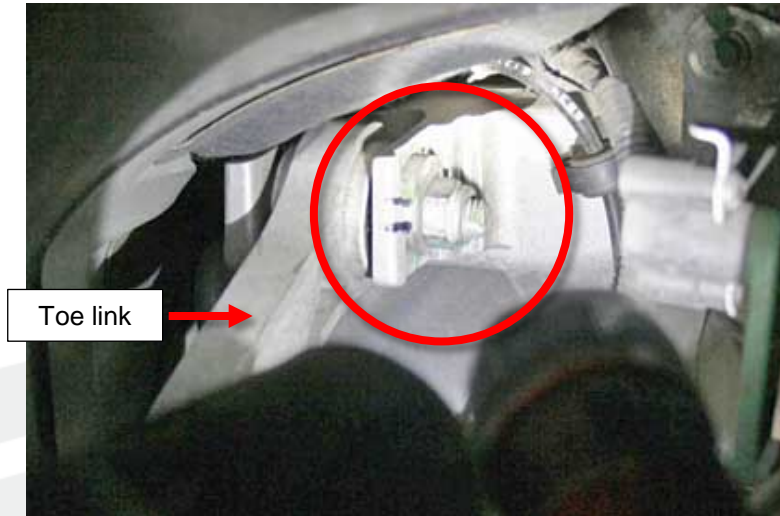
Figure 2 (LH side shown)

8. Remove the nut and washer from the bolt that secures the toe link to the subframe (torque 80 Nm) (Figure 2).

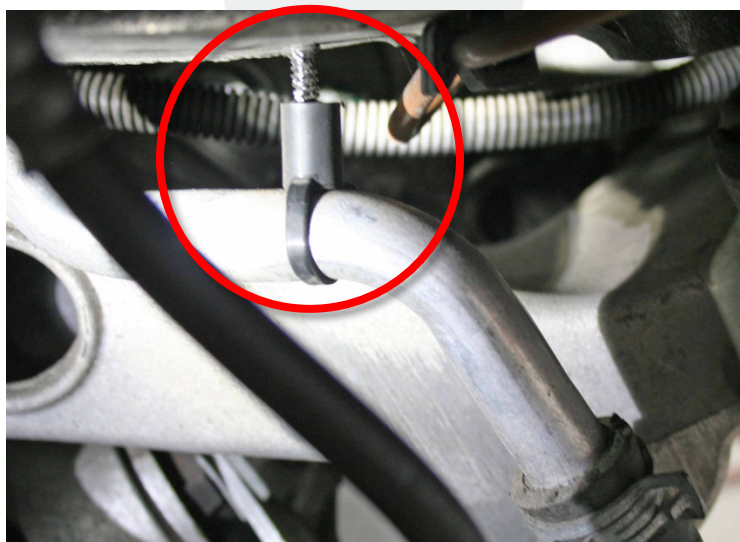
Figure 3

9. On the LH side of the vehicle, release the pipe retainer from the body stud (Figure 3).

21. Resecure the pipe retainer to the body stud (Figure 3).

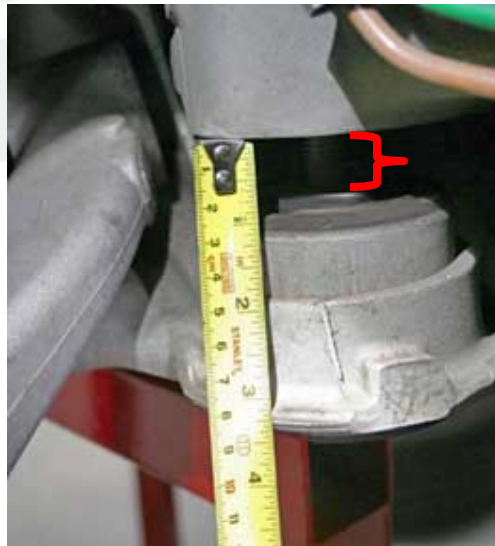
Figure 4

NOTE: To determine how much the vehicle has been raised, measure the distance between the body and the bolt hole on the subframe (Figure 4).

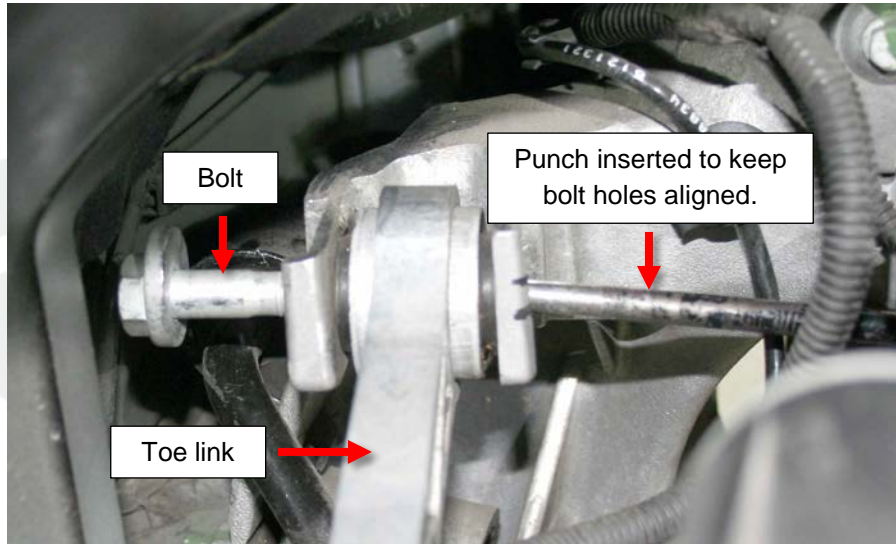
Figure 5

TIP: As the bolt is removed, insert a punch or similar tool into the hole to maintain the alignment of the bolt holes in the toe link and the subframe (Figure 5). This makes installation of the new bolt easier.

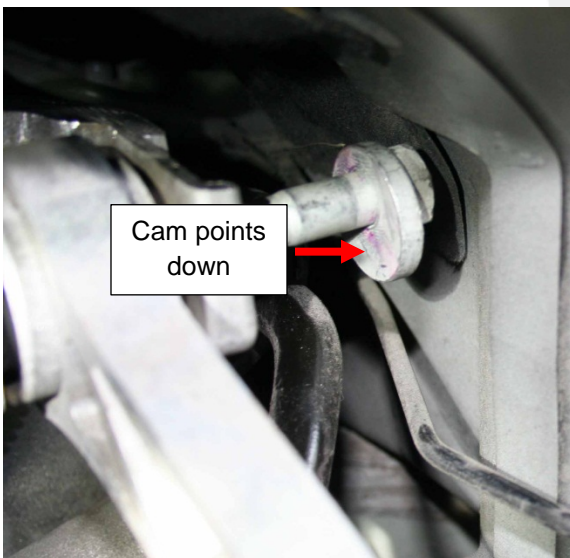
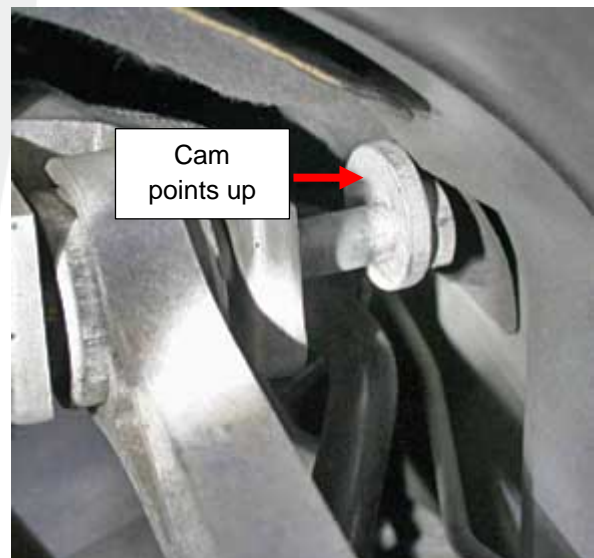
13. Rotate the LH toe link bolt so that the cam points down (Figures 6 and 7).

✓ Correct
Figure 6

✗ Incorrect
Figure 7

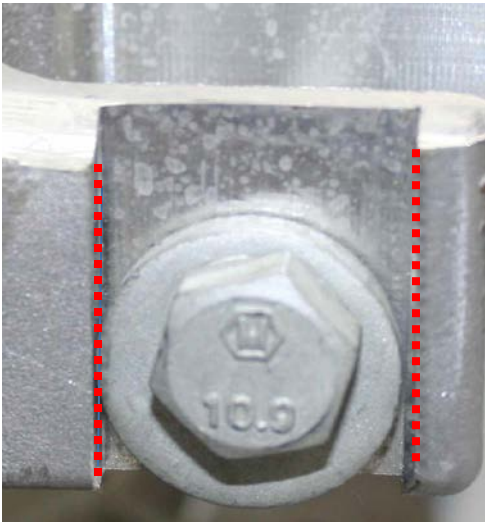
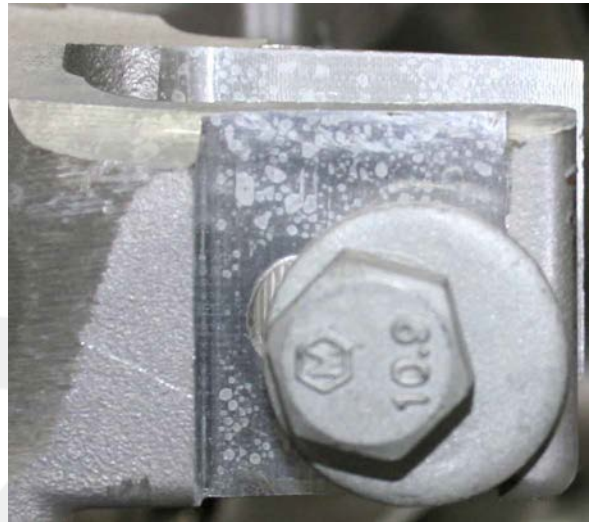
15. Install the new bolt. Ensure that the entire cam rests within the notch on the subframe (Figures 8 and 9).

✓ Correct
Figure 8

✗ Incorrect
Figure 9

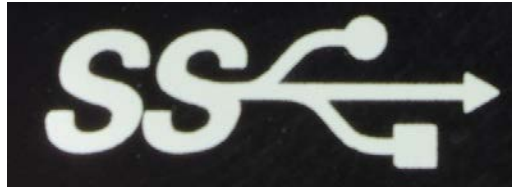
✗ Figure 10

NOTE: Before continuing, inspect the laptop's USB ports. Do not use a port with the "SS" symbol (Figure 10).
